06895 Version 1

Popping or No Sound from Speakers

AFFECTED VEHICLES

Year	Model	Trim	VIN Range
2016	Civic	Touring	ALL

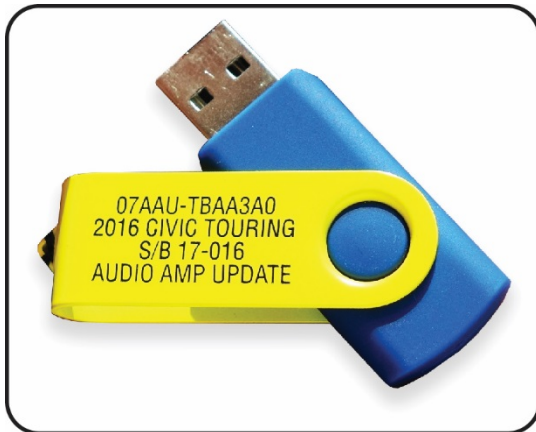
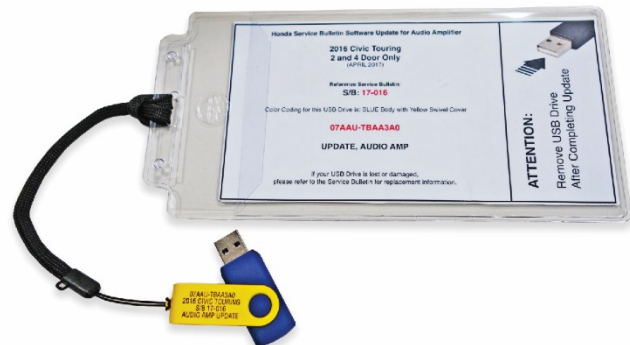
Part Name	Part Number	Quantity
2016 Civic (Yellow/Blue) USB Update Device	07AAU-TBAA3A0	1

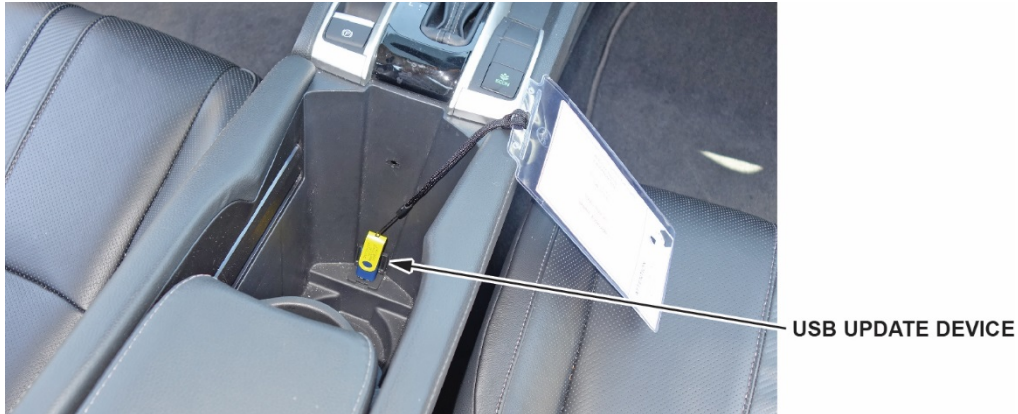
1. Connect a battery charger or a fully charged jumper battery to the vehicle, and leave it connected during the entire update procedure to maintain a steady voltage.
2. Insert the USB update device into the USB port in the center console.

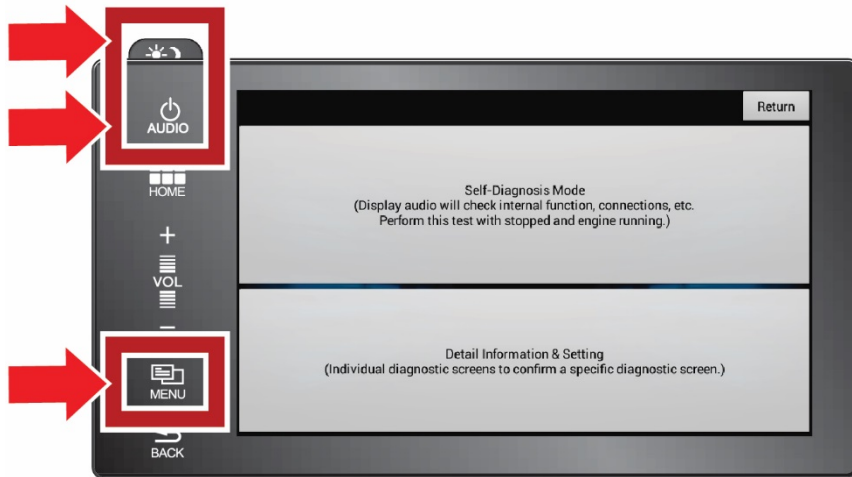
3. Turn the ignition to ON.
4. Allow the audio system to boot up (about 20 seconds), then press and hold the **MENU** icon, **AUDIO** icon, and Display Mode button at the same time until the diagnostic screen appears.

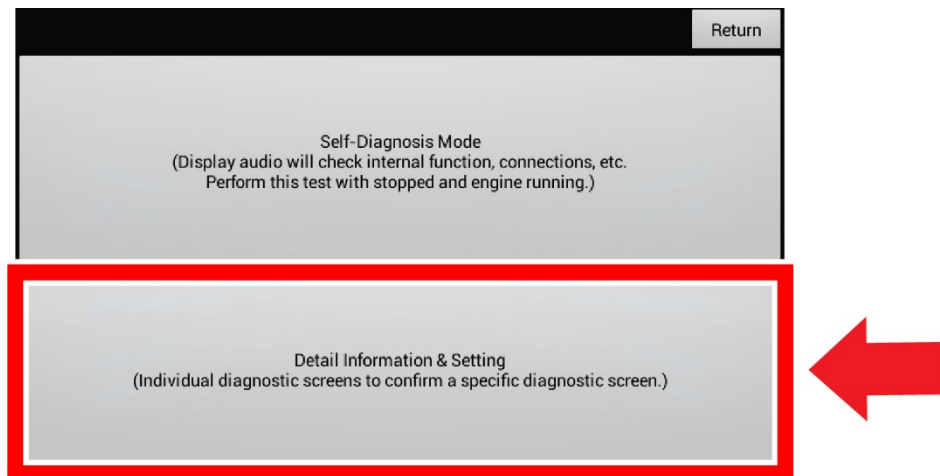
5. Select **Detail Information & Setting**.

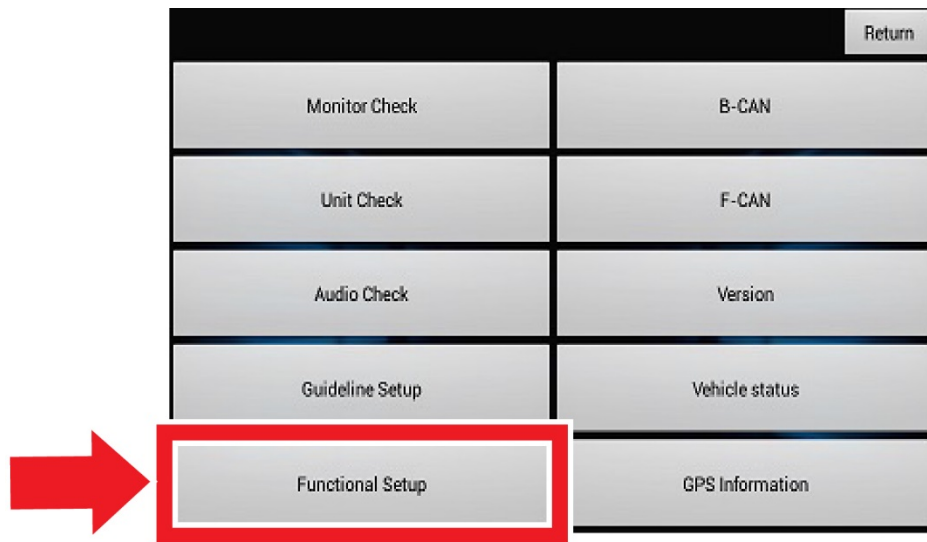
6. Select **Functional Setup**.

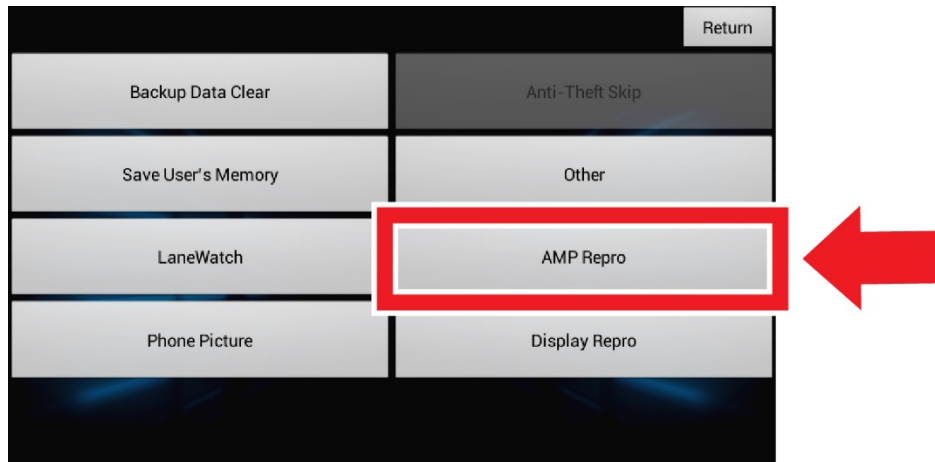
7. Select **AMP Repro**.

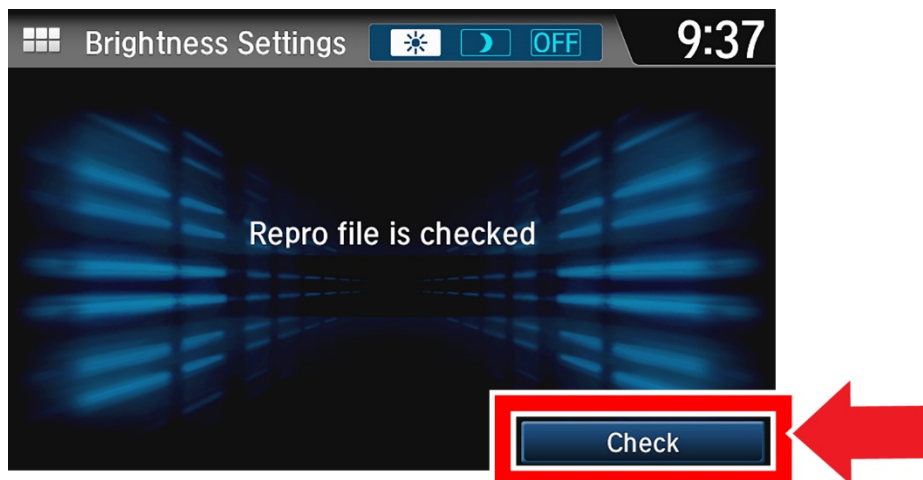
8. Select **Check**.

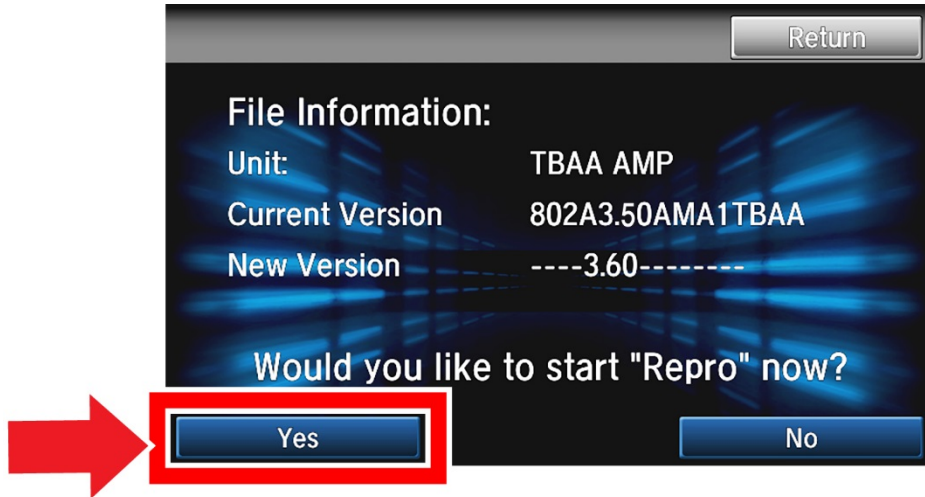
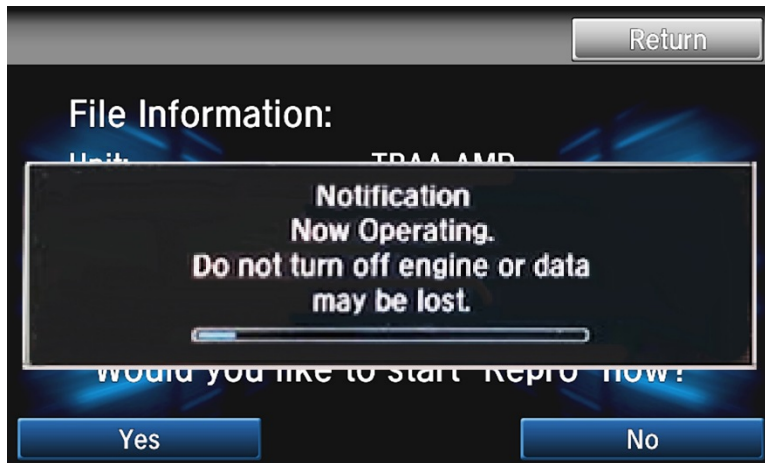
9. Select **Yes** to start the update.

NOTE: Once the update begins, no action is needed. The update will take about 15 minutes. You do not need to stay with the vehicle.

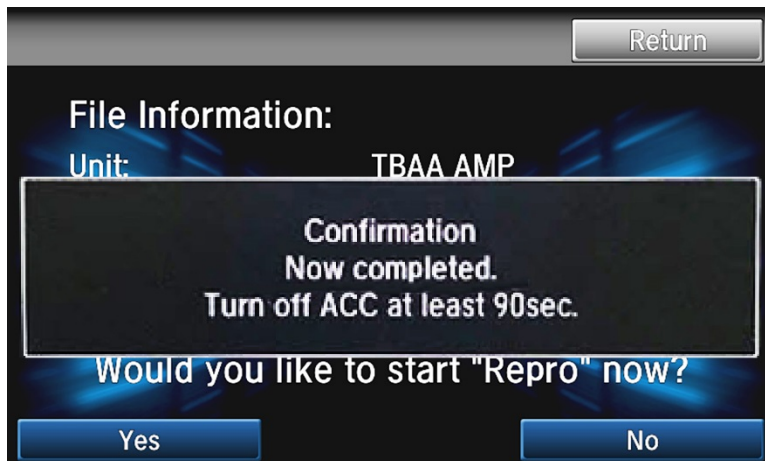
10. When the update is complete, the confirmation screen will appear. **Do not remove the USB update device.**

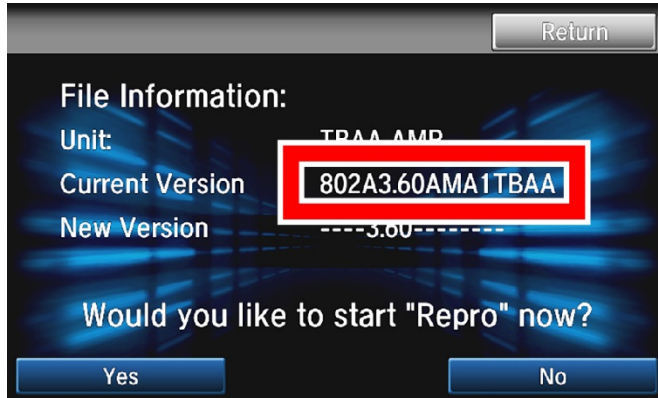
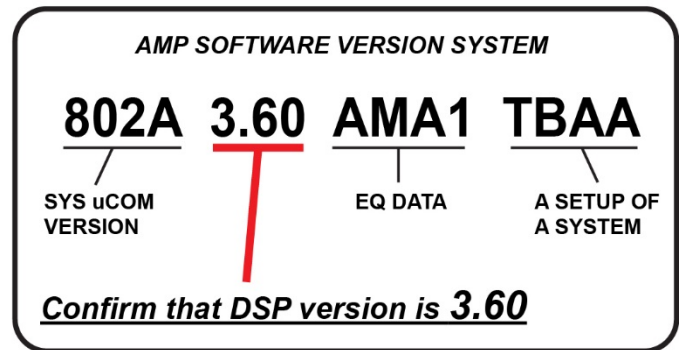
12. Turn the ignition to ON, and do steps 3 through 8 to confirm the DSP software version was updated.

Software	Software Version
SYS uCOM	802A
DSP	3.60
EQ DATA	AMA1
A setup of a system	TBAA
