JTB00549NAS2

# TECHNICAL BULLETIN

413-13: Parking Aid

Parking Aid System Sounds With No Objects Nearby

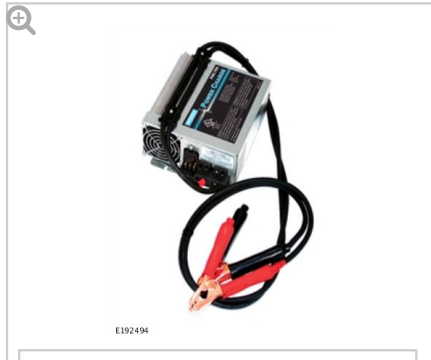
Jaguar Land Rover-  
approved Midtronics  
battery power supply

- **A Jaguar Land Rover-approved Midtronics battery power supply must be connected to the vehicle battery during diagnosis / module programming.**
- **Make sure all ignition ON/OFF requests are carried out; failure to perform these steps may cause damage to control modules in the vehicle.**

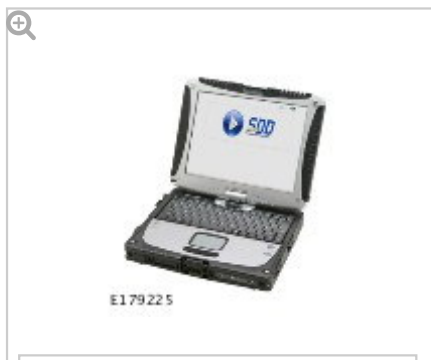
Jaguar Land Rover-  
approved diagnostic tool  
with latest SDD software,
