LTB01009NAS2

TECHNICAL BULLETIN

415-00

InControl® Touch Pro™ Features May Not Function As Expected (Additional Updates)

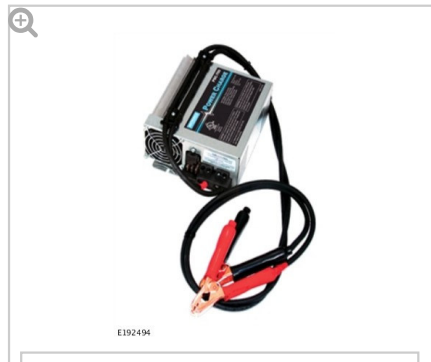
Jaguar Land Rover-
approved Midtronics
battery power supply

- Battery support unit: it is extremely critical to use a battery support unit and have a vehicle with a battery that has a good state of health to start. The battery support unit must also be in proper working condition to be able to supply 13v consistently. If the voltage is compromised during the installation of software, the IMC may switch off.

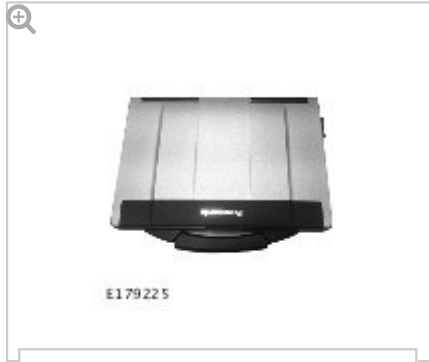
Jaguar Land Rover-approved diagnostic tool with latest SDD software, Calibration File, and InControl® Touch Pro™ Software

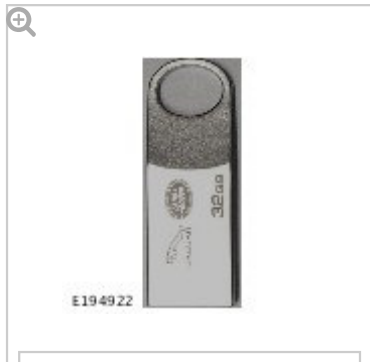
DTSE9G2/32GB
Jaguar Land Rover-approved USB memory device
