LTB01028NAS1

TECHNICAL BULLETIN

Incorrect Symbols for 'Night Speed' and/or 'No Overtaking' Unintentionally Displayed in the Message Center

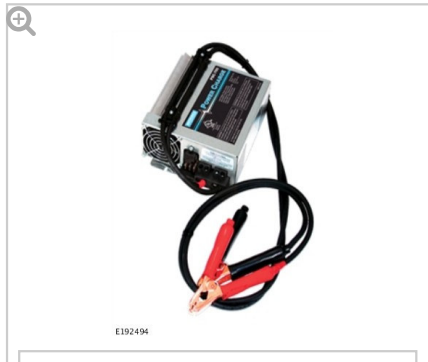
Jaguar Land Rover-
approved Midtronics
battery power supply

- **A Jaguar Land Rover-approved Midtronics battery power supply must be connected to the vehicle battery during diagnosis / module programming.**
- **Make sure all ignition ON/OFF requests are carried out; failure to perform these steps may cause damage to control modules in the vehicle.**

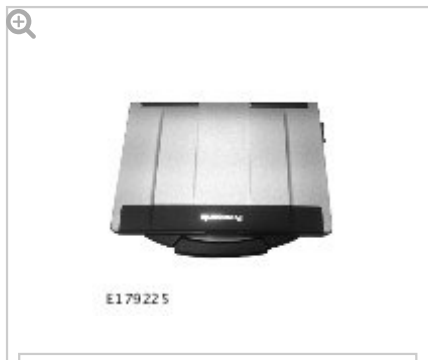
Jaguar Land Rover-
approved diagnostic
tool with latest SDD
software, Calibration File
