# TECHNICAL BULLETIN

415-00

Service Action: InControl Touch Pro Phase 2.5 Software Update

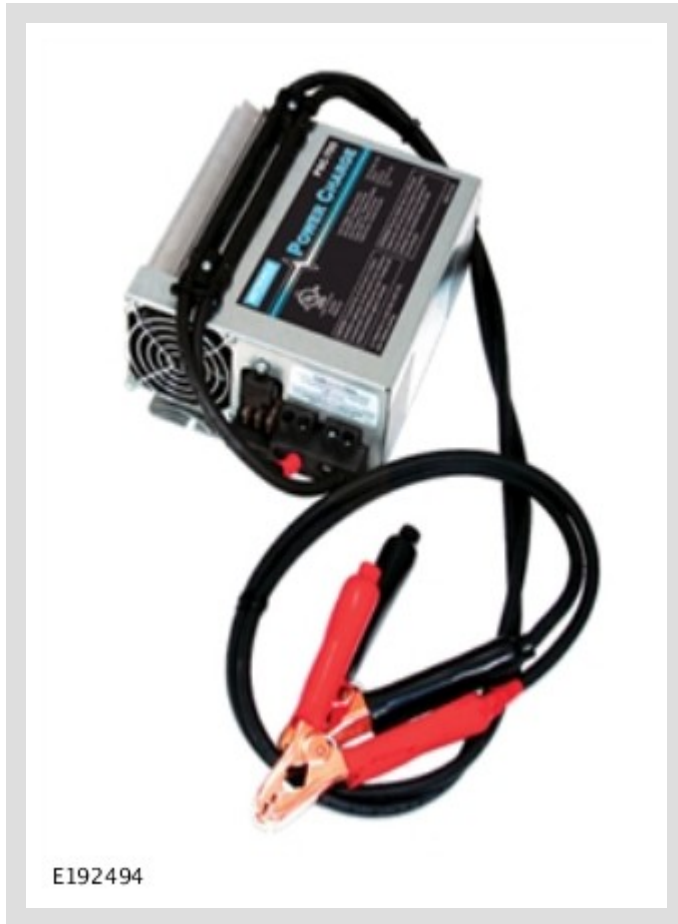
Jaguar Land Rover-approved Midtronics Battery Power Supply

- Battery support unit: it is extremely critical to use a battery support unit and have a vehicle with a battery that has a good state of health to start. The battery support unit must also be in proper working condition to be able to supply 13v consistently. If the voltage is compromised during the installation of software, the IMC may switch 'OFF'.
