07227 Version 1

MIL Comes On with DTC P0430 (Front Bank Catalyst System Efficiency Below Threshold [Bank 2])

AFFECTED VEHICLES

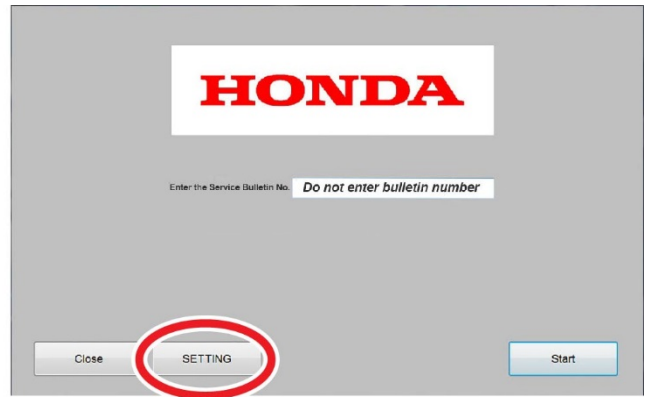
To change this, click on either of the **SETTING** selection buttons at the bottom of the J2534 initial screens as shown.

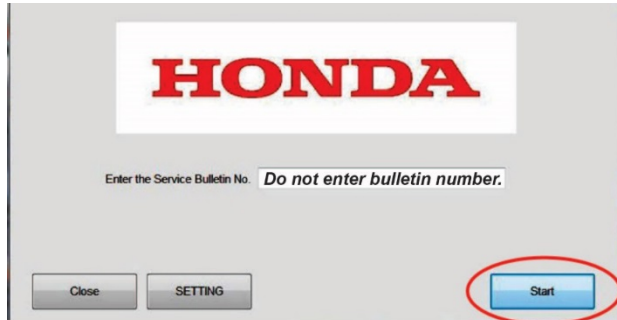
4. Select **Start**, then follow the screen prompts.

- **Do not enter a bulletin number.**
- If you receive a message that the vehicle has been already updated or that no update is available, check the **PGM-FI Data List**. The header should indicate one of the following numbers (or later):

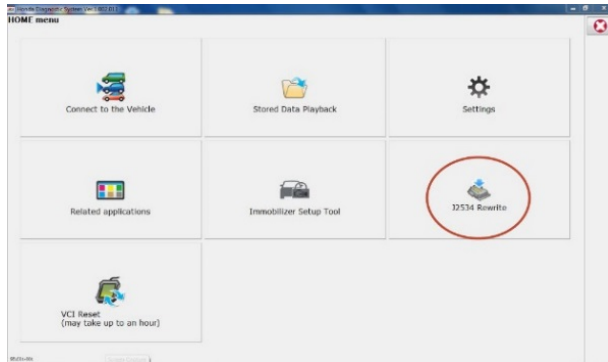
1. Select **J2534 Rewrite**.

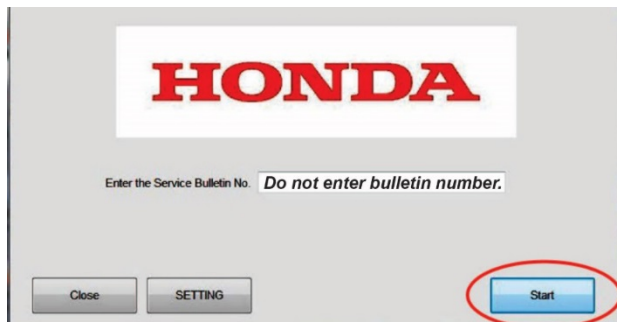
2. Select **Start**.

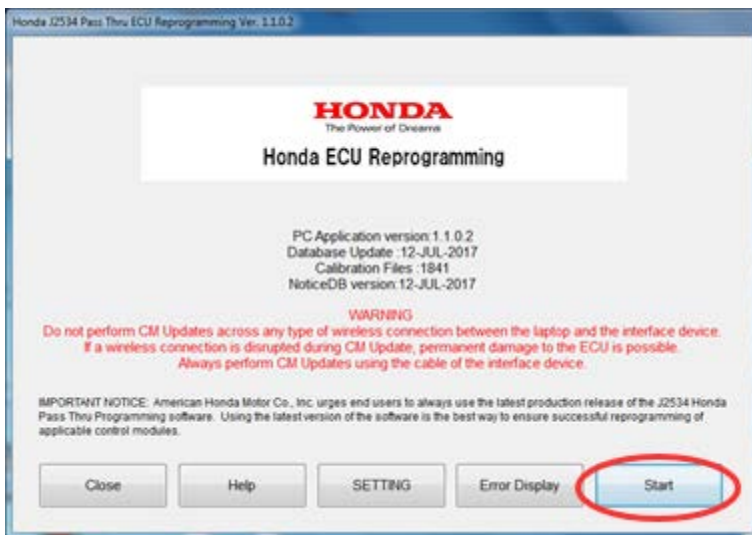
3. Select **Start**.

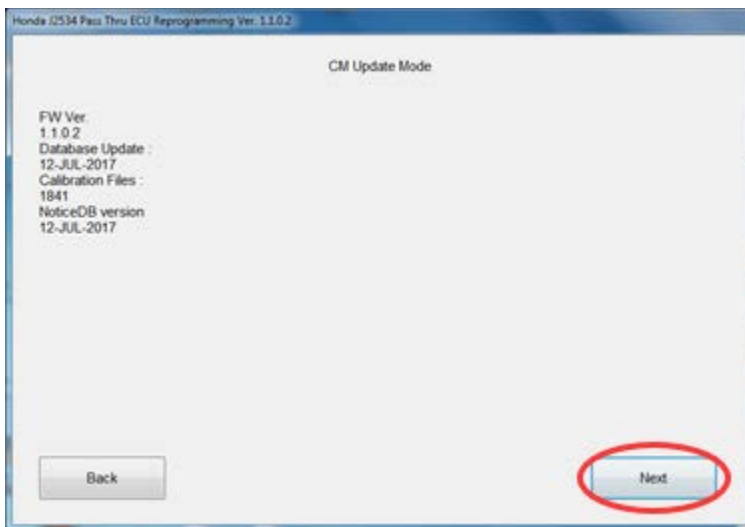
4. Select **Next**.

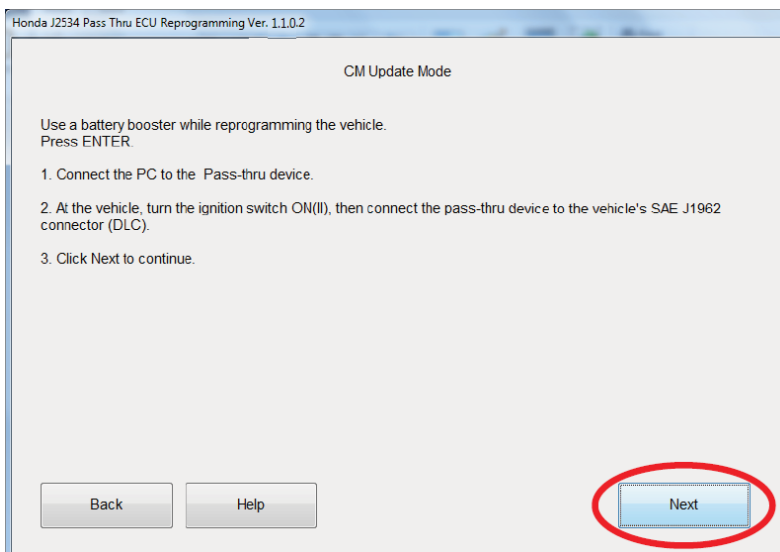
5. Select **Next**.

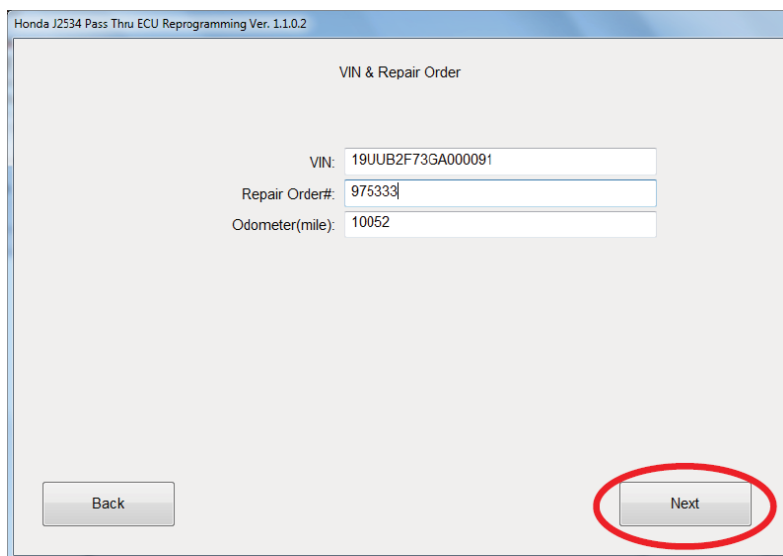
6. Select **Next** and a loading screen will appear.

Honda J2534 Pass Thru ECU Reprogramming Ver. 1.1.0.2

VIN & Repair Order

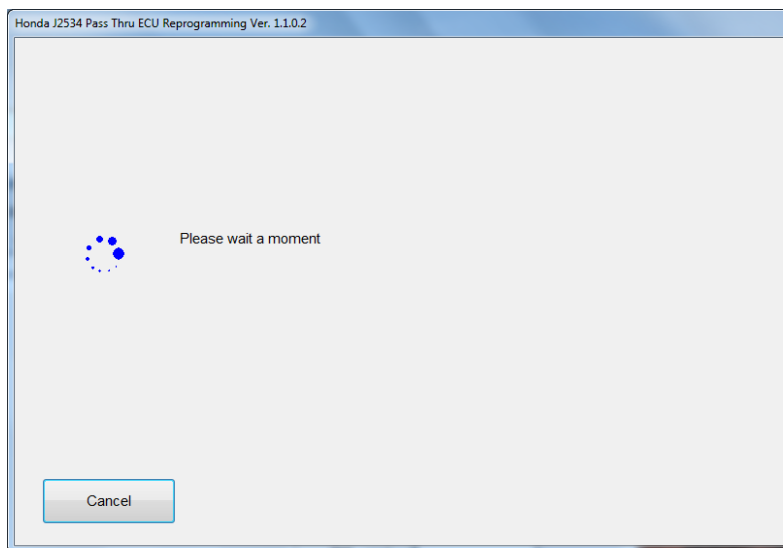
Honda J2534 Pass Thru ECU Reprogramming Ver. 1.1.0.2

Please wait a moment
