AT17-002b

2016-2017 QX80; 7-3 DOWN SHIFT SHOCK AND/OR LACK OF POWER/HESITATION

APPLIED VEHICLES: 2016-2017 QX80 (Z62)

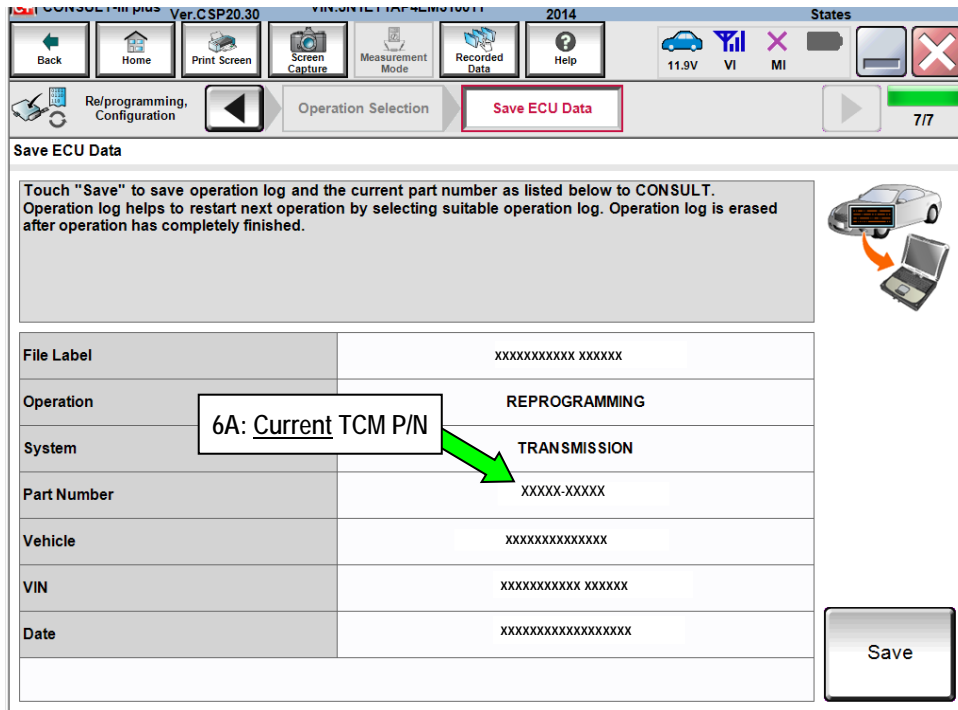
6. When you get to the screen shown in Figure 2, confirm this bulletin applies as follows.

A. Find the TCM Part Number and write it on the repair order.

NOTE: This is the current TCM Part Number (P/N).

5. Follow the on-screen instructions and navigate C-III plus to the screen shown in Figure 2 on the next page.

B. Compare the P/N you wrote down to the numbers in the **Current TCM Part Number** column in **Table A** below.

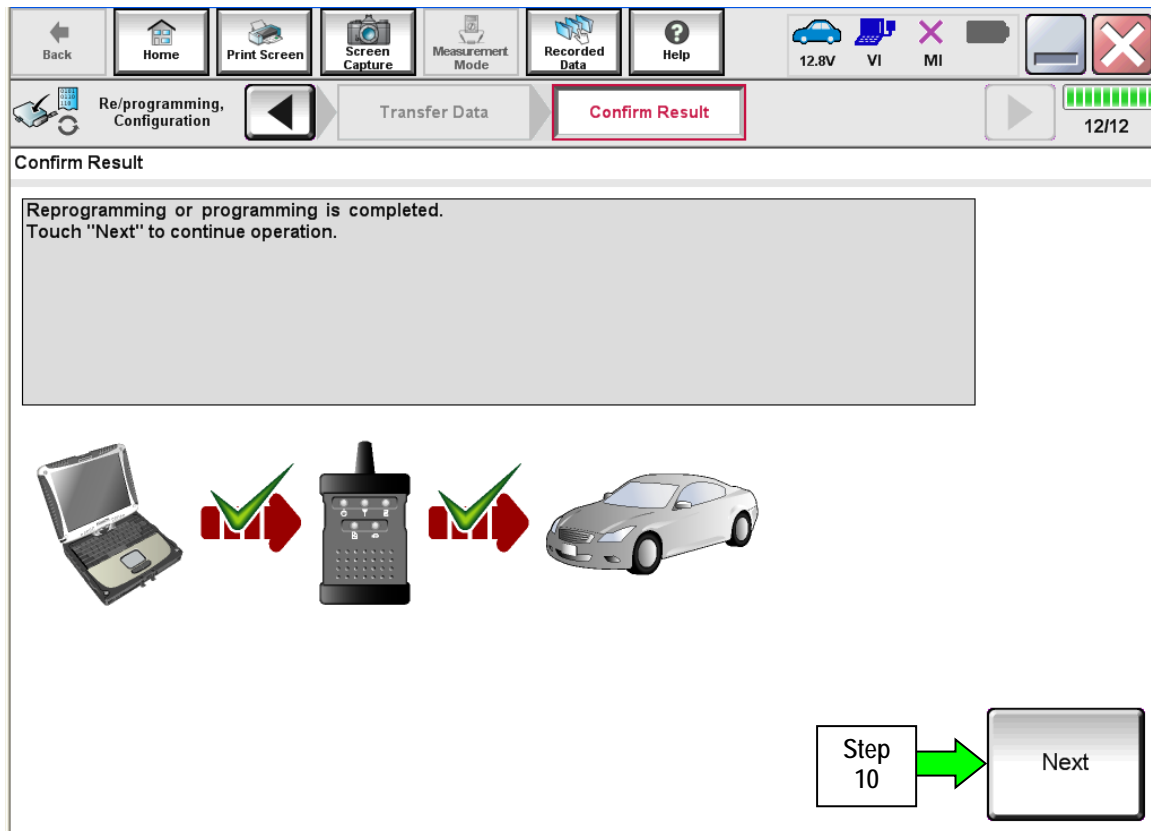
8. When the screen in Figure 4 displays, reprogramming is complete.

NOTE: If the screen in Figure 4 does not display (indicating that reprogramming did not complete), refer to TCM recovery on the next page.

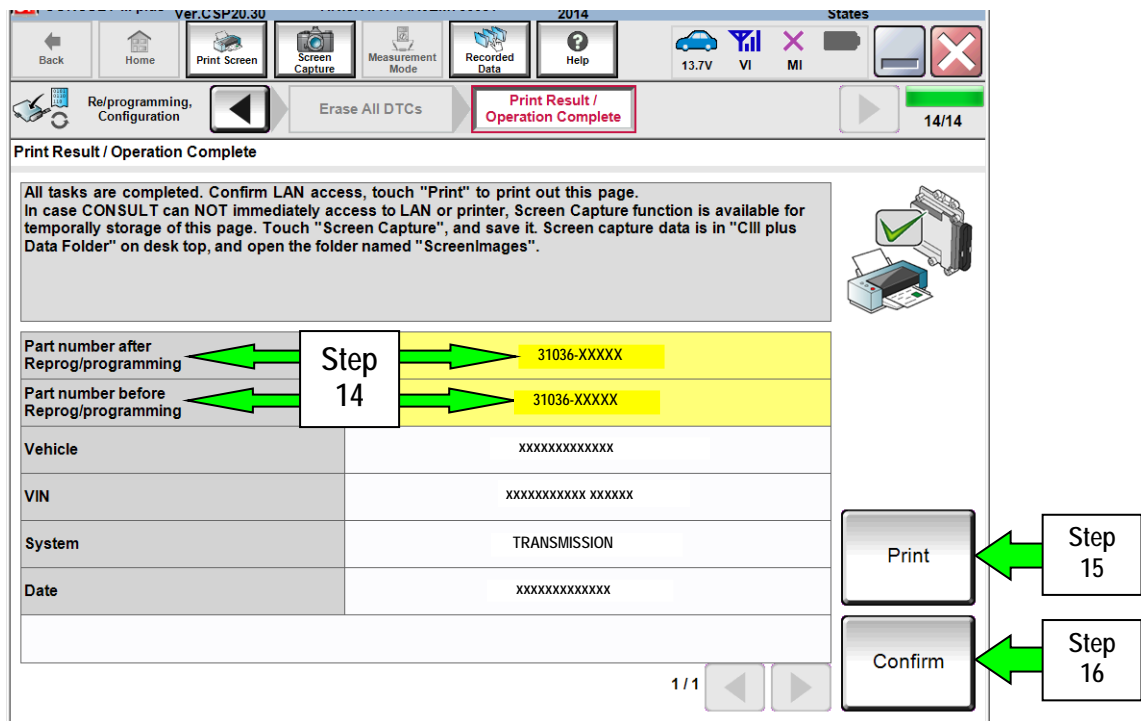
11. Follow the on-screen instructions to **Confirm Shift Lever Position Display**.
12. Follow the on-screen instructions to **Erase DTCs**.
13. When the entire reprogramming process is complete, the screen in Figure 7 will display.
14. Verify the before and after part numbers are different.
15. Print a copy of this screen (Figure 7) and attach it to the repair order for warranty documentation.
16. Select **Confirm**.
