SERVICE BULLETIN

Classification: EC13-007a	Reference: NTB13-054a	Date: August 14, 2017
------------------------------	--------------------------	--------------------------

ALTIMA AND ROGUE; ENGINE TURNS OFF OR HESITATES WHEN ACCELERATING FROM A STOP DURING HOT AMBIENT TEMPERATURES (+100° F)

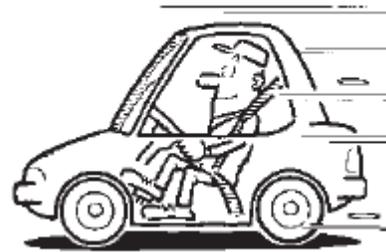
Figure A

- Take the vehicle for a 10 minute drive in order to meet the following Idle Air Volume Learn (IAVL) conditions:
 - Engine coolant temperature: 70 -100°C (158 -212°F)
 - Battery voltage: More than 12.9V (At idle)
 - Transmission: Warmed up
