WH30 - Re-programming the Airbag Control Unit (Workshop Campaign)

Model Line: Panamera (971)

Subject: Airbag control unit

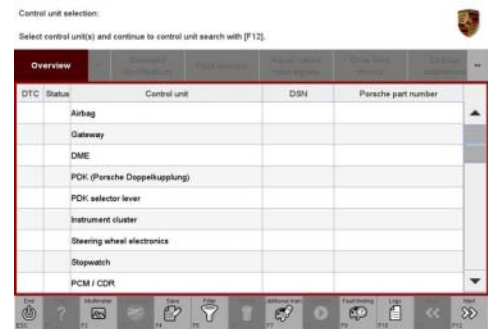
Control unit selection

- 6 Once you have erased the fault memories, select the '**Overview**' menu to return to the control unit selection screen ⇒ *Control unit selection*.
