MODEL: Karma Revero

TITLE: Baseline BL1021 Release

APPLICABILITY: MY17 and MY18 Revero

PURPOSE: This document will be used as a reference guide for technicians to update a vehicle to Baseline 1021

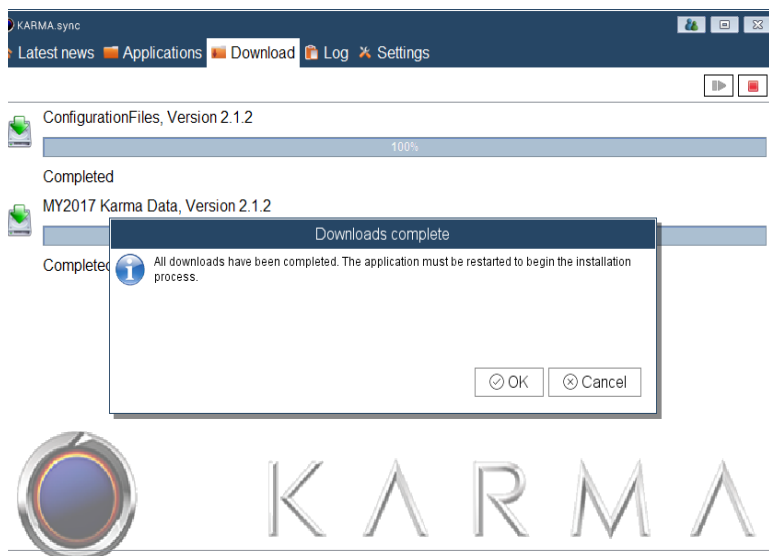
fig.2b

5. When download is complete, follow the on screen prompt, to allow the Software to update on the next restart (fig.2b). Doing this restart is a complete closing of Karma SYNC and relaunching as the to restart the program.

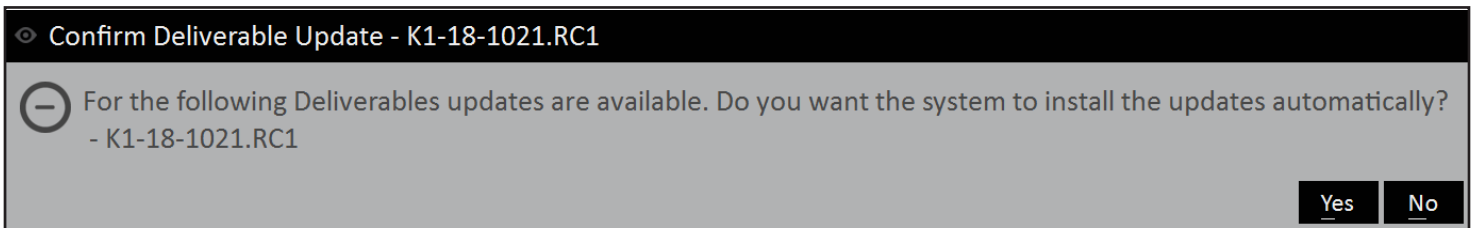
fig.4a

6. Open the Karma Sync application again.
The “Confirm Deliverable Update - K1-18-1021.RC1” box should appear, click “Yes” (fig.4a)

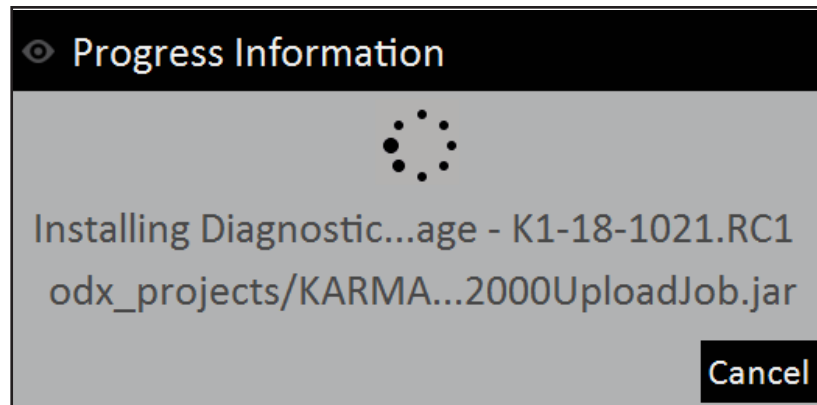
fig.4b

A progress screen will pop up after (fig.4b)

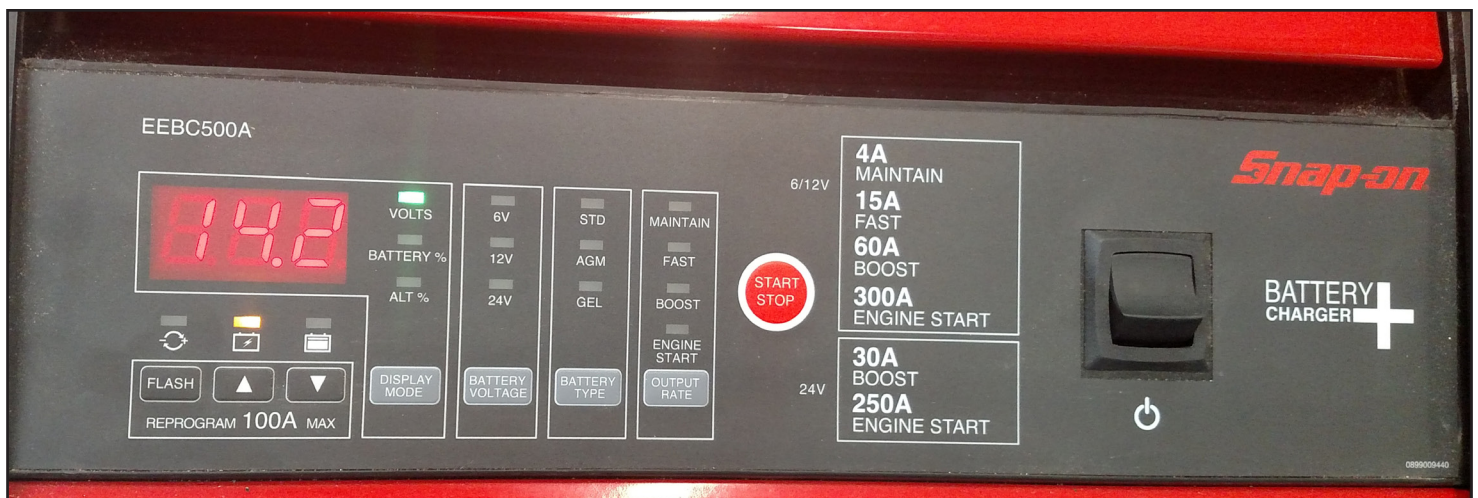
fig.8b

Below is an example of a suitable and recommended power supply (fig.8b)

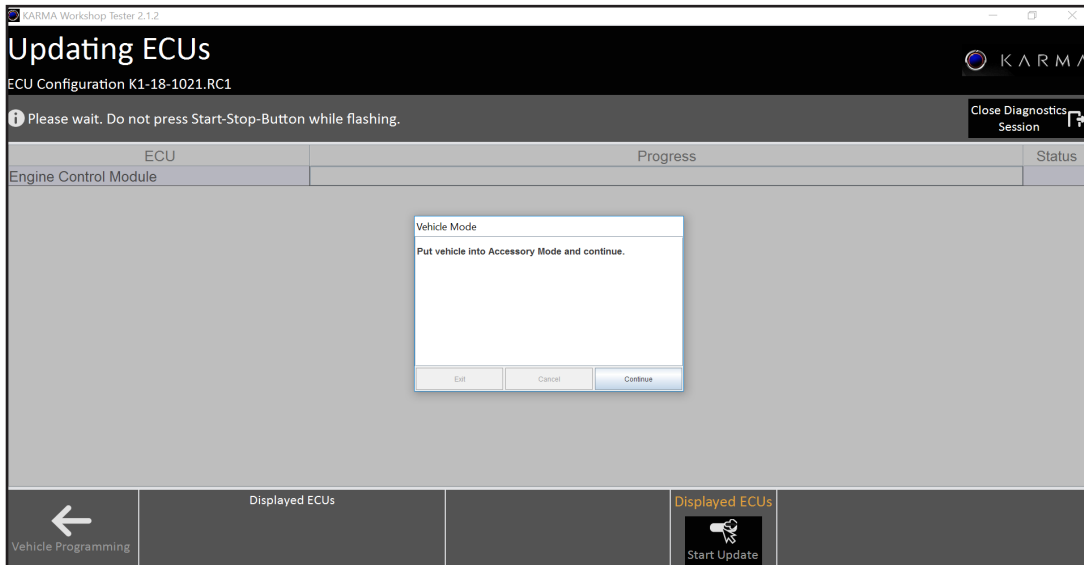
fig.9a

6. When the prompt is displayed the car has already been shut down for you, cycle back to Accessory Mode only! (fig.9a)

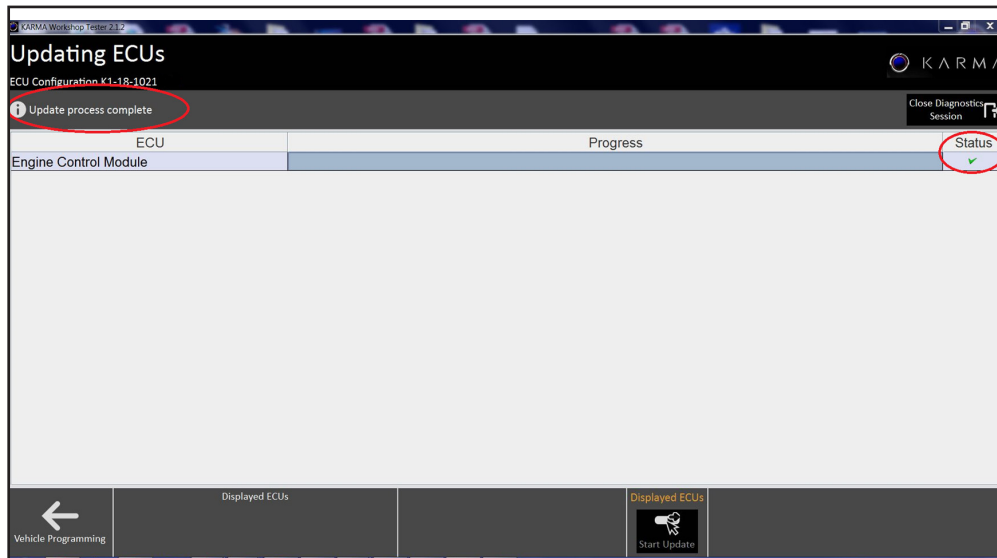
fig.9c

The “Update Complete” message will appear at the top left of the screen at the end of the update the status box will also display a green check mark (fig.9c). If the update is incomplete the status box will display a red “x”. A reattempt of the update may be necessary.

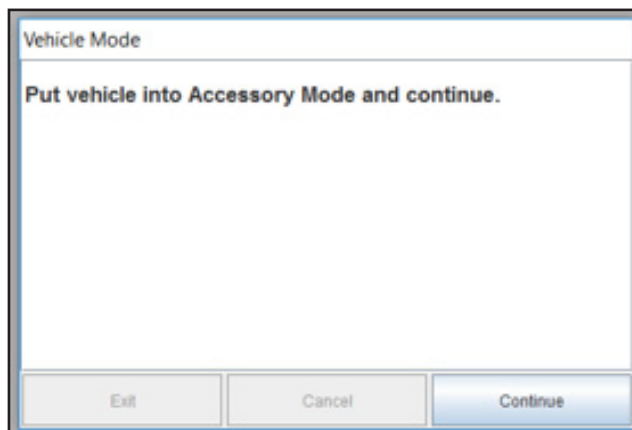
fig.10

7. When update complete the vehicle will power off by itself.
 Once the update is complete, the vehicle mode dialog will appear. (fig.10)
 Turn the car back on in Accessory Mode

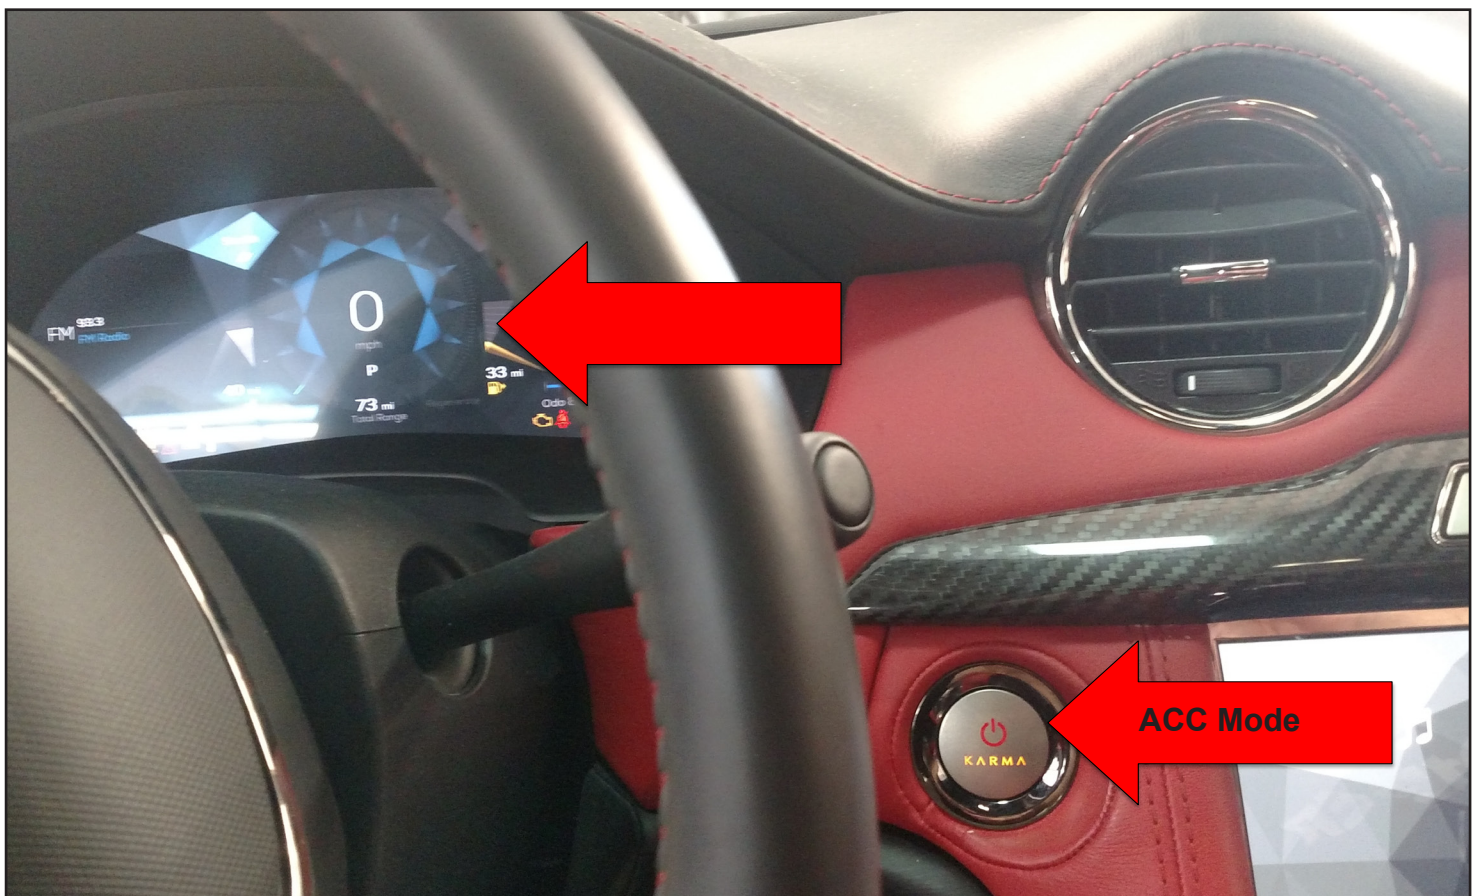
fig. 17

During the ADAS flash the request to enter Accessory Mode is performed by the vehicle. This may take up to two minutes to complete the ADAS flash. Note: Inspection of the vehicle will show the DIS appearing as Ready mode but the power mode button on the dash is YELLOW, because it is in Accessory Mode. The button state is the tell tale (fig. 17). When complete the Sync tool will proceed follow any prompts provided CAREFULLY.

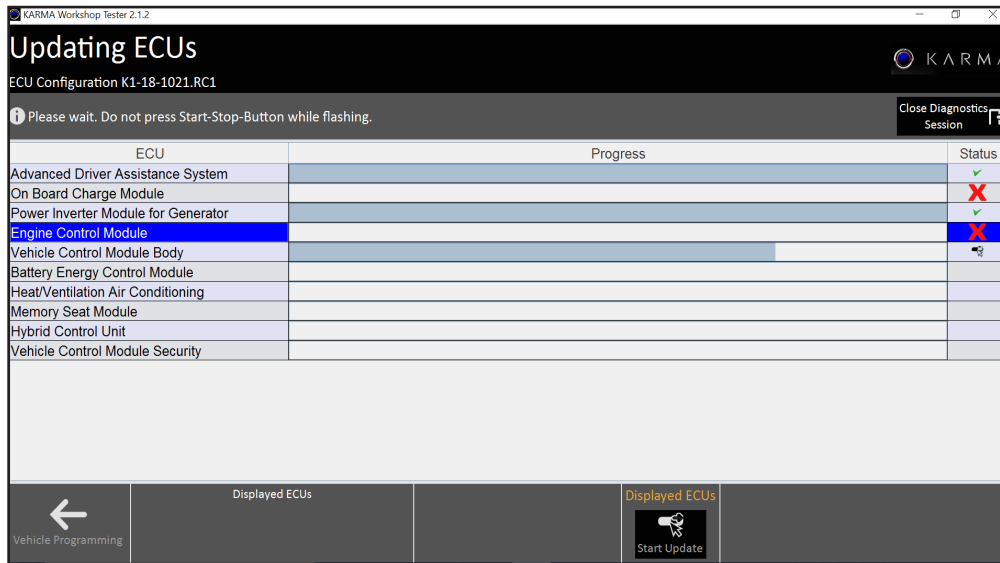
fig.18a

The OBCM will not update and the ECM will show a red “X” as well this is expected in this bulletin at this step (fig. 18a). When complete all modules should appear as below (fig.18b).

to repeat, the OBCM will not update and the ECM will show a red “X” as well this is expected in this bulletin at this step (p.23, fig. 18a). When complete all modules should appear as below (p.23, fig.18b). However:

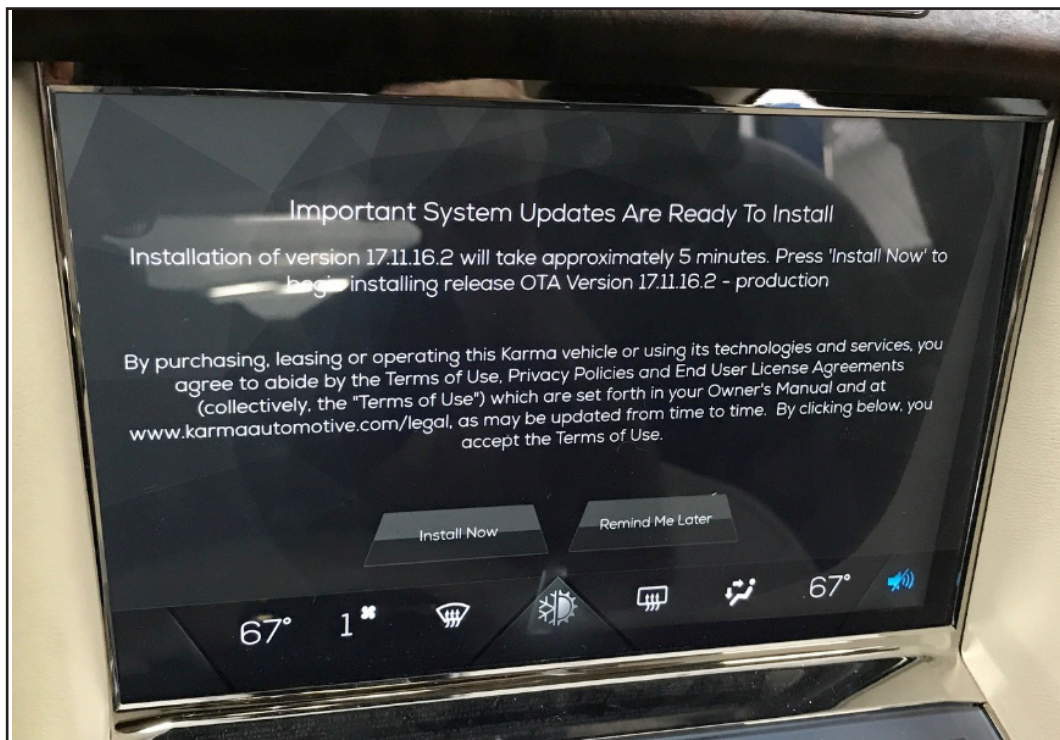
fig. 22

19. Keep the door latched (closed position) the update will not show up on TPI until power button is powered off with door still latched. This is when you can verify the TPI for update available messaging screen. If the download completed, the vehicle will prompt to accept the update (Fig. 22) Accept this and allow the vehicle to update. Note that changing the door latch state will interrupt the accessory delay and shut down the TPI. If the TPI shuts down at power off, the update available screen will not display.

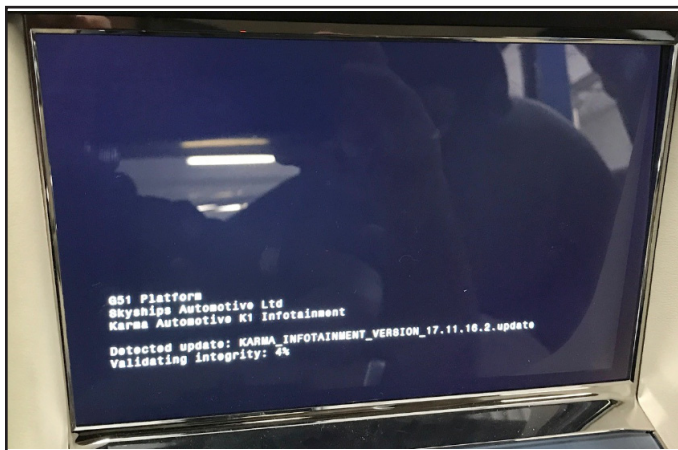
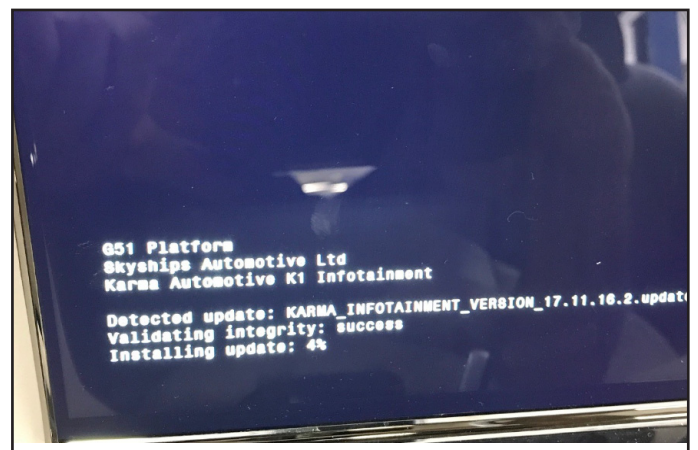
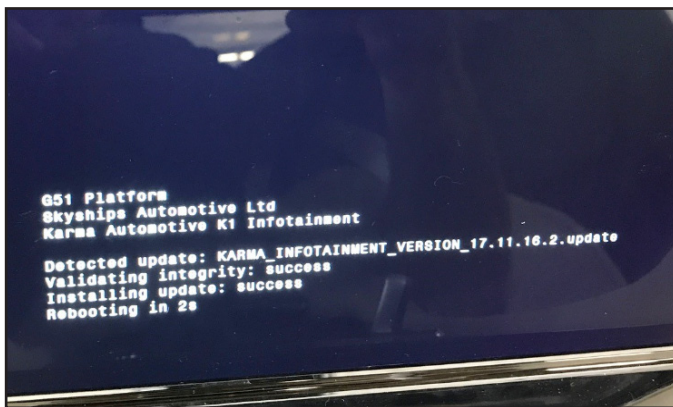
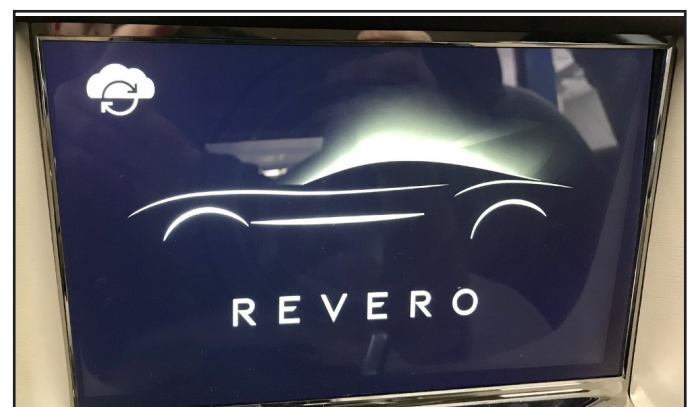
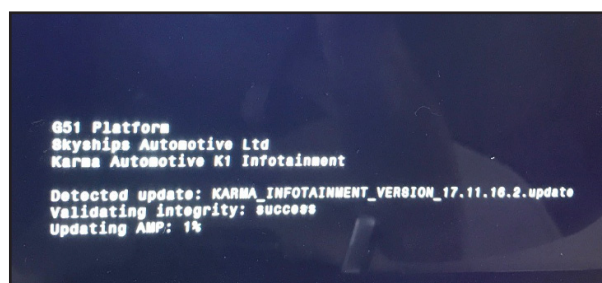
Below are the screens of the TPI read out as the CIU is updating (Fig.23 a,b,c,d,e) When this is completed updating, the screen may go blank or black or cycle on and off, normal function will resume upon cycling the mode button.

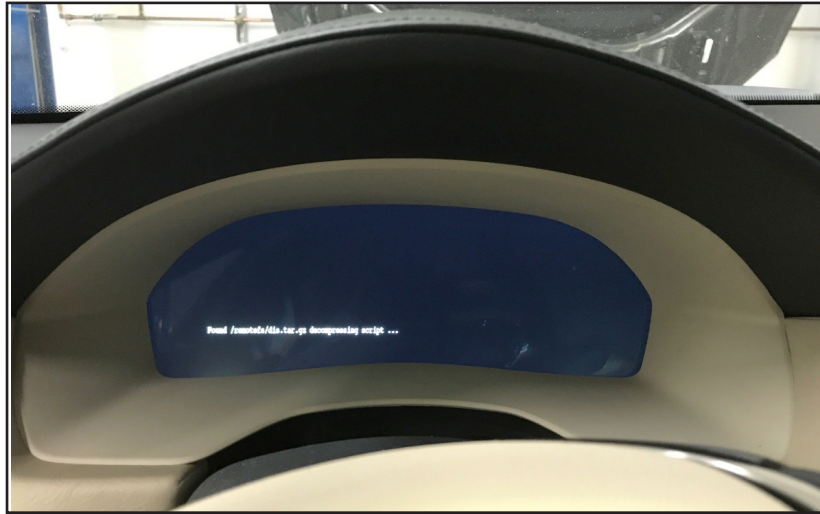
fig. 24

This is the image of the DIS during the update (fig. 24)

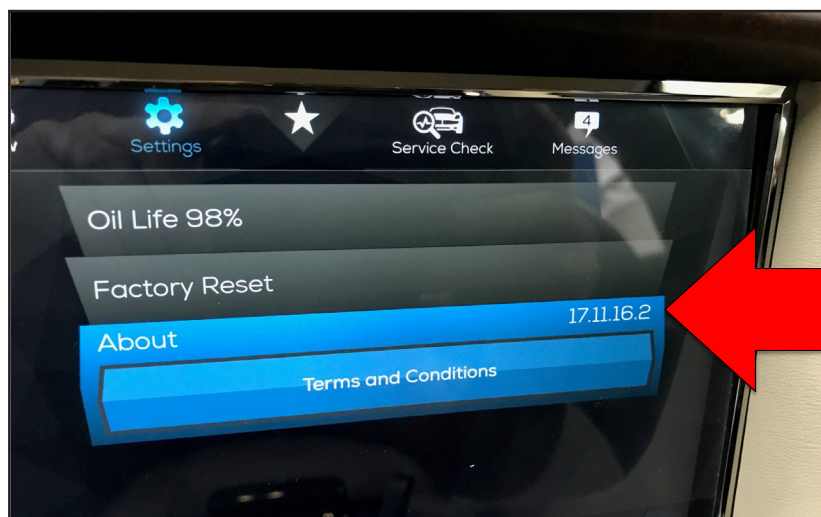
fig. 25

20. Verify the CIU software ID in the TPI after the vehicle has been placed in ready mode. go to Setting > About, the version should be displayed above the Terms and Conditions bar (fig 25.)

Test drive the vehicle and ensure everything is functioning correctly and address any DTC's before returning vehicle to the customer. The CIU Software ID should be as displayed- 17.11.16.2.
