07263 Version 2

## AcuraLink® Sending Excessive Notifications for Low Power

There is a false CAN signal transmitted through the telematics control unit.

Update the telematics control unit software with the HDS HFL (HFT) Control Unit Update tool.

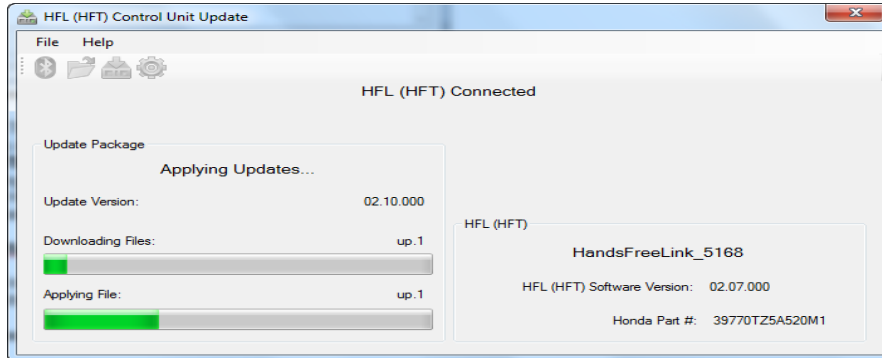
The HFL reflash process begins. Allow several minutes for the programming to complete. The blue bars indicate the programming status and progression.

In the i-HDS laptop, a pop-up window alerts you when the reflash process is finalizing, then another popup tells you that the reflash process has completed.

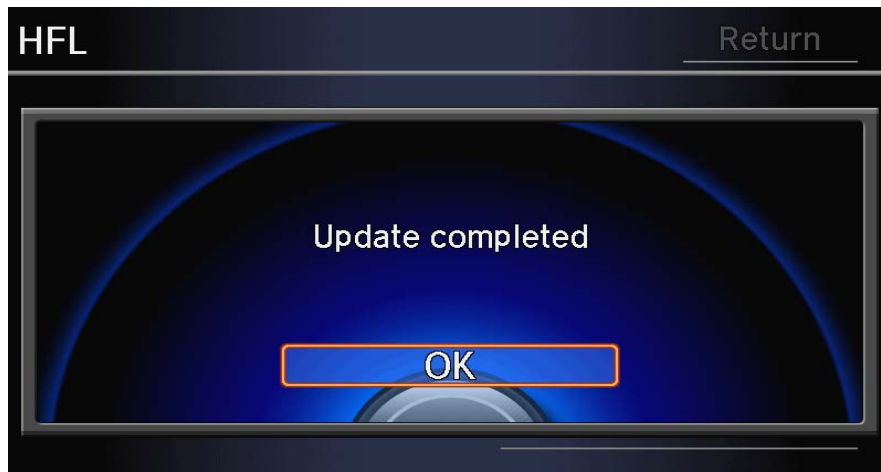
The **HFL** screen will indicate the HFL tool update has been completed.

NOTE: Selecting **OK** will return to the **HFL** screen, which will not show the newly updated software version.

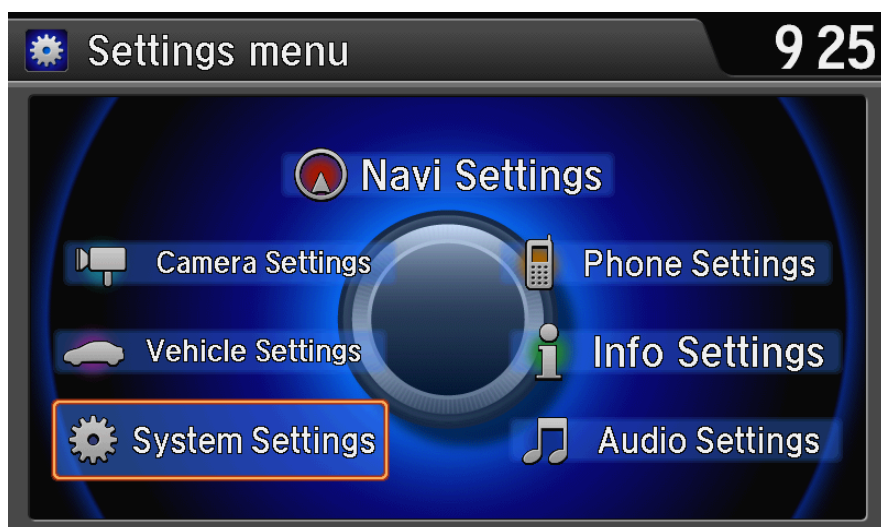
18. Press **SETTINGS** on the center switch panel, and select **System Settings**.
