07070 Version 1

## Steering Intermittently Pulls to the Right

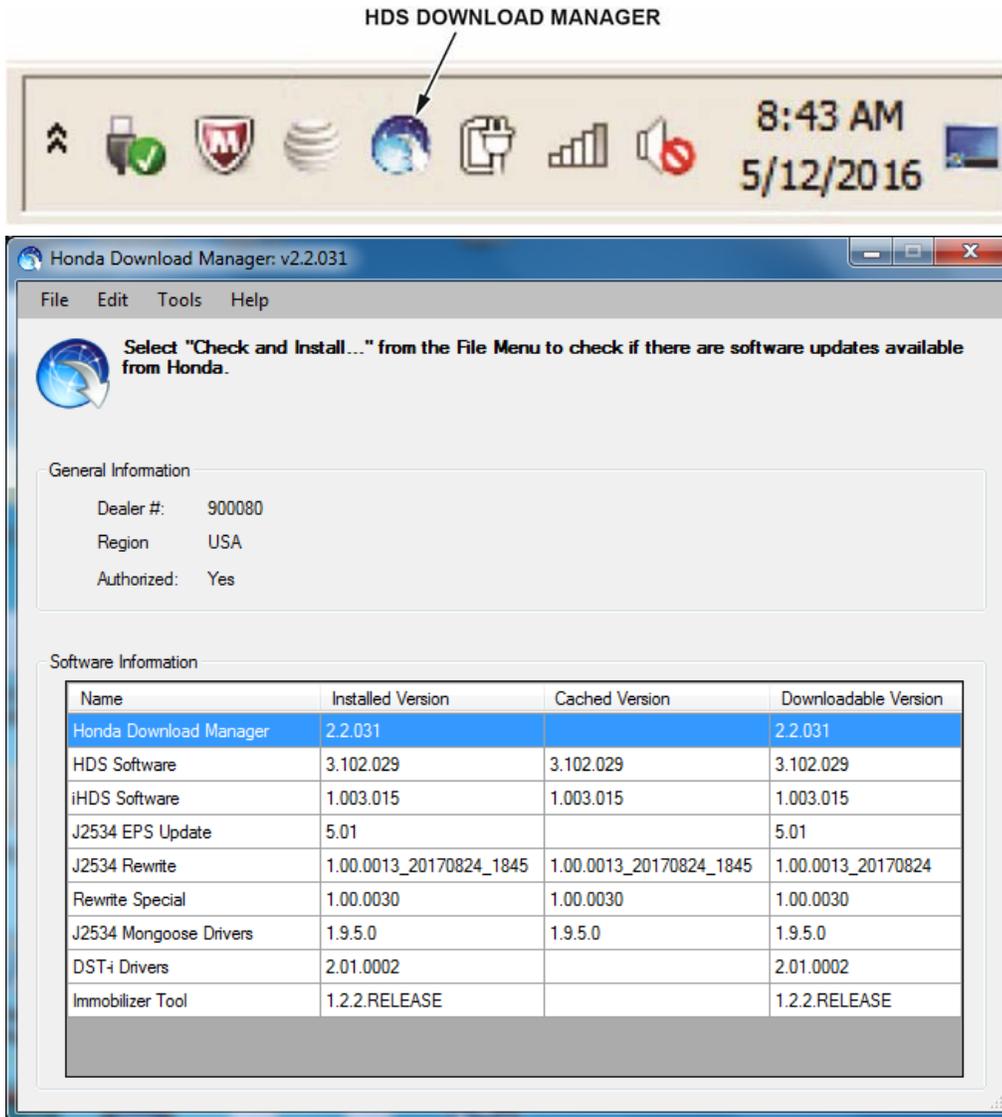
To check the database update version on the i-HDS laptop, right click on the HDS Download Manager icon on the taskbar, and select **Open Download Manager** from the dropdown menu.

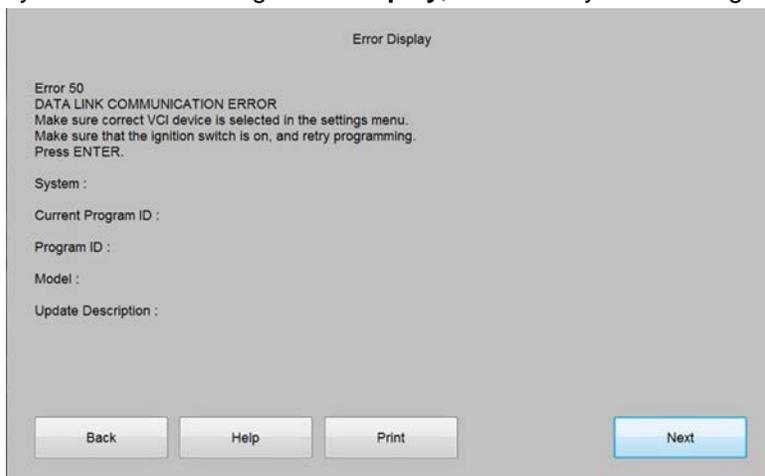
- Connect a fully charged jumper battery to the vehicle, and leave it connected during the entire procedure to maintain steady voltage.
- Never turn the ignition to OFF or ACCESSORY during the update. If there is a problem with the update, leave the ignition turned to ON.
- To prevent EPS control unit damage, do not operate anything electrical (headlights, audio system, brakes, A/C, power windows, door locks, etc.) during the update.
- If you see the following **Error Display**, check that you are using the correct tool (MVCI or DST-i) with the i-HDS.

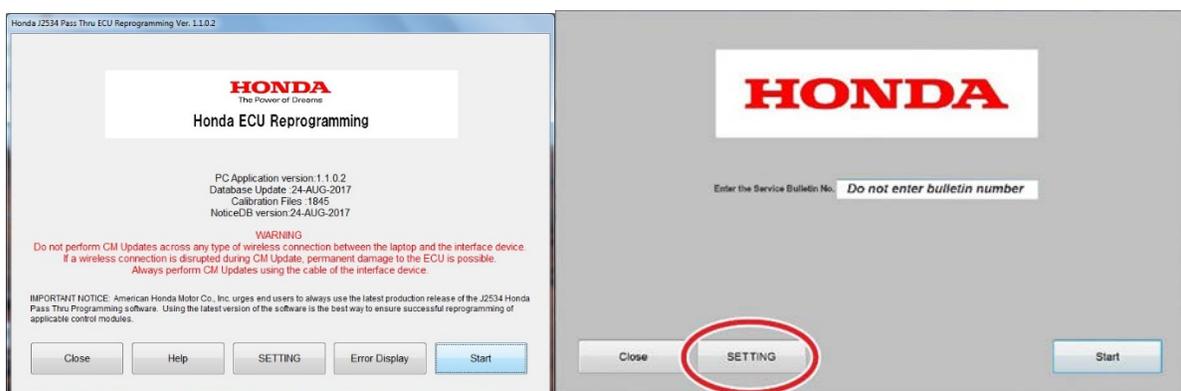
To change this, click on either of the **SETTING** selection buttons at the bottom of the J2534 initial screens as shown.

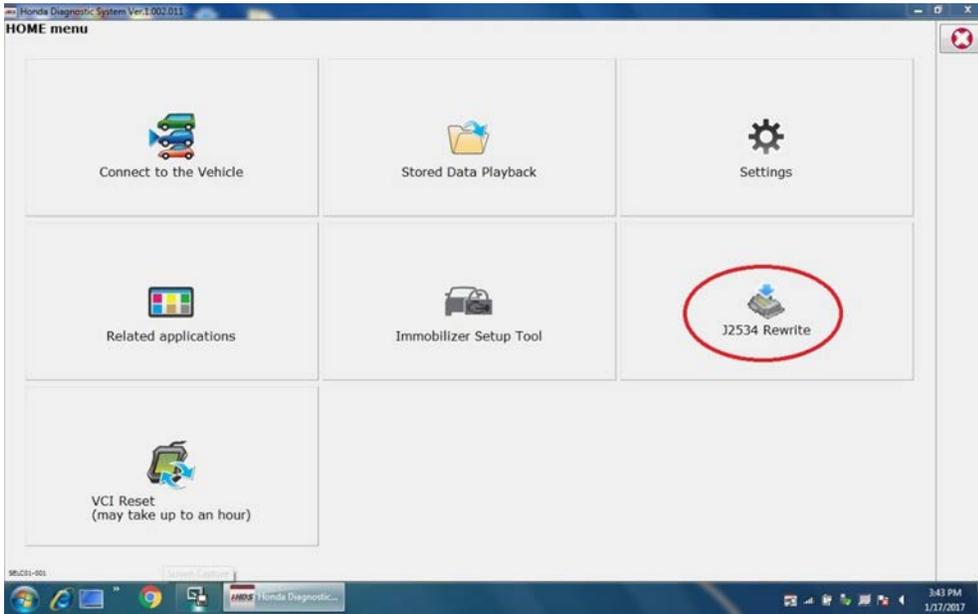
3. Select **J2534 Rewrite**.

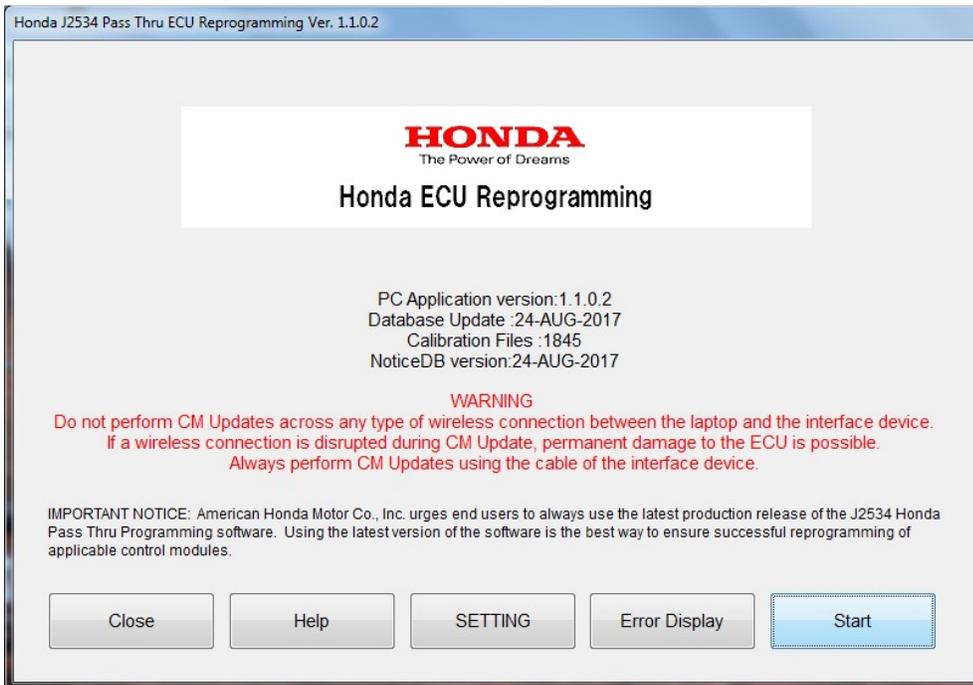
4. Confirm the software is the same or later as listed in SOFTWARE INFORMATION.

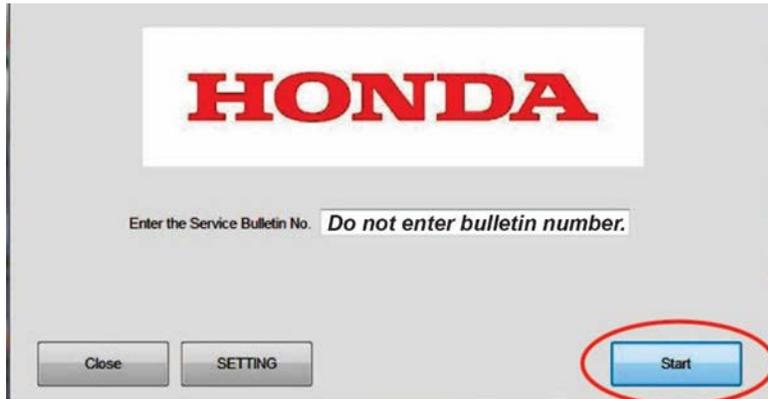
5. Select **Start**, and then follow the screen prompts.

- Do not enter a bulletin number.
- When the programming begins, the headlights will turn on, and several dash MIL lights will come on. This is normal.
