JTB00557NAS1

TECHNICAL BULLETIN

'Adaptive Dynamics Fault' Message Displayed in Instrument Cluster

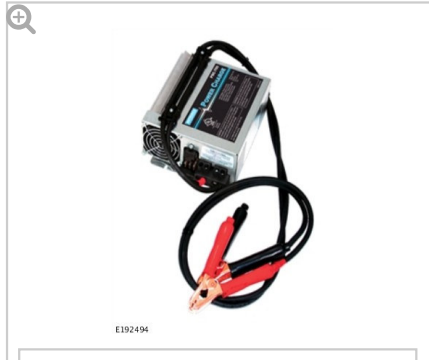
Jaguar Land Rover-approved Midtronics battery power supply

- **A Jaguar Land Rover-approved Midtronics battery power supply must be connected to the vehicle battery during diagnosis / module programming.**
- **Make sure all ignition ON/OFF requests are carried out; failure to perform these steps may cause damage to control modules in the vehicle.**

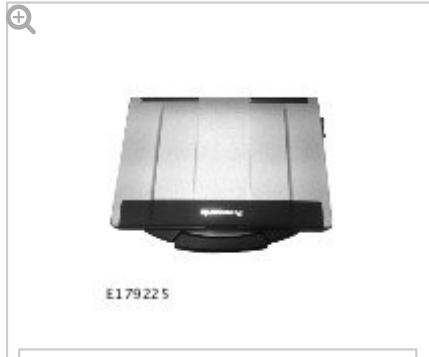
Jaguar Land Rover-approved diagnostic tool with latest SDD software, Calibration File
