JTB00533NAS1

TECHNICAL BULLETIN

Engine Misfire / MIL Illuminated After Cold-Start

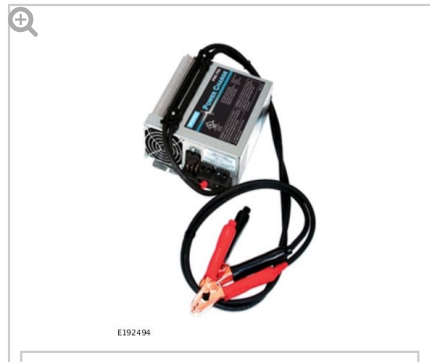
Jaguar Land Rover-
approved Midtronics
battery power supply

- **A Jaguar Land Rover-approved Midtronics battery power supply must be connected to the vehicle battery during diagnosis / module programming.**
- **Make sure all ignition ON/OFF requests are carried out; failure to perform these steps may cause damage to control modules in the vehicle.**

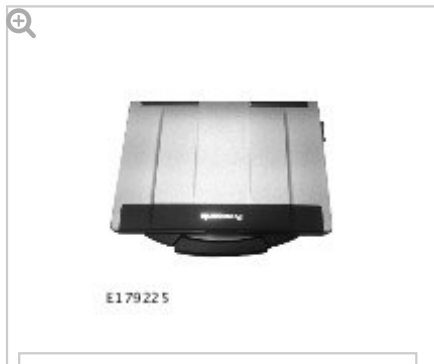
Jaguar Land Rover-approved diagnostic tool with latest SDD software, Calibration File
