September 23, 2017

07348 Version 2

MID Displays ACC, CMBS, LKAS, RDM, Brake Warnings and Other Listed Symptoms

Supersedes 17-064, dated August 4, 2017, to revise the information highlighted in yellow

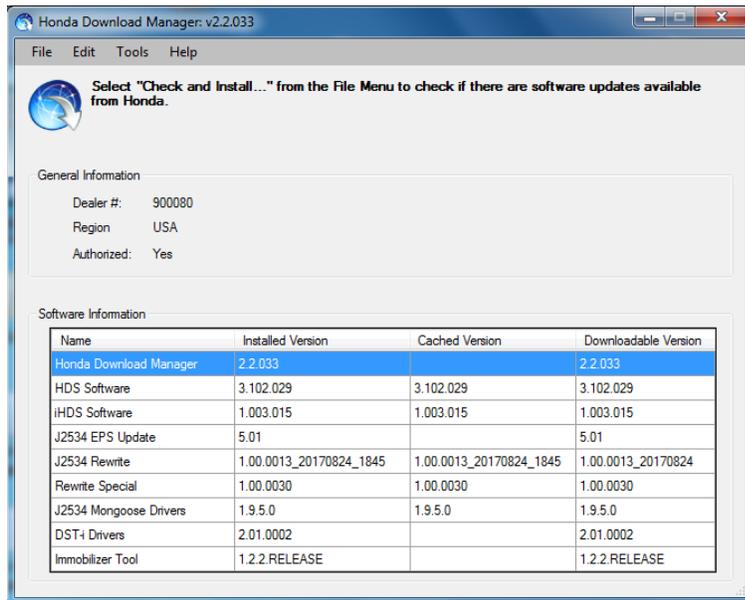
Select Open HDS Download Manager, and use the File pull-down menu to select Check and Install.

NOTE: If you are not connected to the Internet, you will see an error message indicating the i-HDS cannot check for updates; connect to the Internet to make sure you have the latest i-HDS software.

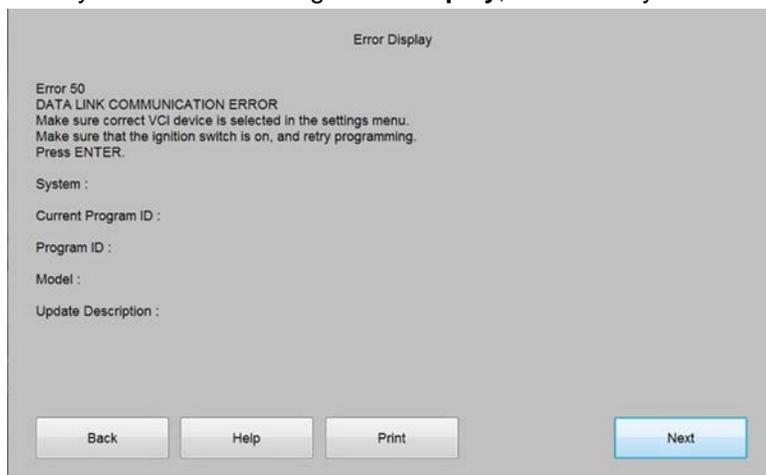
- You cannot update the vehicle using the MVCI as a standalone tool.
- Do not use the Mongoose Pro VCI tool.
- Connect a fully charged jumper battery to the vehicle, and leave it connected during the entire procedure to maintain steady voltage.
- Never turn the ignition to OFF or ACCESSORY during the update. If there is a problem with the update, leave the ignition turned to ON.
- To prevent control unit damage, do not operate anything electrical (headlights, audio system, brakes, A/C, power windows, door locks, etc.) during the update.
- If you see the following **Error Display**, check that you are using the correct tool (MVCI or DST-i) with the i-HDS.

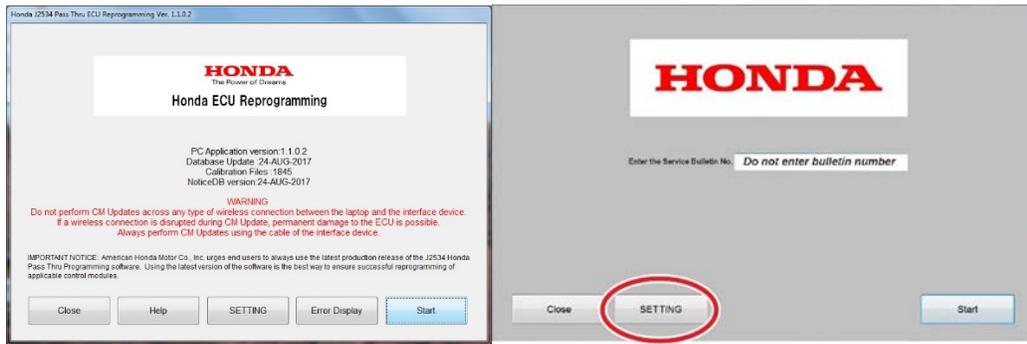
To change this, click on either of the **SETTING** selection buttons at the bottom of the J2534 initial screens as shown.

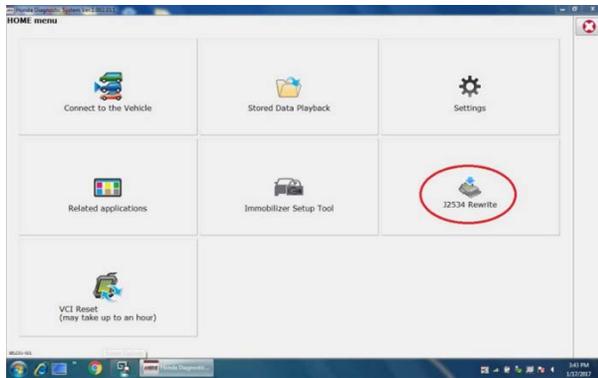
4. Select **J2534 Rewrite**.

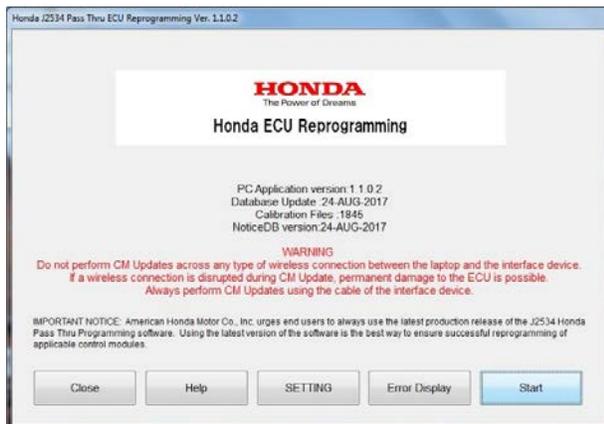
5. Confirm the software is the same or later as listed in SOFTWARE INFORMATION.
