## Technical Service Bulletin

17-01-001-1-G

G90 (HI) MULTIMEDIA & NAVIGATION UPDATE  
(SERVICE CAMPAIGN T01G)

**Description:** This bulletin provides information for new software to update the Navigation and Map database for 2017 G90 vehicles.

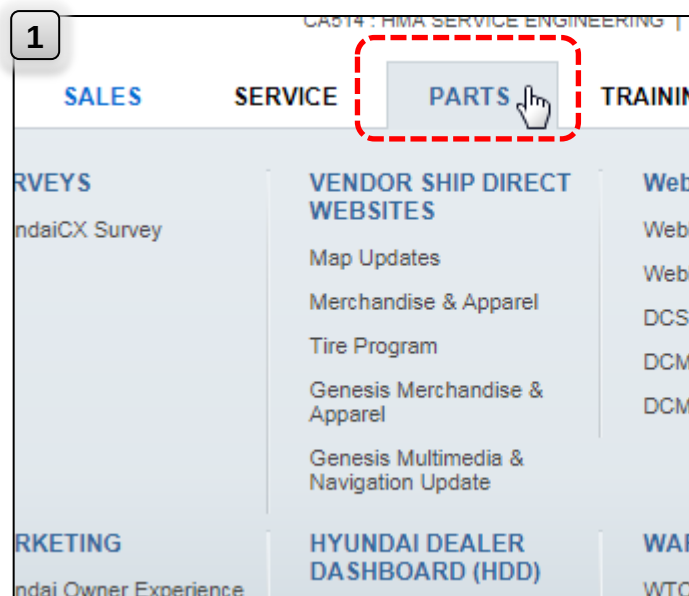
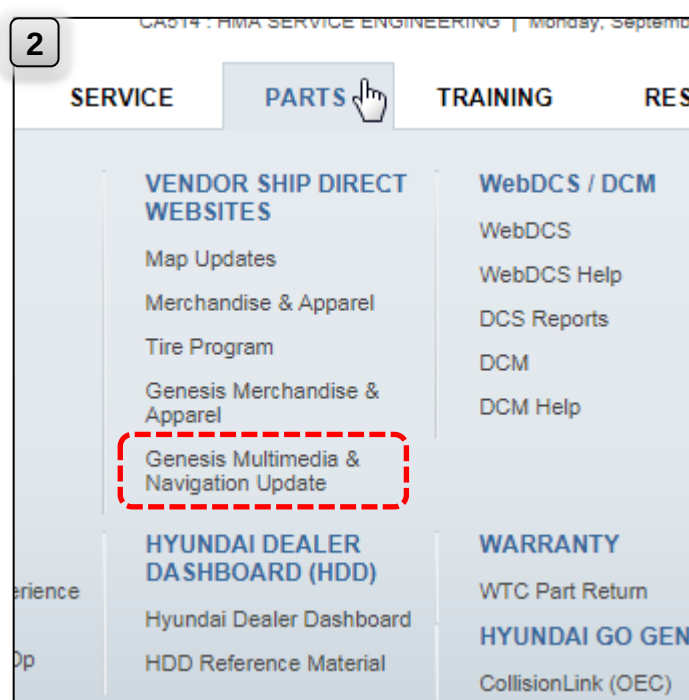
1. Navigate to HyundaiDealer.com to input VIN information before starting the update process:
  1. Select “Parts” tab.
  2. Select “Genesis Multimedia & Navigation Update”.

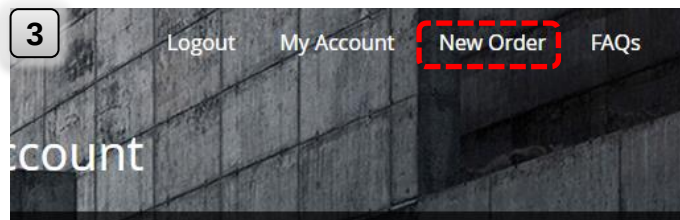
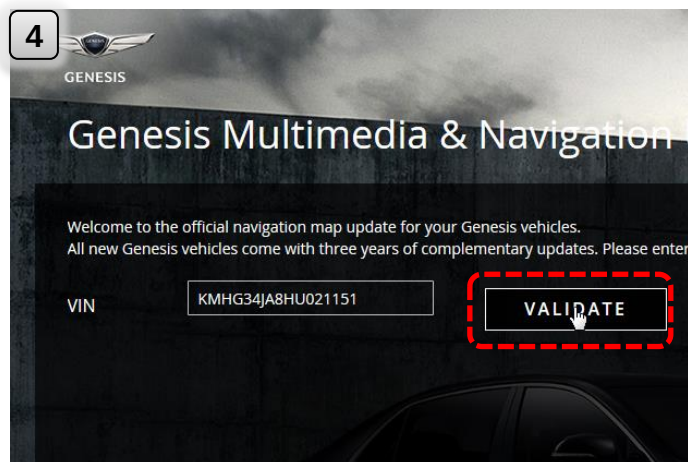
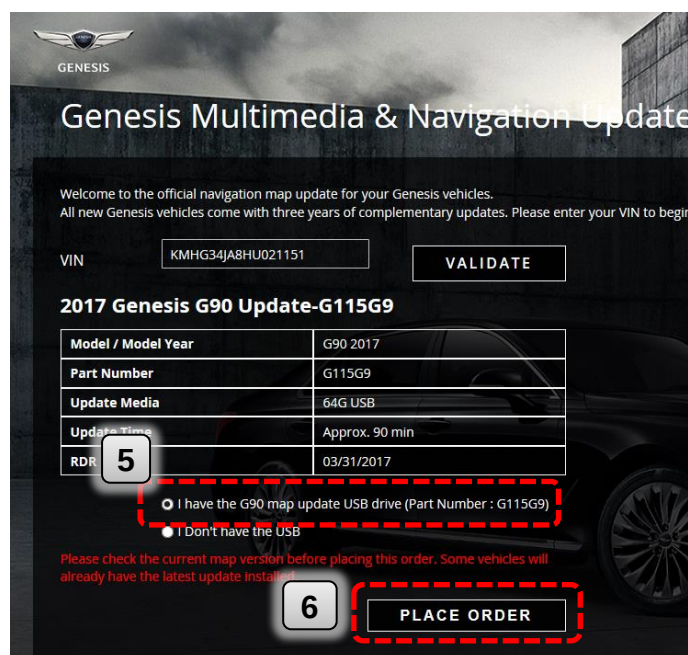
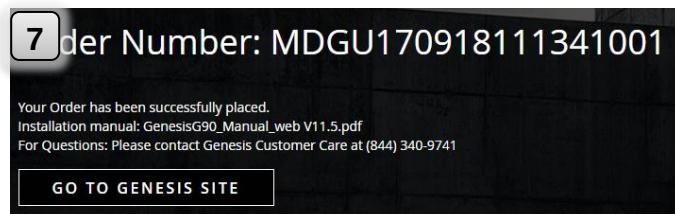
3. Select “New Order” at the top right of the webpage.
4. Enter the VIN of the vehicle that will be updated and Select “Validate”.
5. Check the box:  
“I have the G90 map update USB drive (Part Number: G115G9)”
6. Select Place Order.
7. Order number will be displayed for reference.

If a USB needs to be ordered, check “I Don’t have the USB” and follow the ordering instructions.

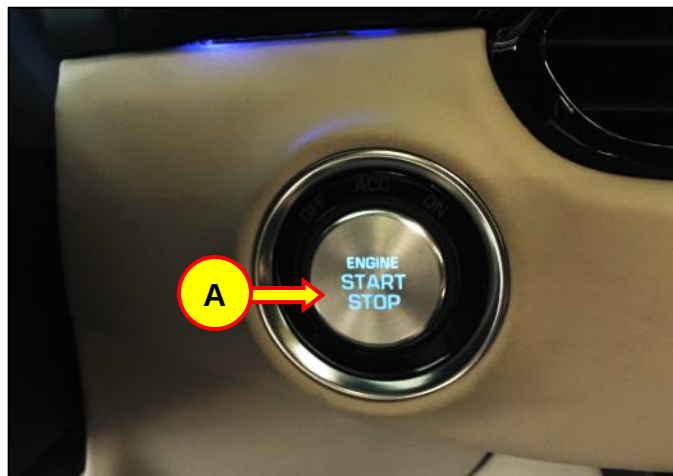
1. Start the vehicle by depressing the brake pedal and pushing the Start Stop Button (A).

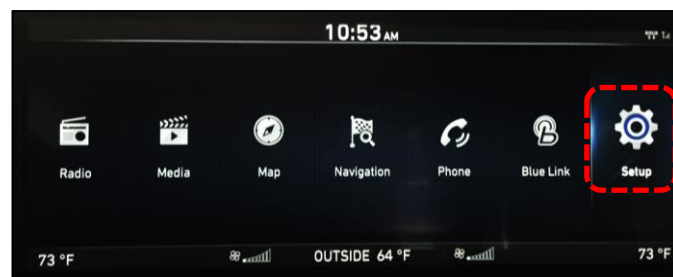
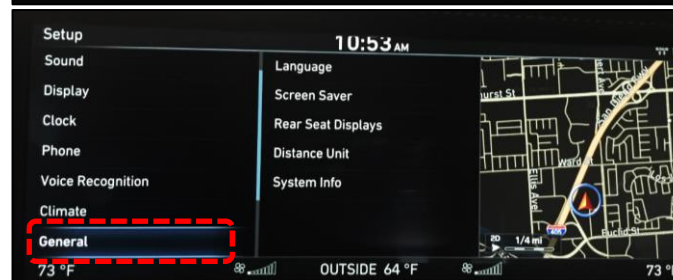
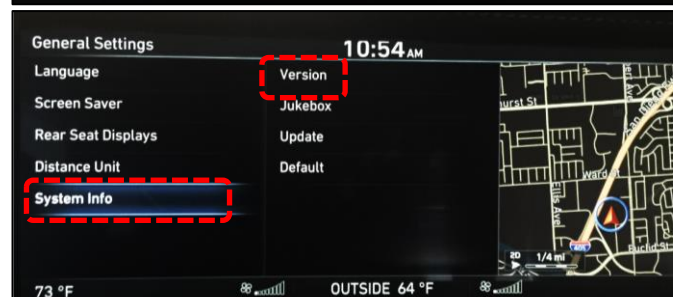
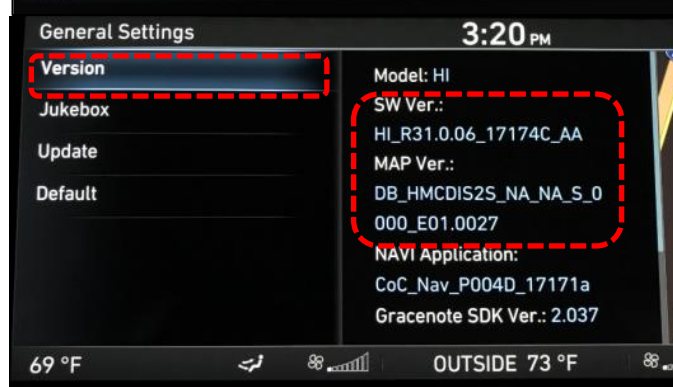
2. Confirm the software version using the following steps:
  - a) Press HOME button on the Central Control Panel
  - b) Select Setup in the HOME screen
  - c) Select General in the Setup screen
  - d) Select System Info in the General Settings screen
  - e) Select Version

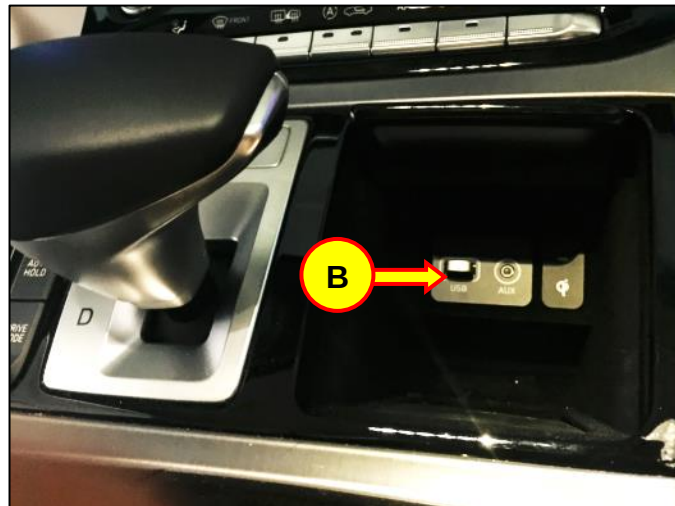
3. Insert the update USB (G115G9) into the vehicle USB port (B).

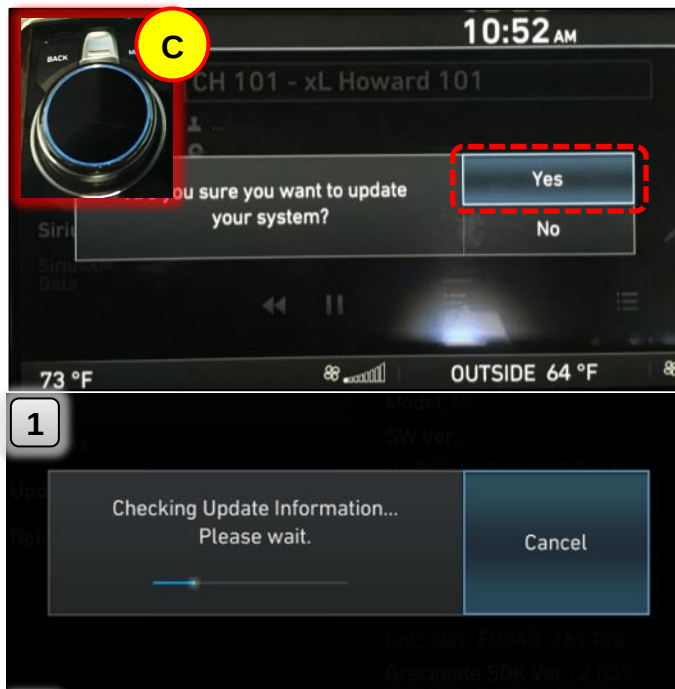
4. Use the jog dial (C) on the Central Control Panel to select 'Yes' when the update pop-up message appears.

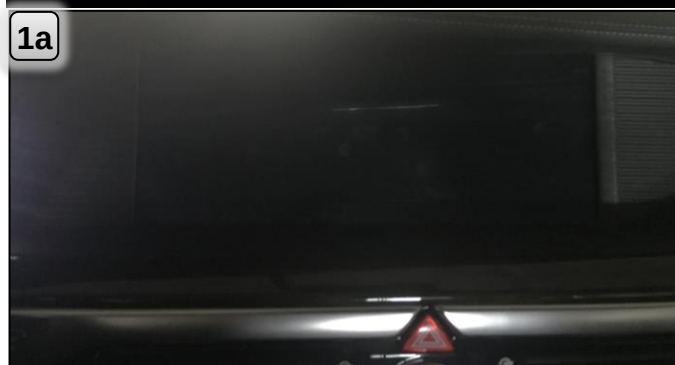
The software will automatically update through 3 steps:

1. Checking update information
  - a. Black screen→System Update
2. Software Download in Progress
  - a. Black screen→System Update
3. Software Download in Progress
  - a. System reboot

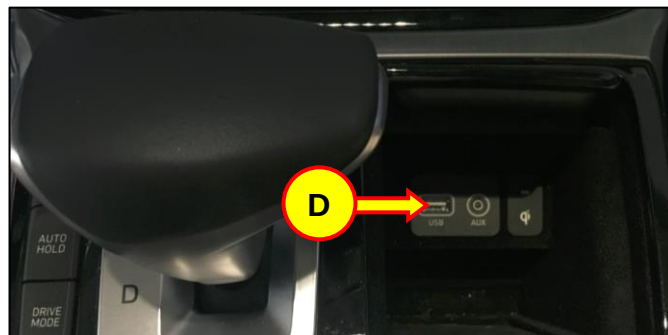
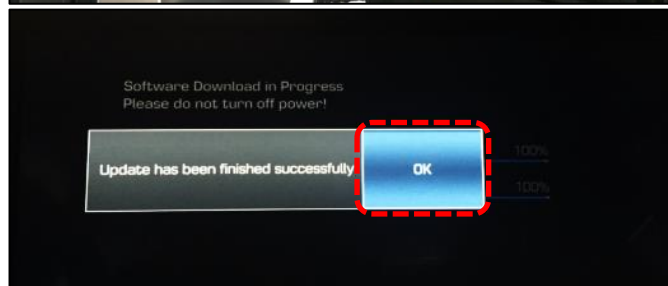
5. An 'Update has been finished successfully' message will appear after the update is complete.

Remove the USB drive from the vehicle USB port (D).

Then select 'OK' on the pop-up message.

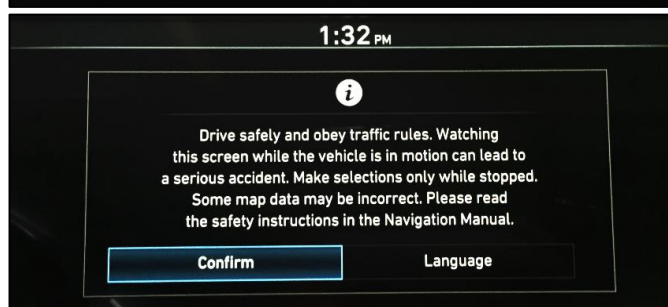
The navigation system will reboot.

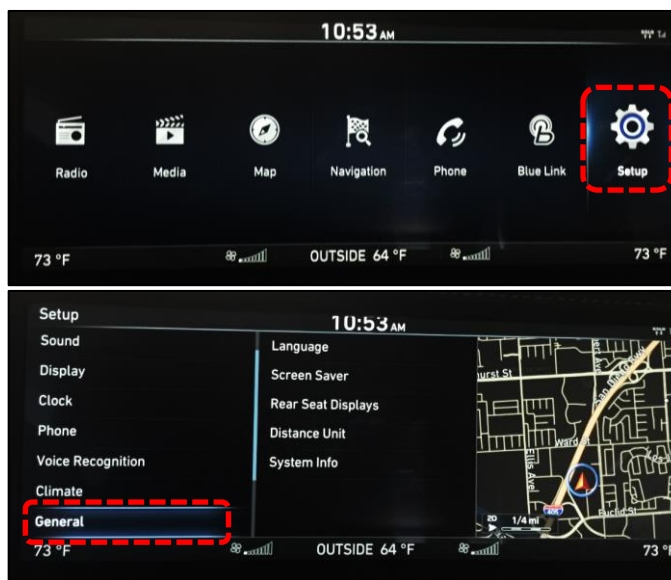
6. Confirm the software version using the following steps:
- Press HOME button on the Central Control Panel
  - Select Setup in the HOME screen
  - Select General in the Setup screen
  - Select System Info in the General Settings screen
  - Select Version

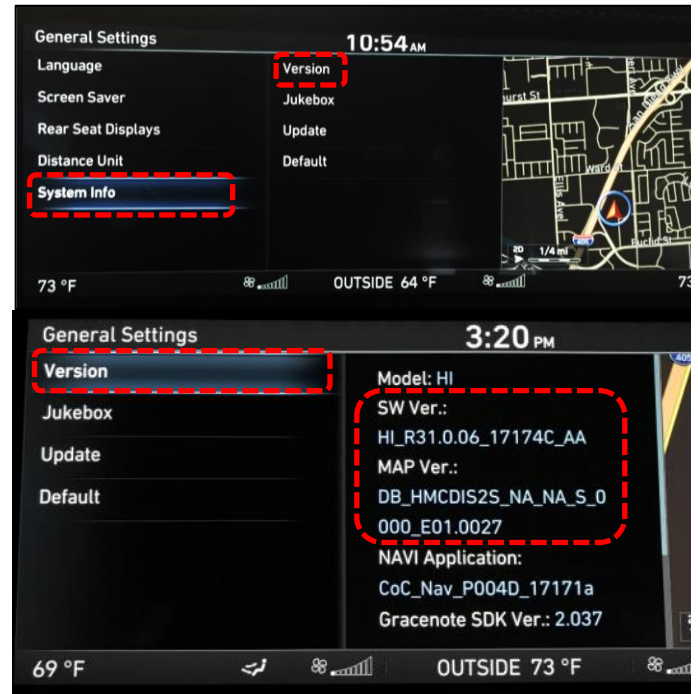
The following software and map version should appear:

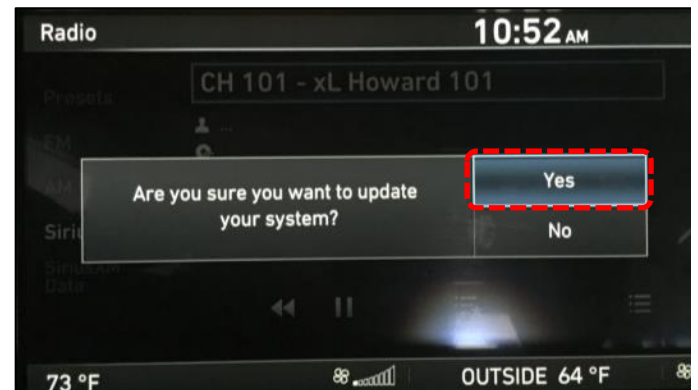
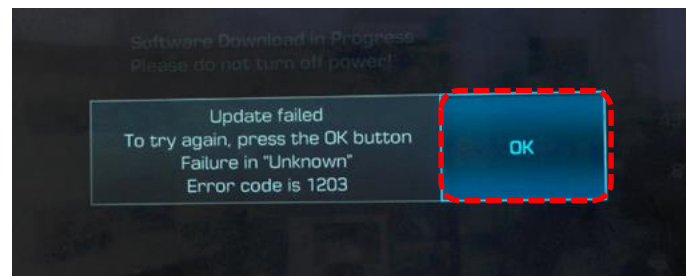
- Ignition turned off during the update process:
  1. Do not remove the USB.
  2. Turn the Ignition On.
  3. The system will reboot and recognize the USB is installed.
  4. The update process will restart from the beginning.
- USB is removed during the update process:
  1. Error message will be displayed.
  2. Insert the USB drive back in the USB port.
  3. Select OK.
  4. The system will reboot and start from the beginning.
  5. After the system reboots, select 'Yes' to restart the update process.
