EC17-031

## 2016-2017 Q50 AND 2017 Q60; MIL IS ON WITH DTC STORED

**APPLIED VEHICLES:** 2016-2017 Q50 (V37)  
2017 Q60 (V37)  
**APPLIED ENGINE:** VR30DDTT

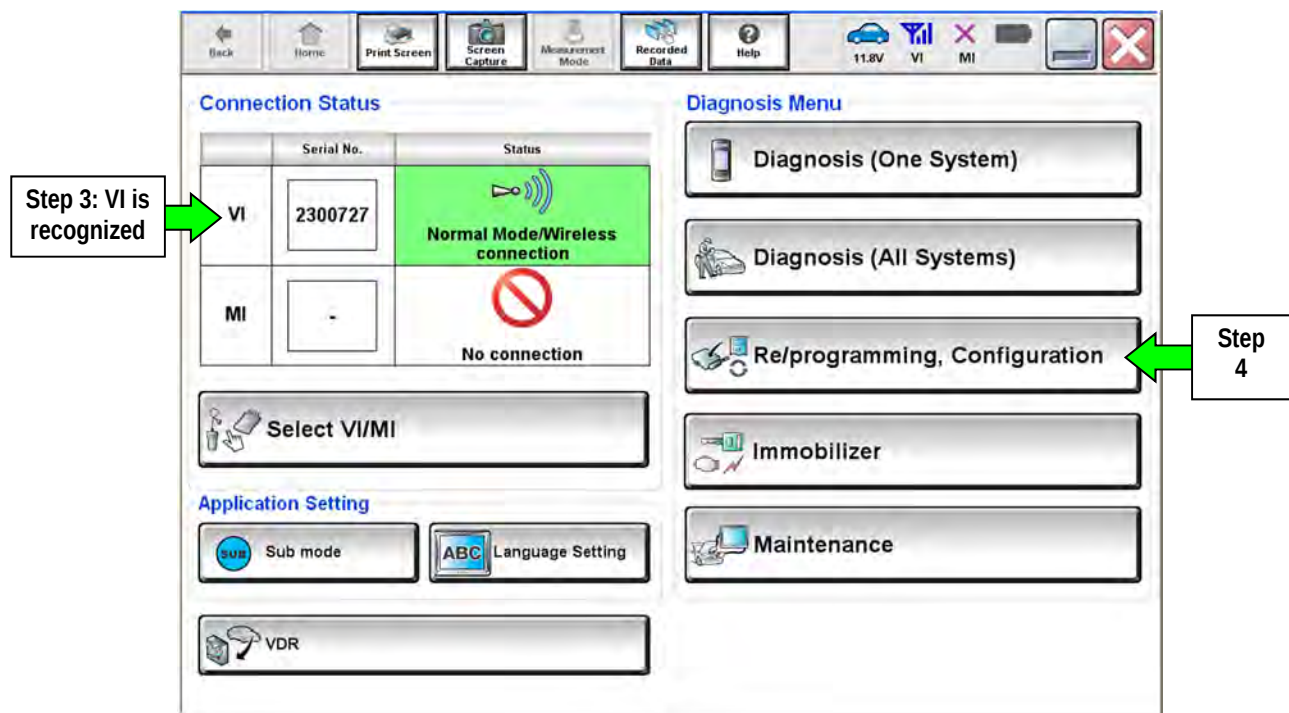
Figure 1

1. Connect the CONSULT PC to the vehicle to begin the reprogramming procedure.
2. Open ASIST on the CONSULT PC and start C-III plus.
3. Wait for the plus VI to be recognized / connected.
  - Serial number will display when the plus VI is recognized / connected.
4. Select **Re/programming, Configuration**.

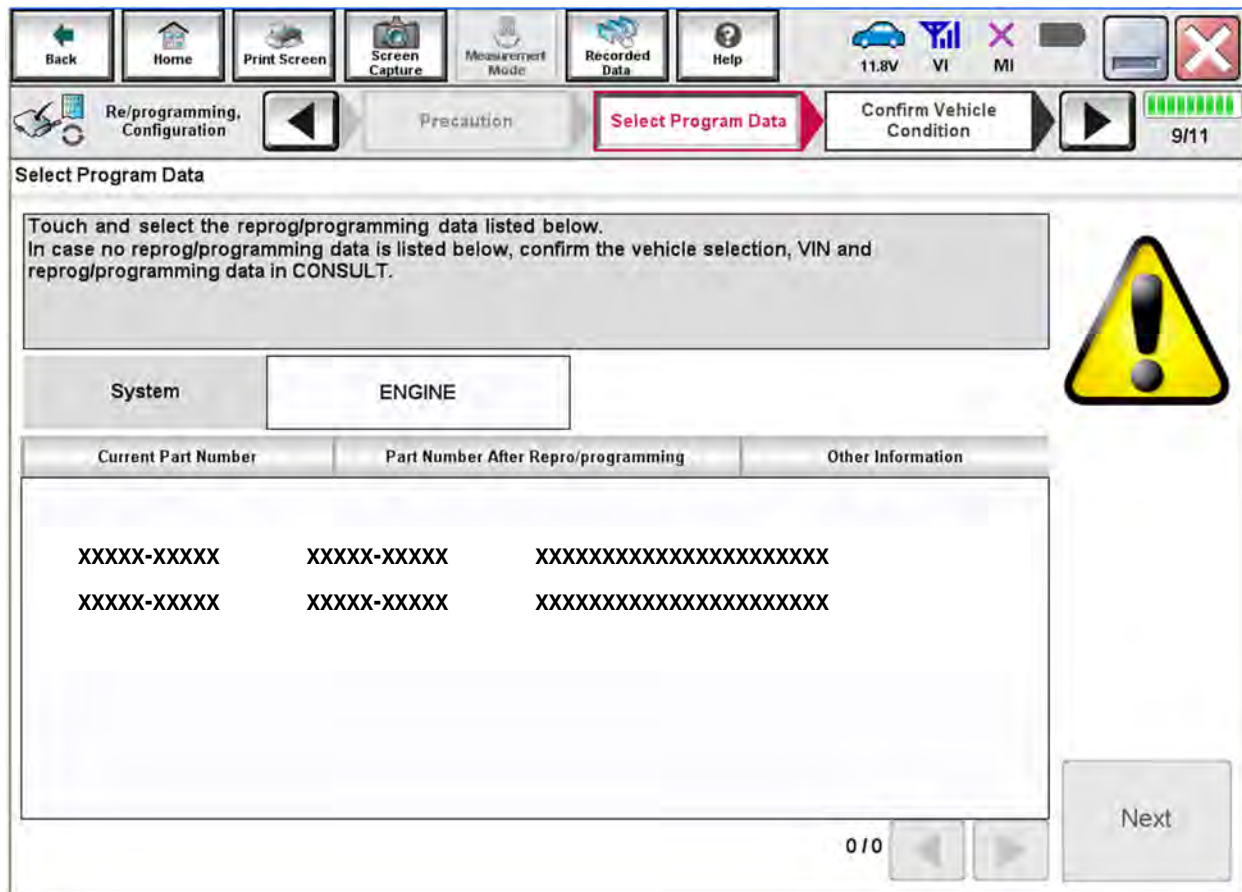
- In some cases, more than one new P/N for reprogramming is available.
  - In this case, the screen in Figure 3 displays.
  - Select and use the reprogramming option that **does not** have the message “Caution! Use ONLY with ITBXX-XXX”.
- If you get this screen and it is blank (no reprogramming listed), it means there is no reprogramming available for this vehicle. Close C-III plus and disconnect from the vehicle.

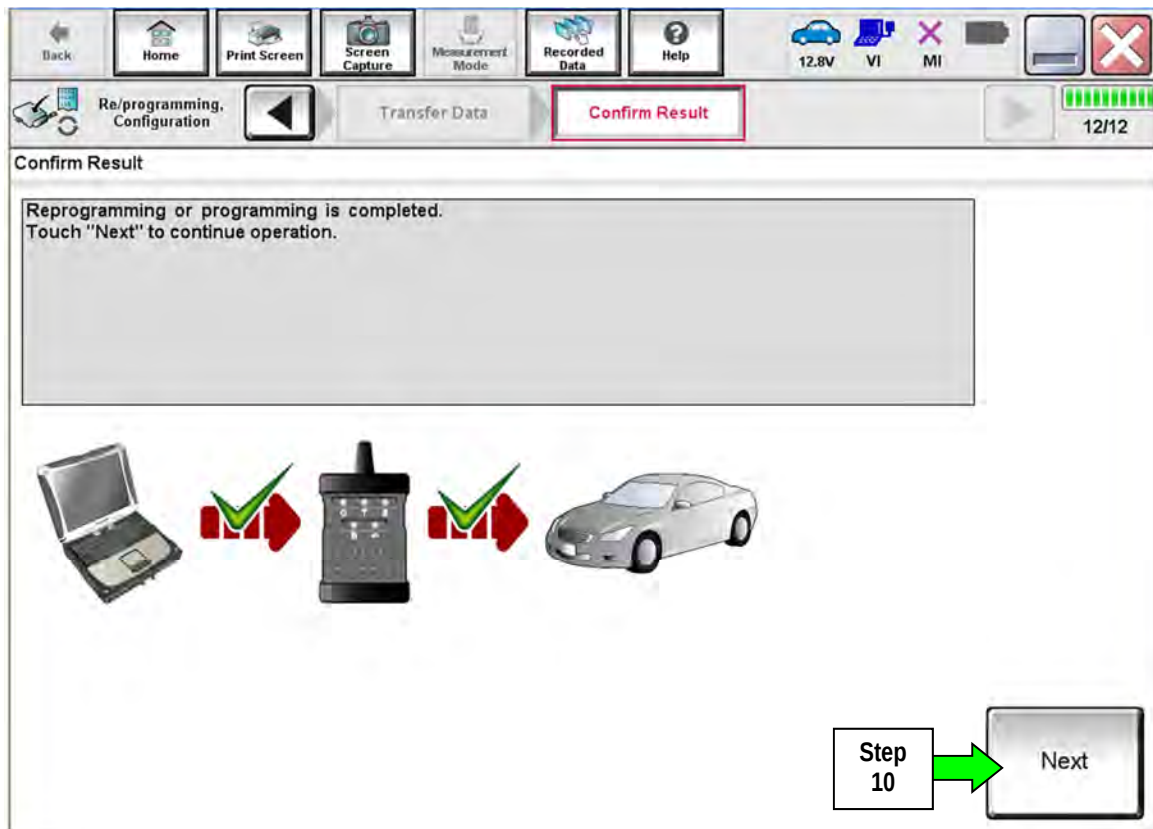
8. When the screen in Figure 4 displays, reprogramming is complete.

**NOTE:** If the screen in Figure 4 does not display (reprogramming does not complete), refer to the information on the next page.

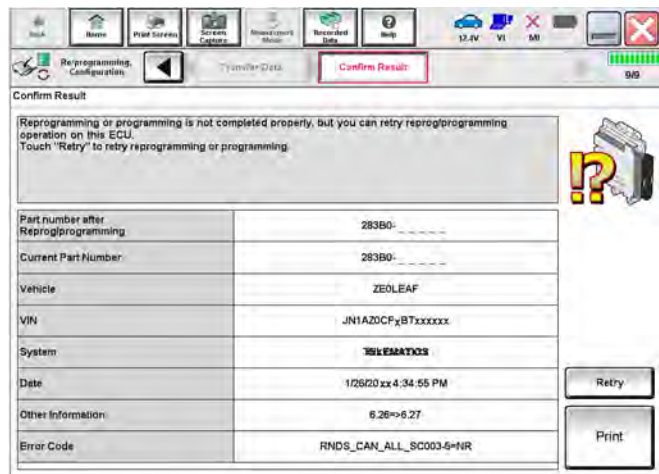
Figure 5

If reprogramming does not complete and the “!?” symbol displays as shown in Figure 5:

- Check battery voltage (12.0 – 15.5V).
- Ignition is ON, engine is OFF.
- External Bluetooth® devices are OFF.
- All electrical loads are OFF.
- **Select Retry and follow the on screen instructions.**

**NOTE:** Retry may not go through on first attempt and can be selected more than once.

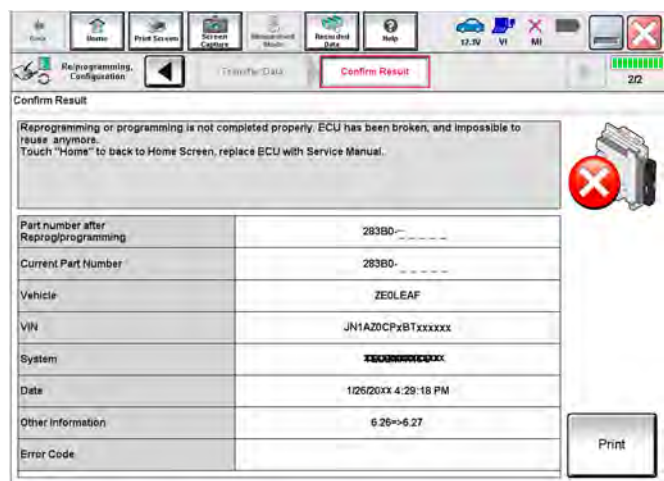
Figure 6

If reprogramming does not complete and the “X” symbol displays as shown in Figure 6:

- Check battery voltage (12.0 – 15.5V).
- CONSULT A/C adapter is plugged in.
- Ignition is ON, Engine is OFF.
- Transmission in Park.
- All C-III plus / plus VI cables are securely connected.
- All C-III plus updates are installed.
- **Select Home, and then restart the reprogram procedure from the beginning.**

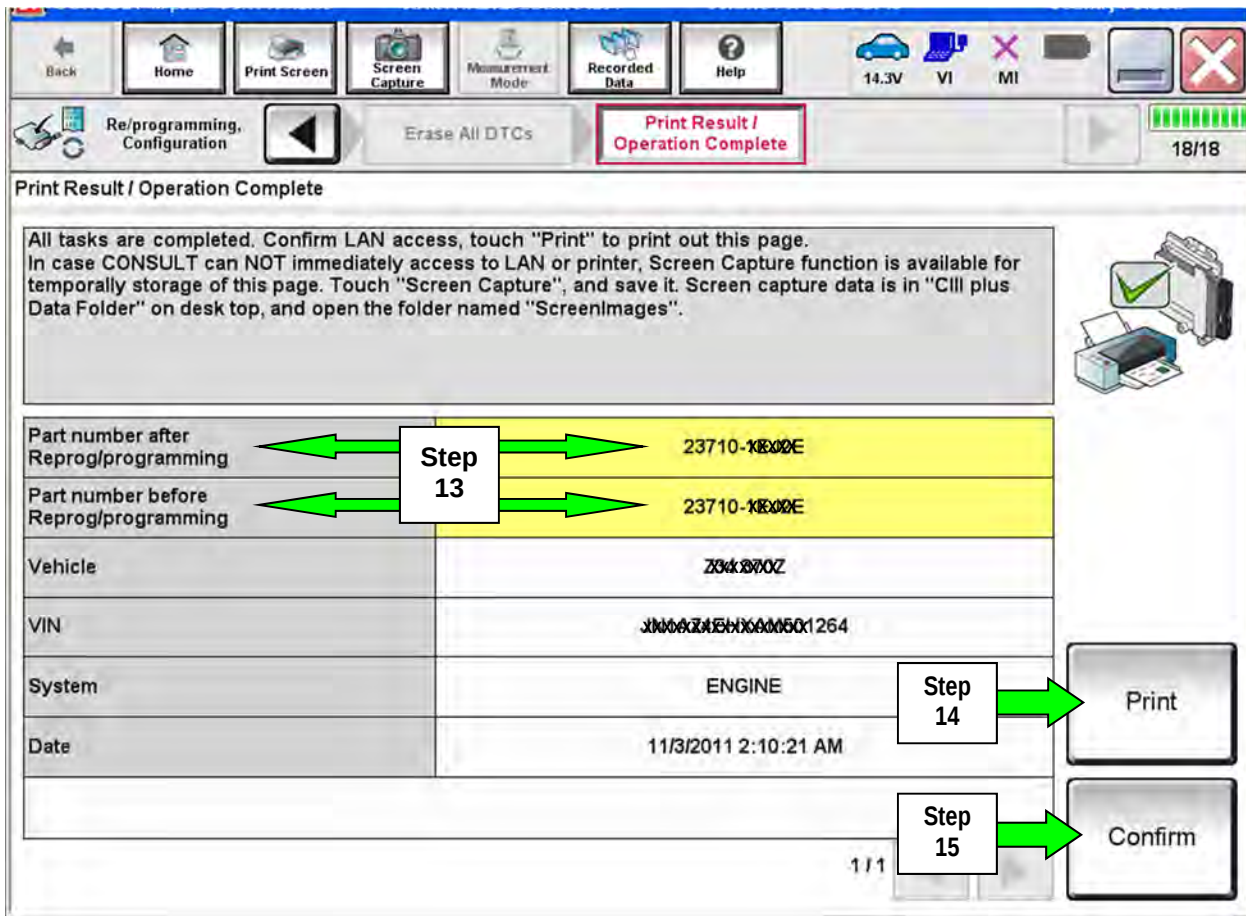
12. When the entire reprogramming process is complete, the screen in Figure 7 will display.
13. Verify the before and after part numbers are different.
14. Print a copy of this screen (Figure 7) and attach it to the repair order for warranty documentation.
15. Select **Confirm**.
