# SERVICE BULLETIN

EC17-028a

## 2015 – 2017 SENTRA; ENGINE TURNS OFF OR HESITATES WHEN ACCELERATING FROM A STOP DURING HOT AMBIENT TEMPERATURES (100° F OR MORE)

**APPLIED VEHICLES:** 2015 - 2017 Sentra (B17)

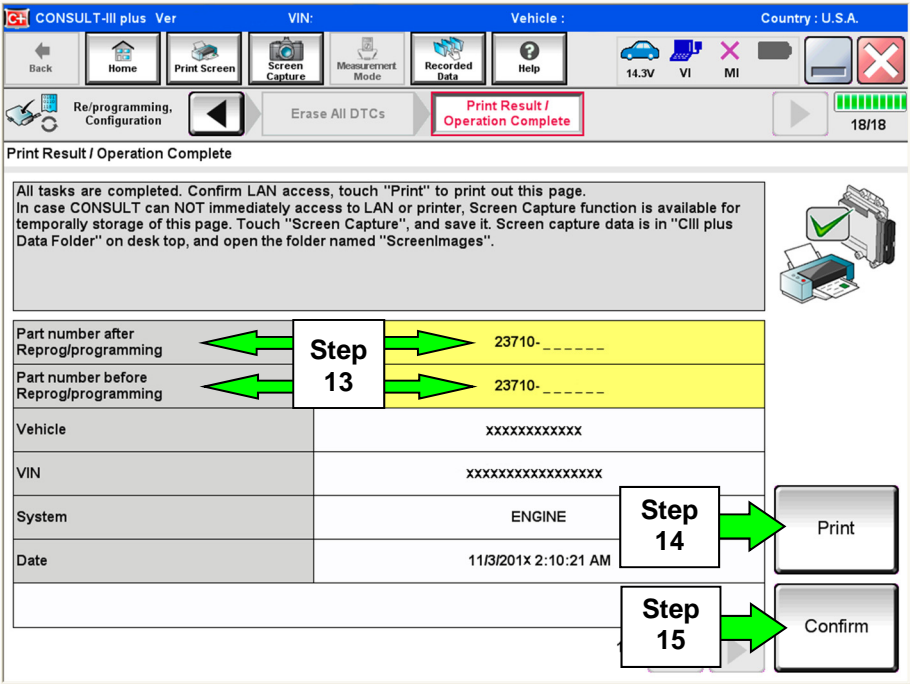
- 12. When the entire reprogramming process is complete, the screen in Figure 7 will display.
- 13. Verify the before and after part numbers are different.
- 14. Print a copy of this screen (Figure 7) and attach it to the repair order for warranty documentation.
- 15. Select **Confirm**.
