## SERVICE BULLETIN

EC17-003

### 2016-2017 TITAN XD; MIL ON WITH DTC U3017

**APPLIED VEHICLES:** 2016-2017 Titan XD (A61)

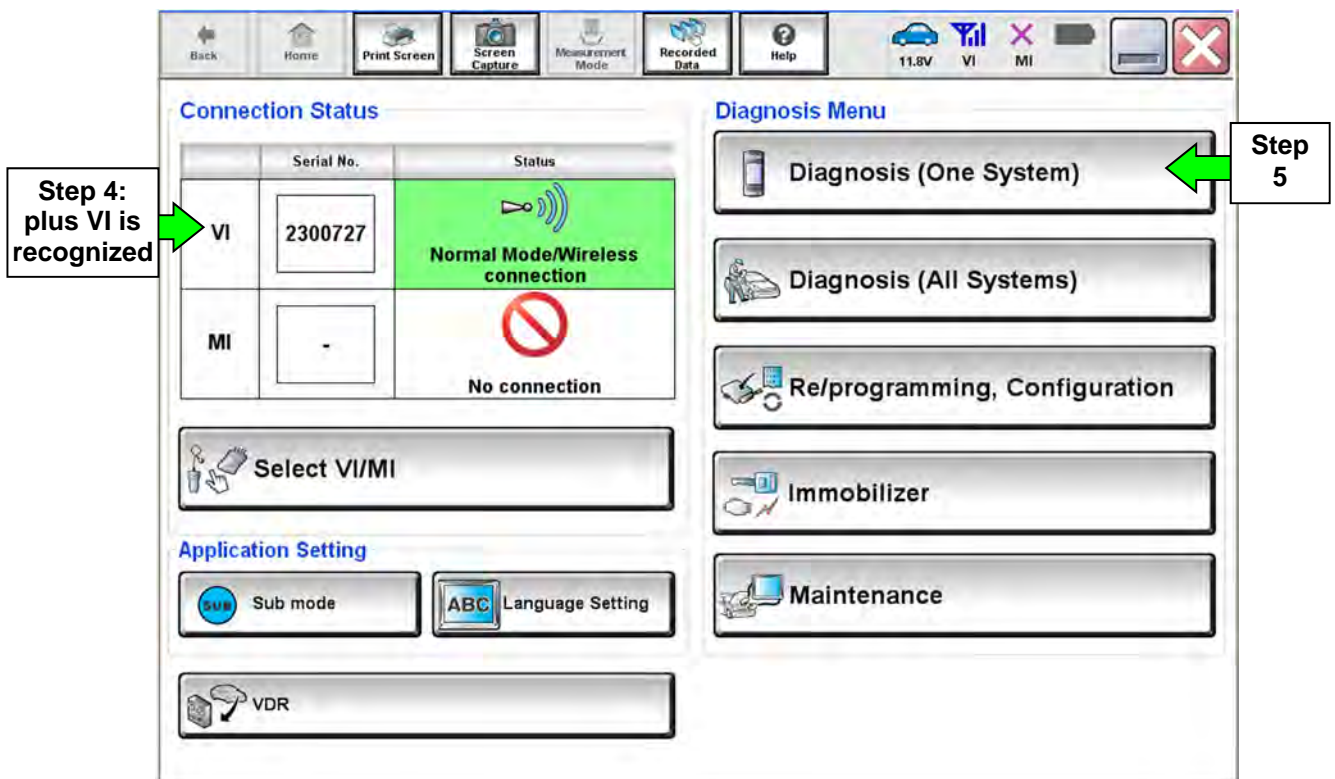
Figure A

1. Connect the CONSULT PC to the vehicle.
2. Open / start C-III plus.
3. Turn the ignition ON, with engine OFF (engine not running).
4. Wait for the plus VI to be recognized.
  - The **Serial No.** will display when the plus VI is recognized.
5. Select **Diagnosis (One System)**.

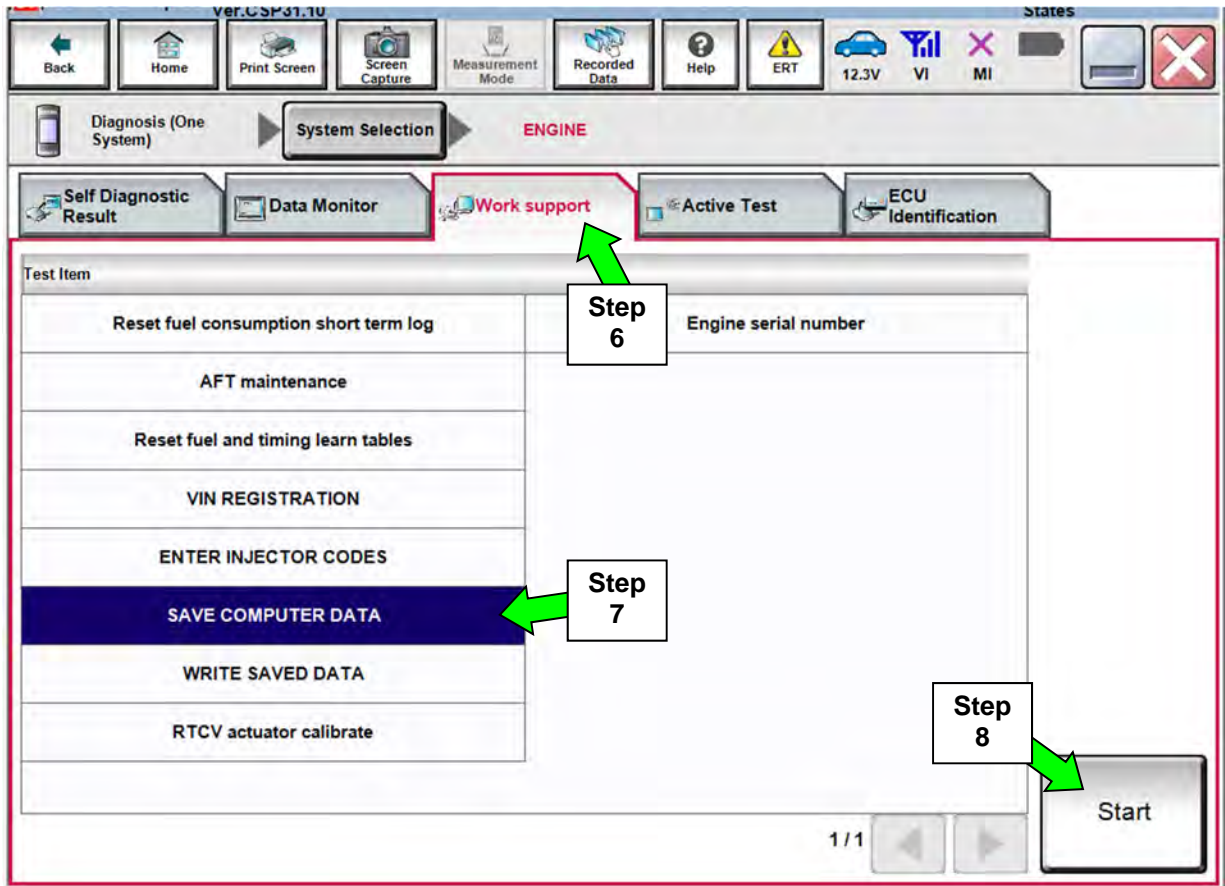
Figure B

6. Navigate C-III plus to **Engine > Work Support** (see Figure B).
7. Select **SAVE COMPUTER DATA**.
8. Select **Start**.

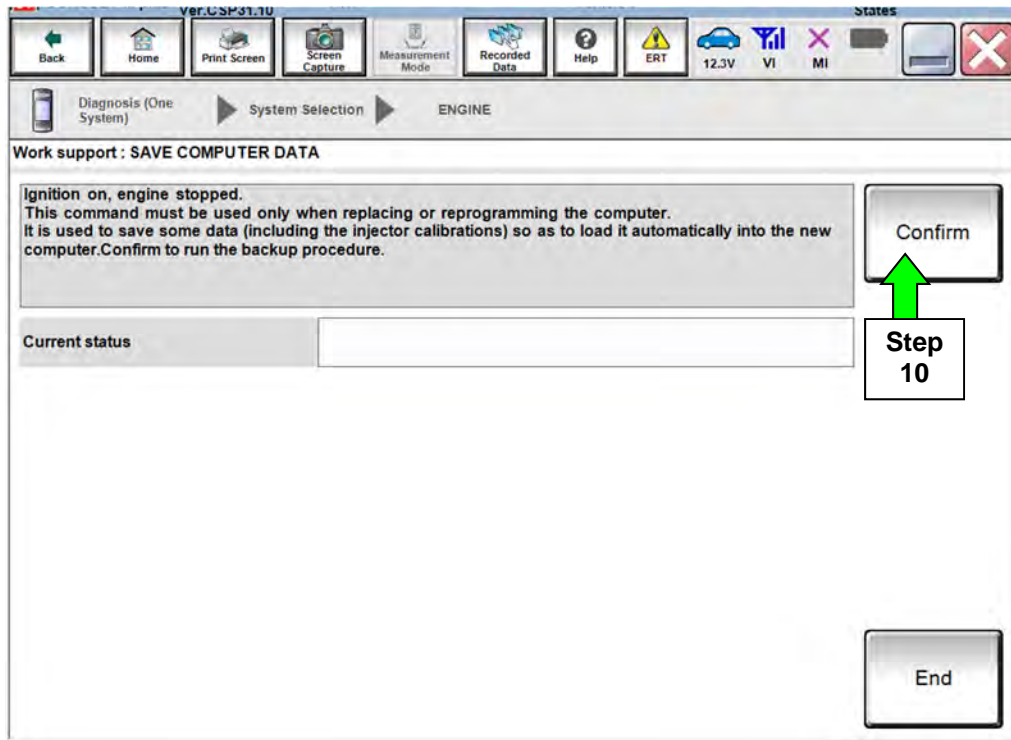
Figure C

9. Make sure the ignition is ON and the engine is OFF (engine not running).

10. Select **Confirm**.

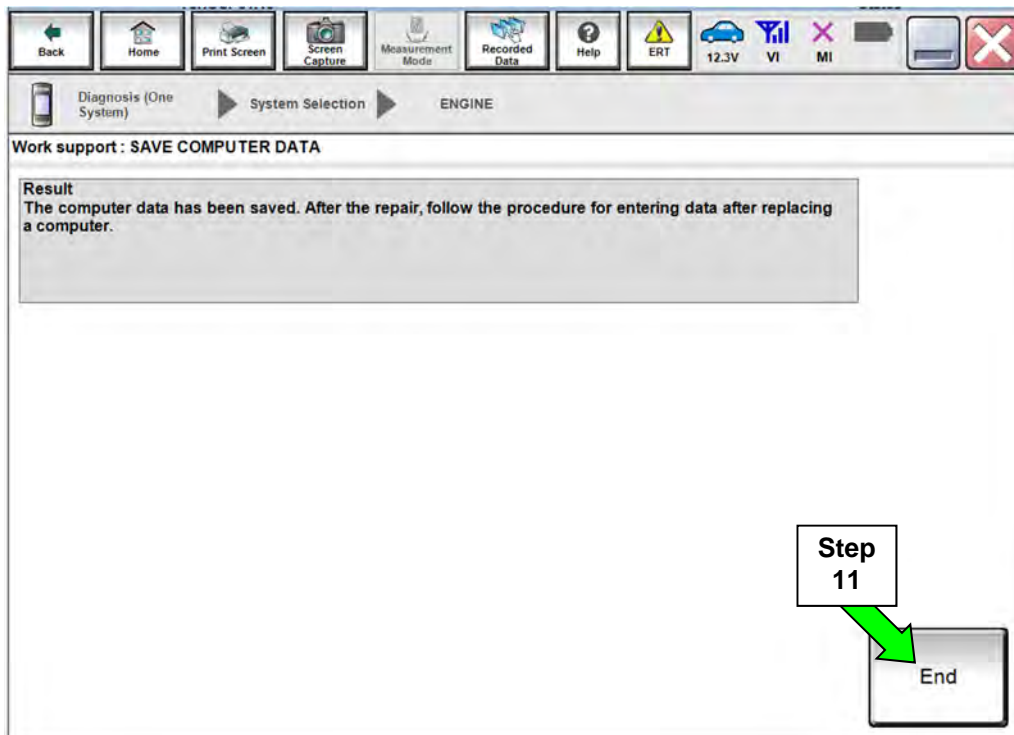
Figure D

11. Select **End**.

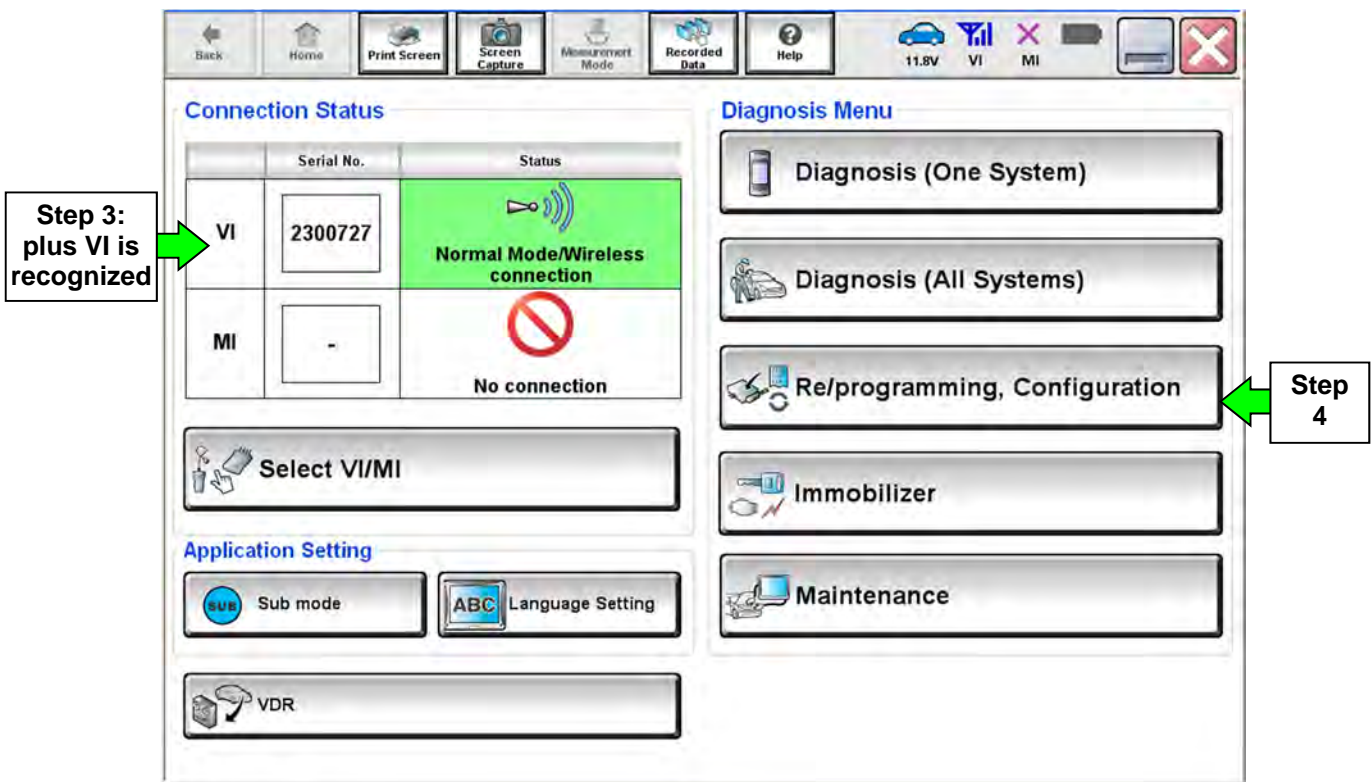
Figure 1

1. Return to the C-III- plus Home screen (see Figure 1).
2. Confirm the ignition is ON, with engine OFF.
3. Confirm the plus VI is recognized.
  - The **Serial No.** will display when the plus VI is recognized.
4. Select **Re/programming, Configuration**.

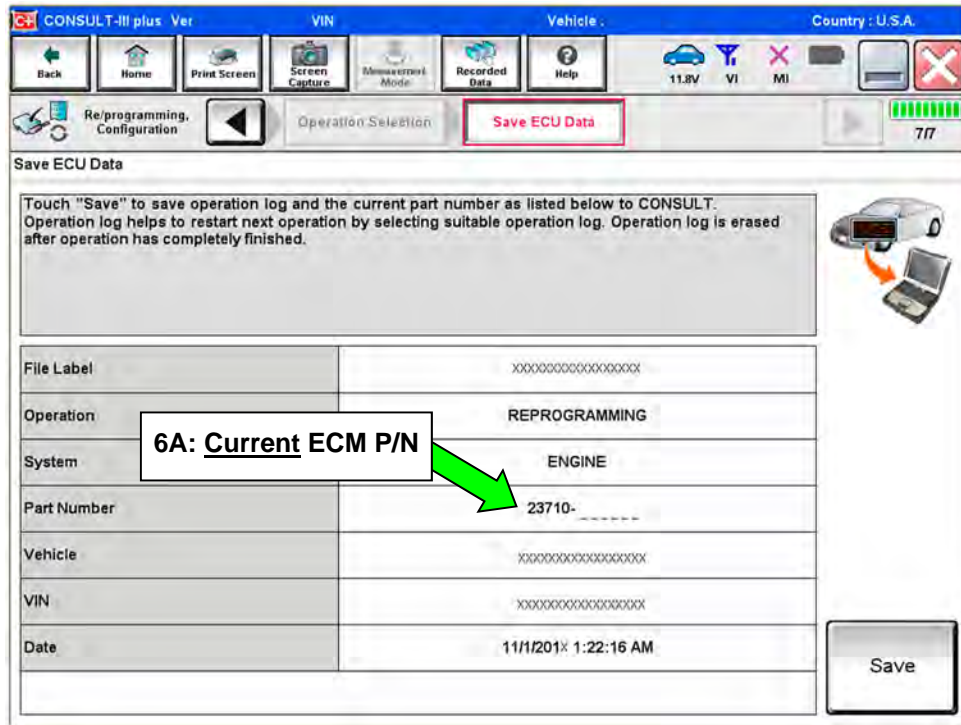
6. When you get to the screen shown in Figure 2, confirm this bulletin applies as follows.

A. Find the ECM **Part Number** and write it on the repair order.

**NOTE:** This is the current ECM Part Number (P/N).

5. Follow the on-screen instructions and navigate C-III plus to the screen shown in Figure 2 on the next page.

B. Compare the P/N you wrote down to the numbers in the **Current ECM Part Number** column in **Table A** below.

- If there is a match, this bulletin applies. Continue with the reprogramming procedure.
- If there is not a match, this bulletin does not apply. Close C-III plus and refer to ASIST for further diagnostic information.

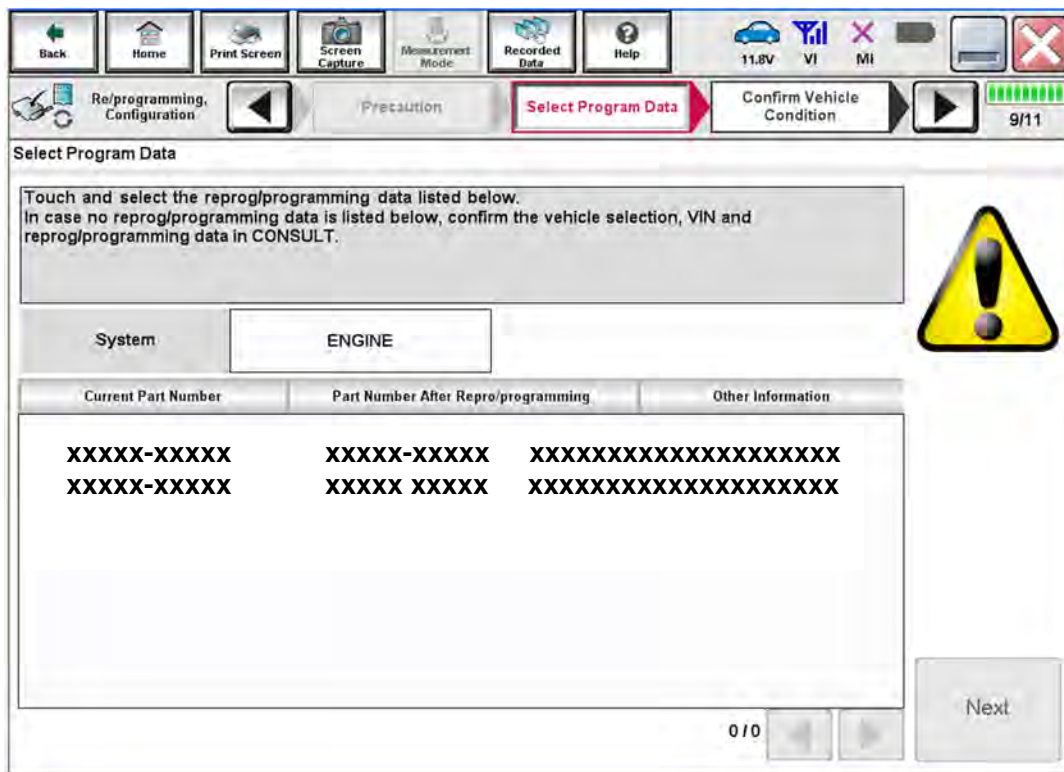
- In some cases, more than one new P/N for reprogramming is available.
  1. If more than one new P/N is available, the screen in Figure 3 displays.
  2. Select and use the reprogramming option that **does not** have the message “Caution! Use ONLY with NTBXX-XXX”.
- If you get this screen and it is blank (no reprogramming listed), it means there is no reprogramming available for this vehicle. Close C-III plus and refer back to ASIST for further diagnosis.

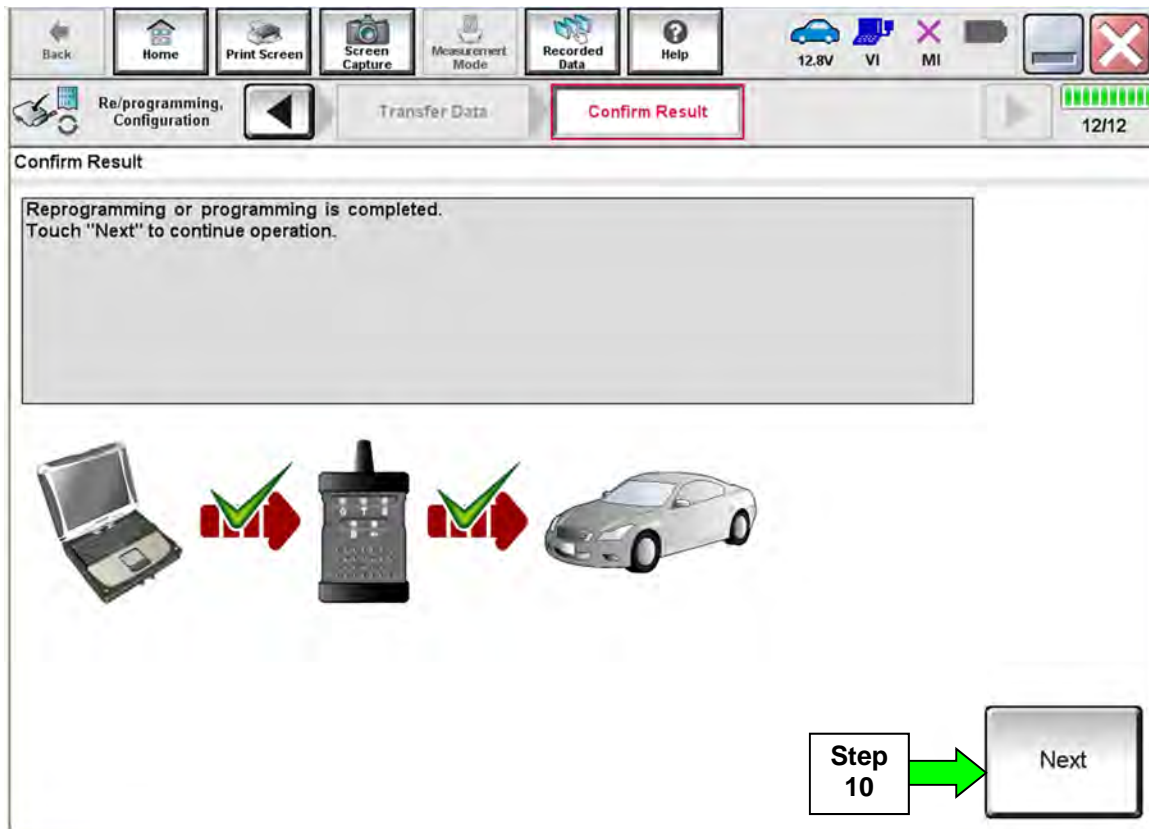
8. When the screen in Figure 4 displays, reprogramming is complete.

**NOTE:** If the screen in Figure 4 does not display (indicating that reprogramming did not complete), refer to ECM recovery on the next page.

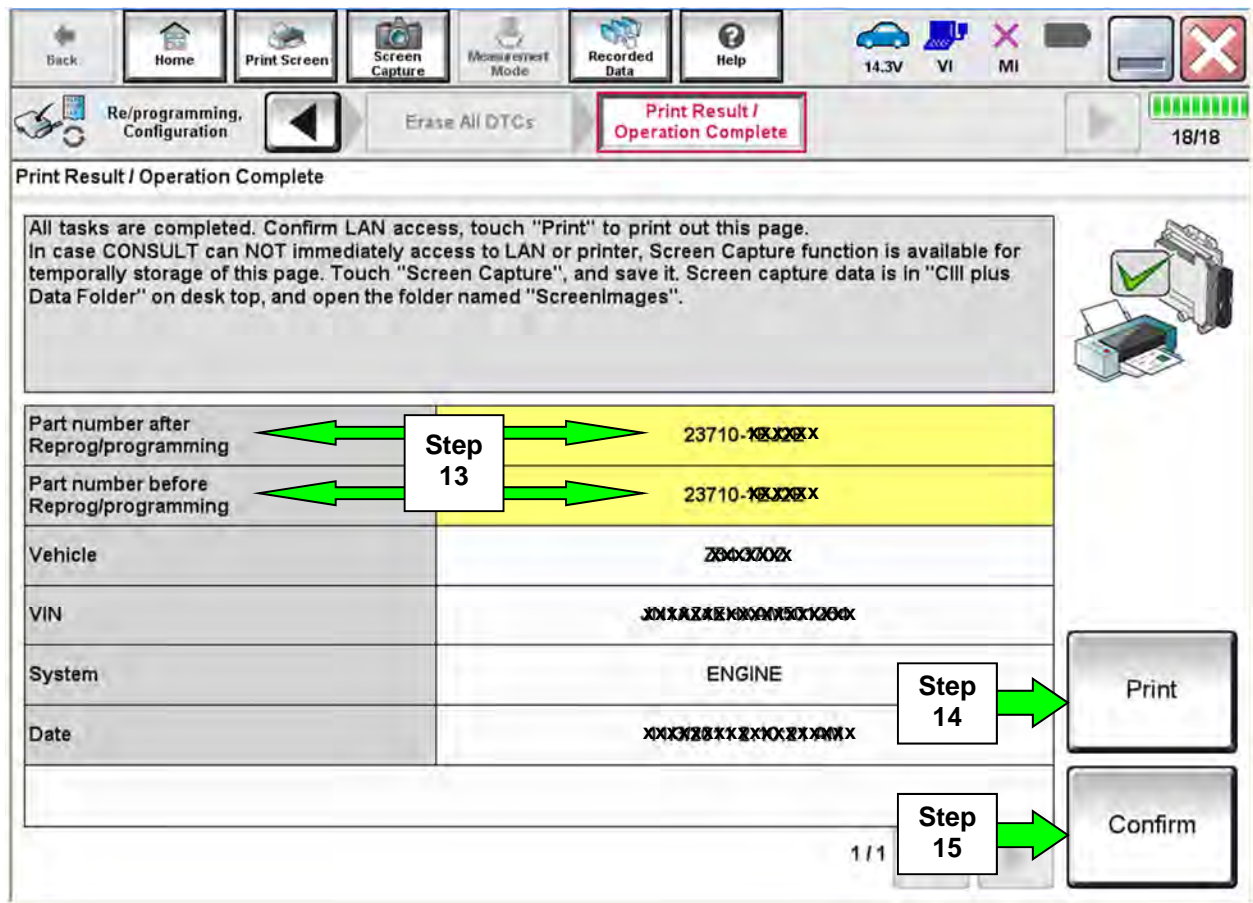
11. Follow the on-screen instructions to **Erase DTCs**.
12. When the entire reprogramming process is complete, the screen in Figure 7 will display.
13. Verify the before and after part numbers are different.
14. Print a copy of this screen (Figure 7) and attach it to the repair order for warranty documentation.
15. Select **Confirm**.

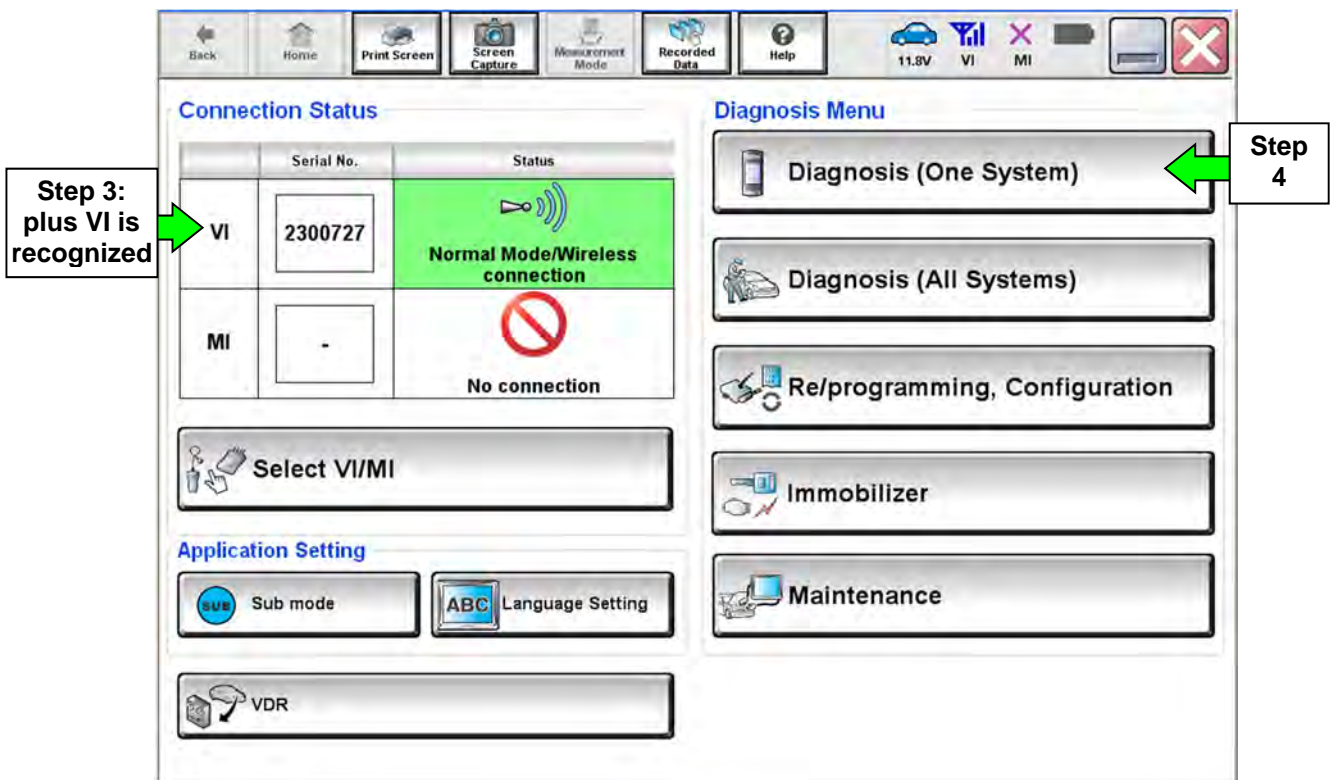
Figure 1A

1. Return to the C-III- plus Home screen (see Figure 1A).
2. Confirm the ignition is ON, with engine OFF.
3. Confirm the plus VI is recognized.
  - The **Serial No.** will display when the plus VI is recognized.
4. Select **Diagnosis (One System)**.

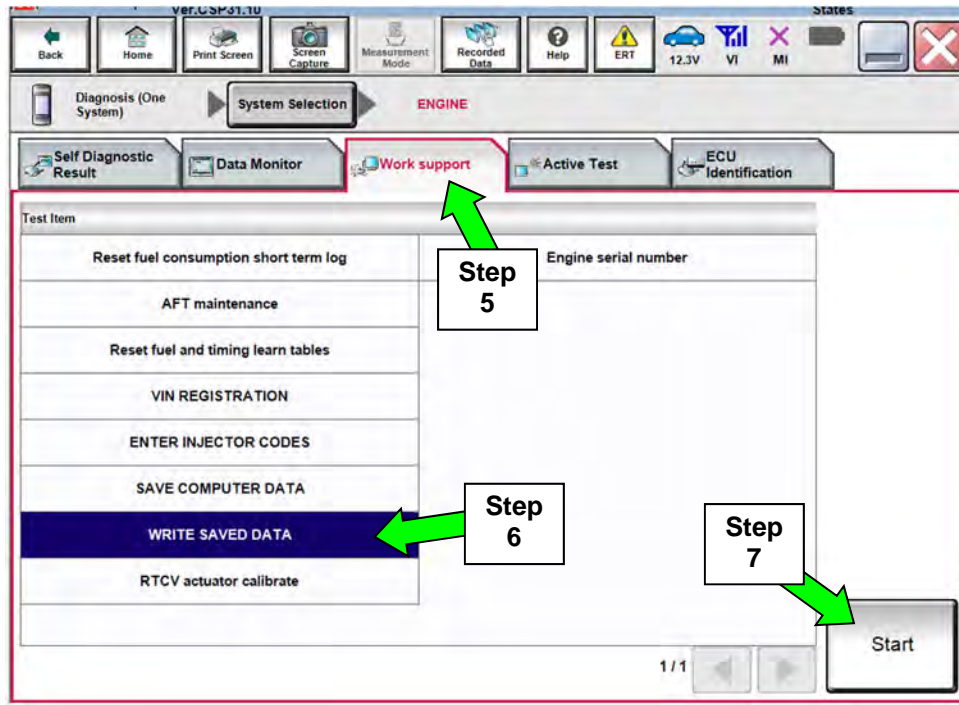
Figure 2A

5. Navigate C-III plus to **ENGINE > Work support** (see Figure 2A).
6. Select **WRITE SAVED DATA**.
7. Select **Start**.

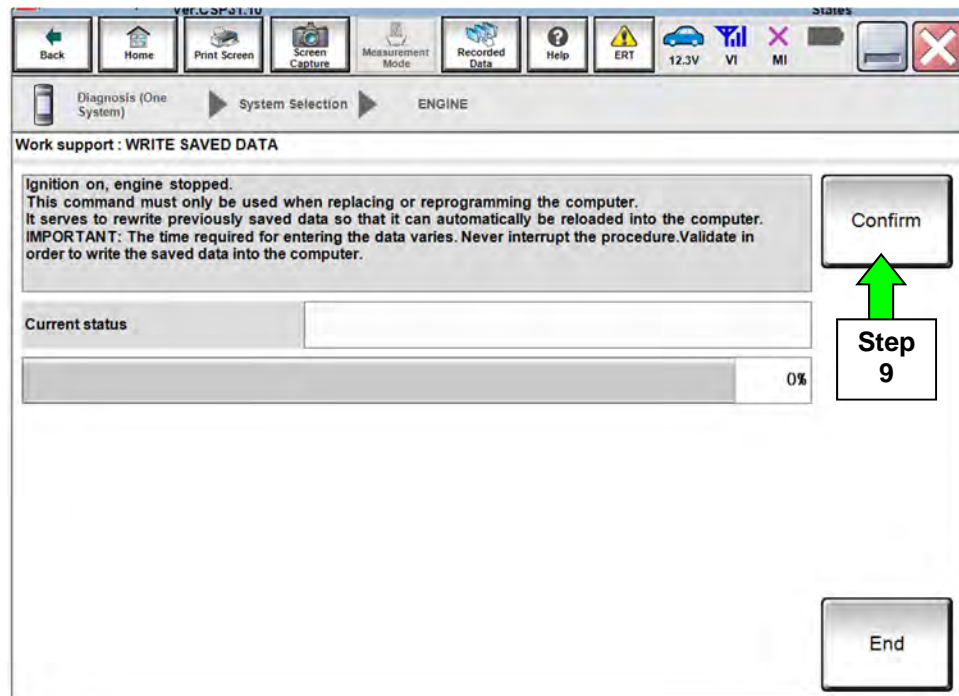
Figure 3A

8. Make sure the ignition is ON and the engine is OFF (engine not running).
9. Select **Confirm**.

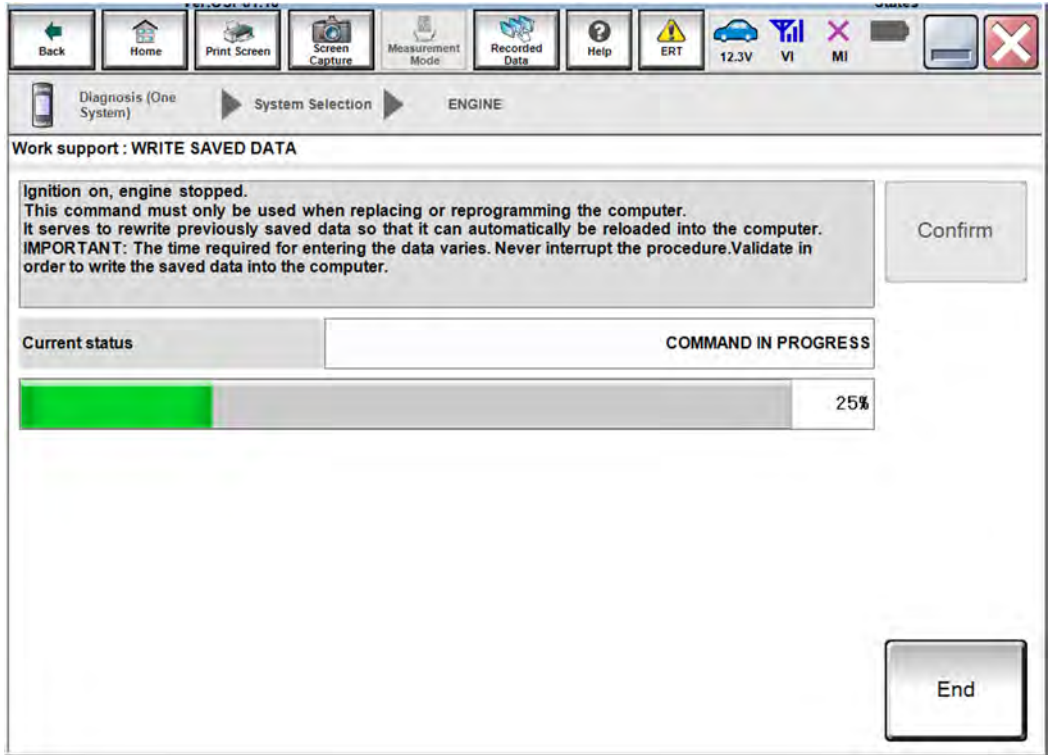
Figure 4A

10. Wait for the procedure to complete.

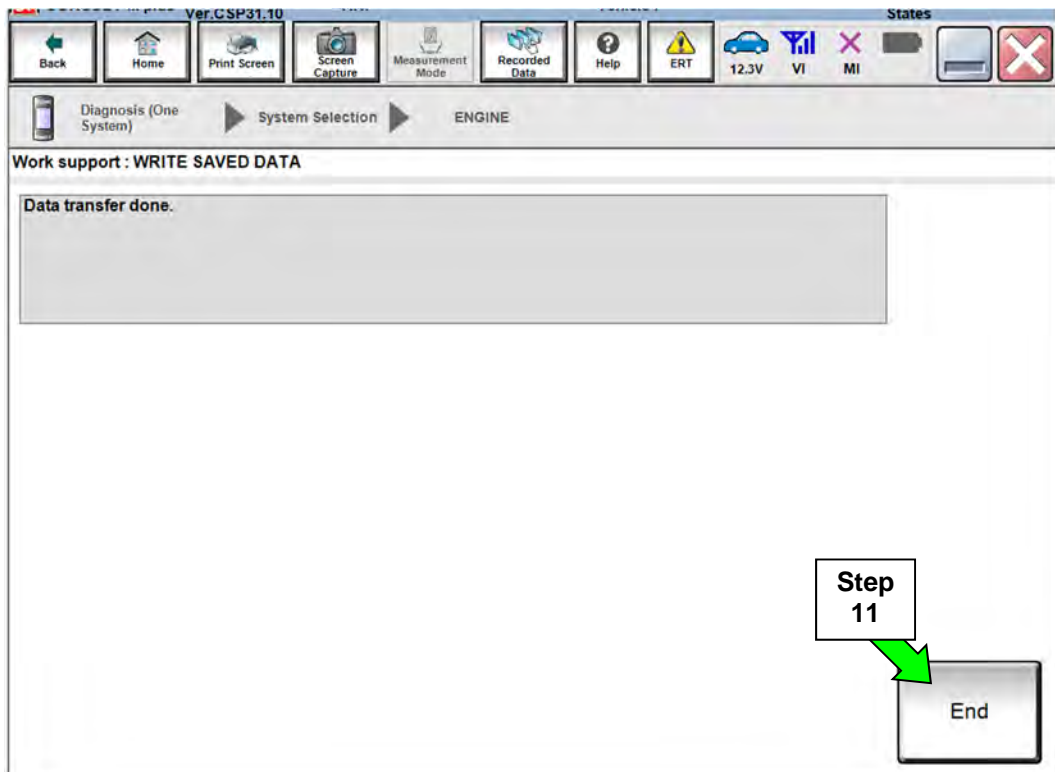
Figure 5A

11. Select **End**.
