SERVICE CAMPAIGN BULLETIN

NTB17-070

VOLUNTARY SERVICE CAMPAIGN 2004-2011 TITAN, AND 2005-2011 FRONTIER AND XTERRA; AIR BAG DIAGNOSIS SENSOR UNIT

CAMPAIGN ID #: P7318

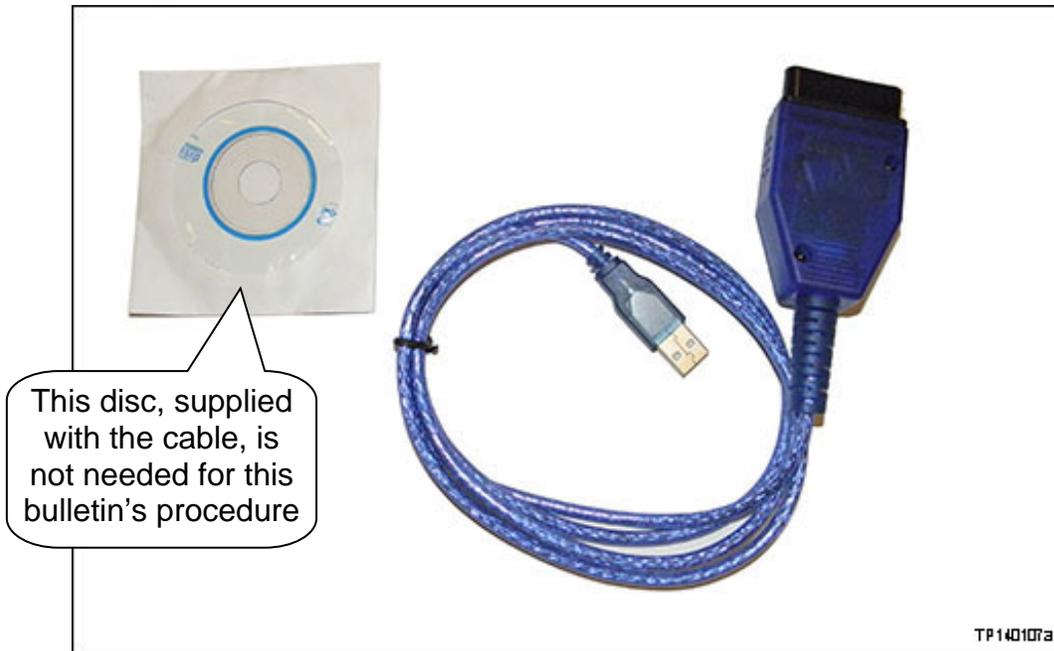
Figure 1

REQUIRED SPECIAL TOOL J-51594 (SRS Reprogramming Cable)

NOTE: One J-51594 SRS reprogramming cable (J-51594 cable) has been supplied to each dealer. Additional J-51594 cables can be obtained from Tech-Mate at 1-800-662-2001.

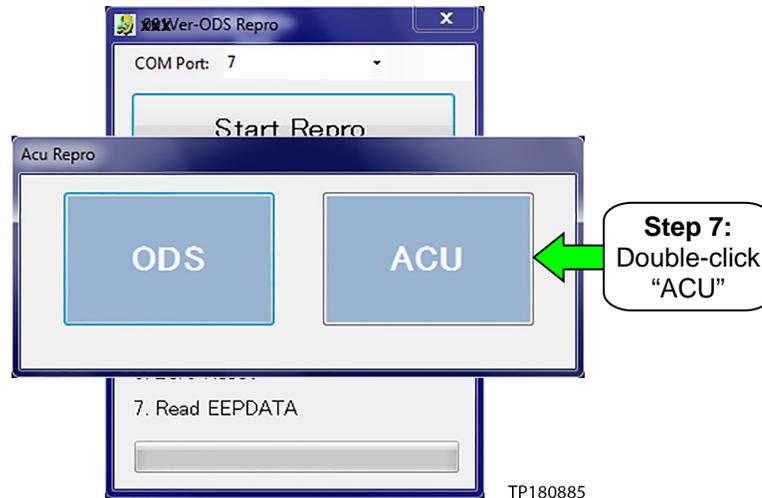
6. Turn ON the CONSULT PC, and then locate the **Acu Repro** icon on the CONSULT PC screen.
7. Select (double-click) "ACU".

NOTE: If the icon shown in Figure 2 does not display, navigate ASIST to **Specialty Tools**, and then select **P7318 ACU Reprogram** (see Figure 3). The icon in Figure 2 should then display.

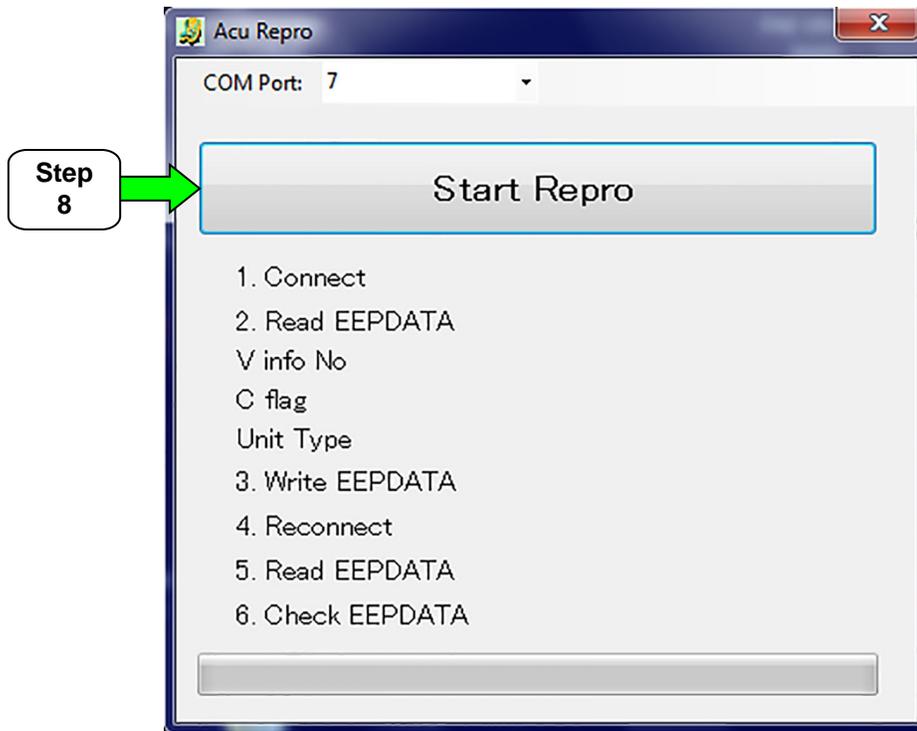
8. When the window in Figure 4 displays, select **Start Repro**.

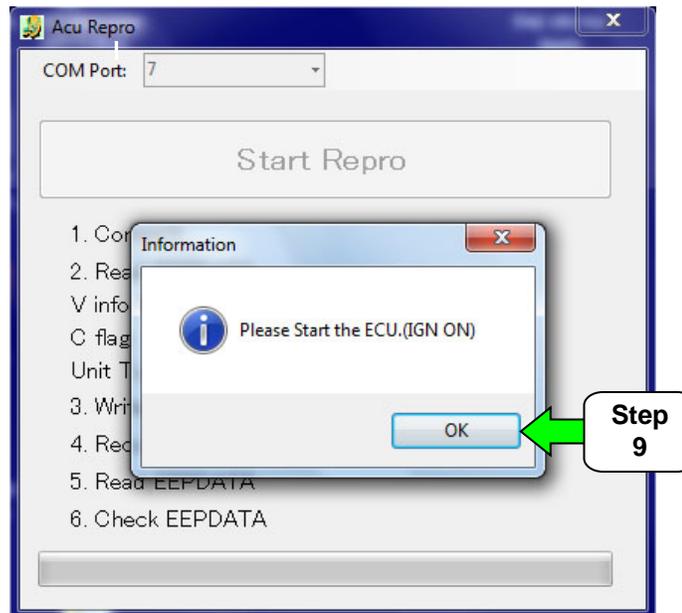
Figure 5

9. Turn the ignition ON, and then select **OK**.

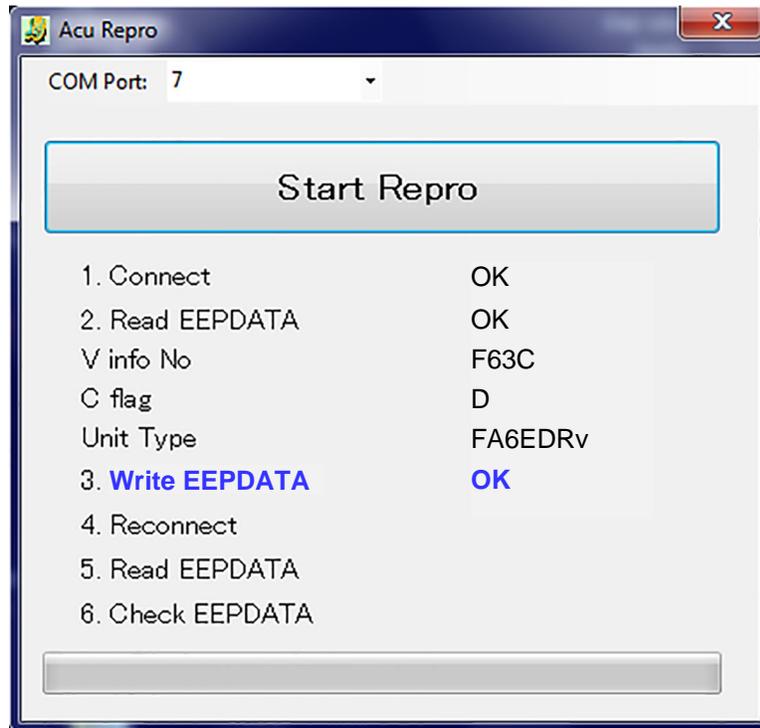
10. After selecting **OK**, the screen in Figure 6 will appear.

- While this screen displays, the air bag diagnosis sensor unit is being reprogrammed.

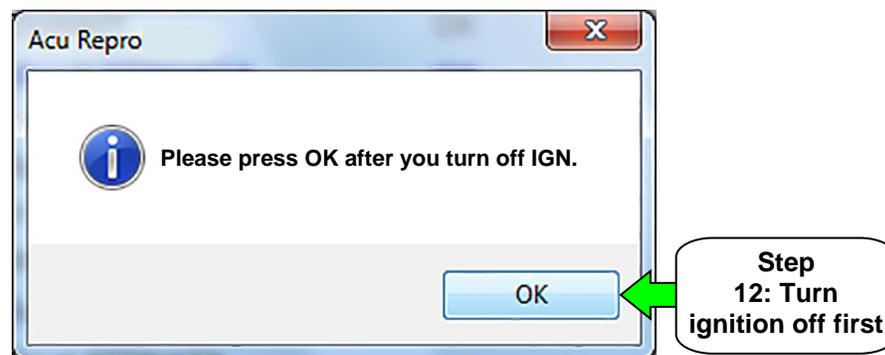
11. When reprogramming completes, the screen in Figure 7 appears.

12. Turn the ignition OFF, and then select **OK**.

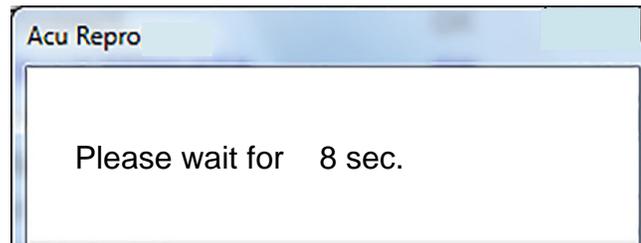
13. The countdown screen in Figure 8 will appear after selecting **OK** in step 12.

14. After **OK** has been selected, wait until the countdown completes (about 10 seconds).

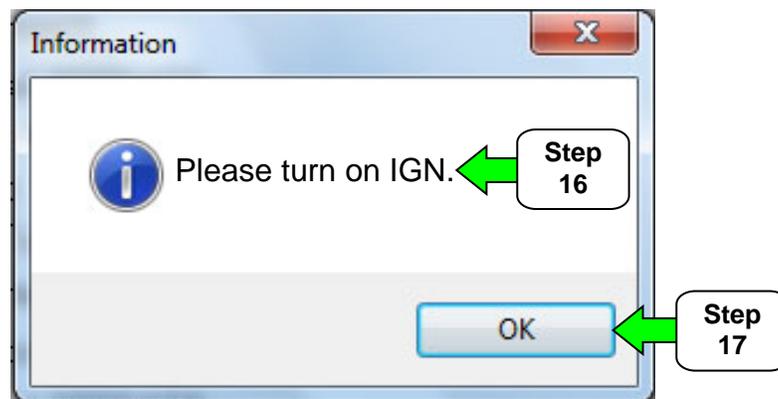
15. After the countdown completes, the screen in Figure 9 displays.

16. Turn the ignition ON.

17. Select **OK**.

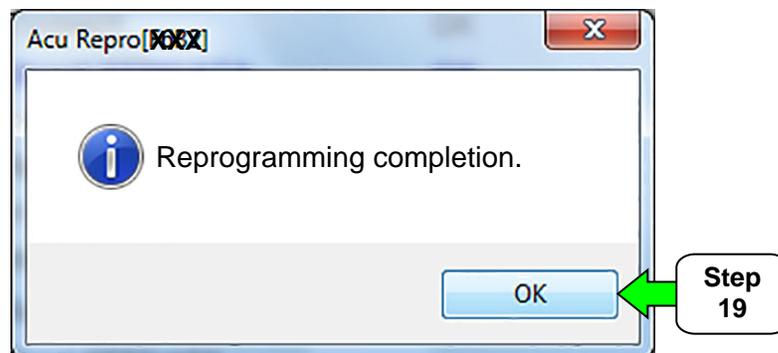
18. When the screen in Figure 10 displays, reprogramming is complete.

19. Select **OK**.

CAUTION: DO NOT disconnect the J-51594 cable until the screen in Figure 10 displays and **OK** is selected.
