# SERVICE BULLETIN

## 2014-2016 ROGUE; ROUGH IDLE ON START UP

**APPLIED VEHICLE:** 2014-2016 Rogue (T32)

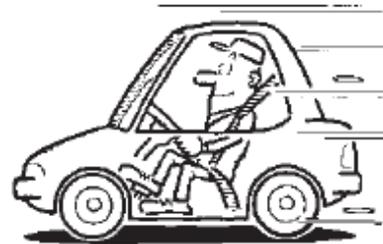
Figure A

- Most instructions for reprogramming with CONSULT-III plus (C-III plus) are displayed on the CONSULT PC screen.
- If you are not familiar with the reprogramming procedure, [click here](#). This will link you to the "CONSULT- III plus (C-III plus) Reprogramming" general procedure.
- Take the vehicle for a 10 minute drive in order to meet the following Idle Air Volume Learn (IAVL) conditions:
  - Engine coolant temperature: 70 - 105°C (158 - 221°F)
  - Battery voltage: More than 12.9V (at idle)
  - Transmission: Warmed up

**NOTE:** After reprogramming is complete, you will be required to perform Throttle Valve Closed Position, Idle Air Volume Learn, Accelerator Closed Position, and DTC erase. The above conditions are required for IAVL to complete.

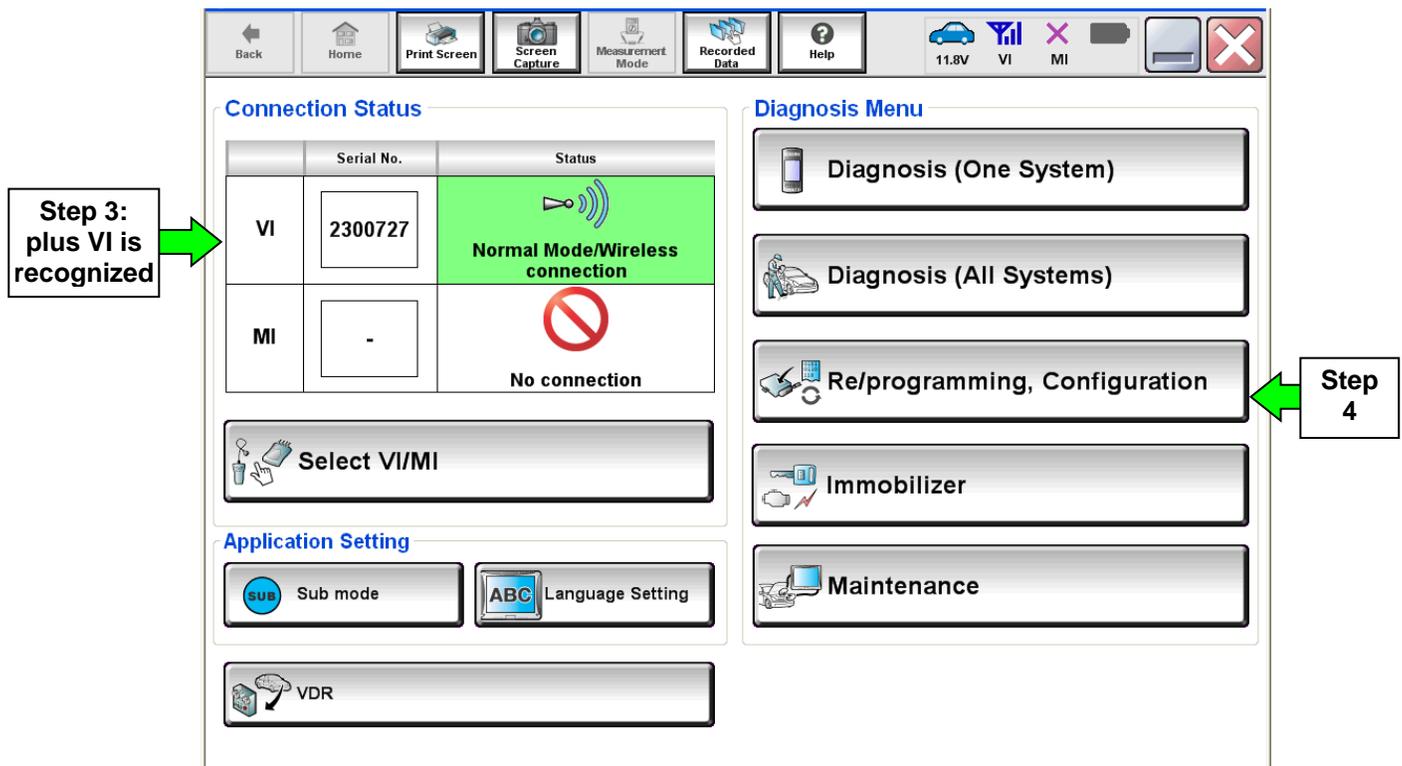
Figure 1

1. Connect the CONSULT PC to the vehicle to begin the reprogramming procedure.
2. Open / start C-III plus.
3. Wait for the plus VI to be recognized.
  - The **Serial No.** will display when the plus VI is recognized.
4. Select **Re/programming, Configuration**.

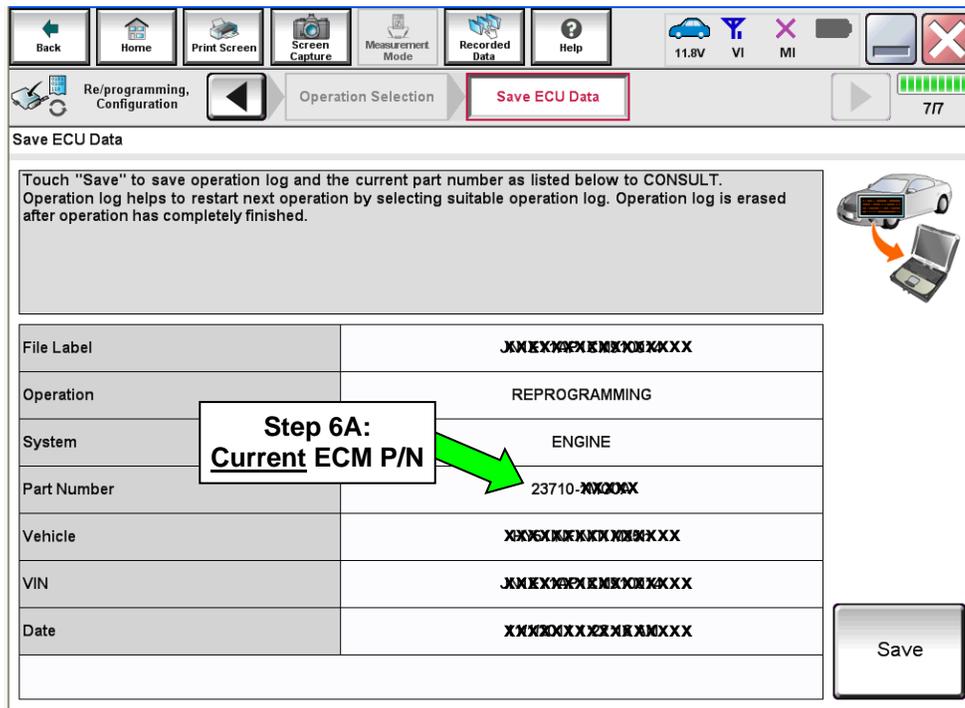
6. When you get to the screen shown in Figure 2, confirm this bulletin applies as follows.

A. Find the ECM **Part Number** and write it on the repair order.

**NOTE:** This is the current ECM Part Number (P/N).

5. Follow the on-screen instructions and navigate C-III plus to the screen shown in Figure 2 on the next page.

B. Compare the P/N you wrote down to the numbers in the **Current ECM Part Number** column in **Table A** below.

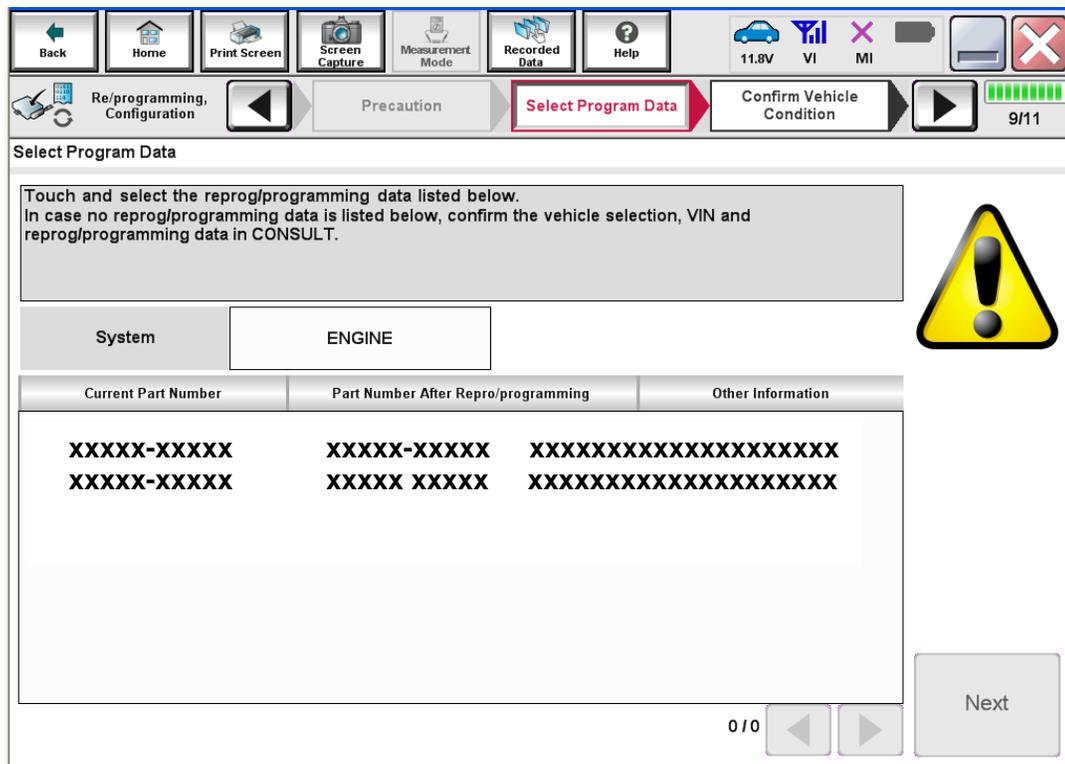
- In some cases, more than one new P/N for reprogramming is available.
  - If more than one new P/N is available, the screen in Figure 3 displays.
  - Select and use the reprogramming option that **does not** have the message “Caution! Use ONLY with NTBXX-XXX”.
- If you get this screen and it is blank (no reprogramming listed), it means there is no reprogramming available for this vehicle. Close C-III plus and refer back to ASIST for further diagnosis.

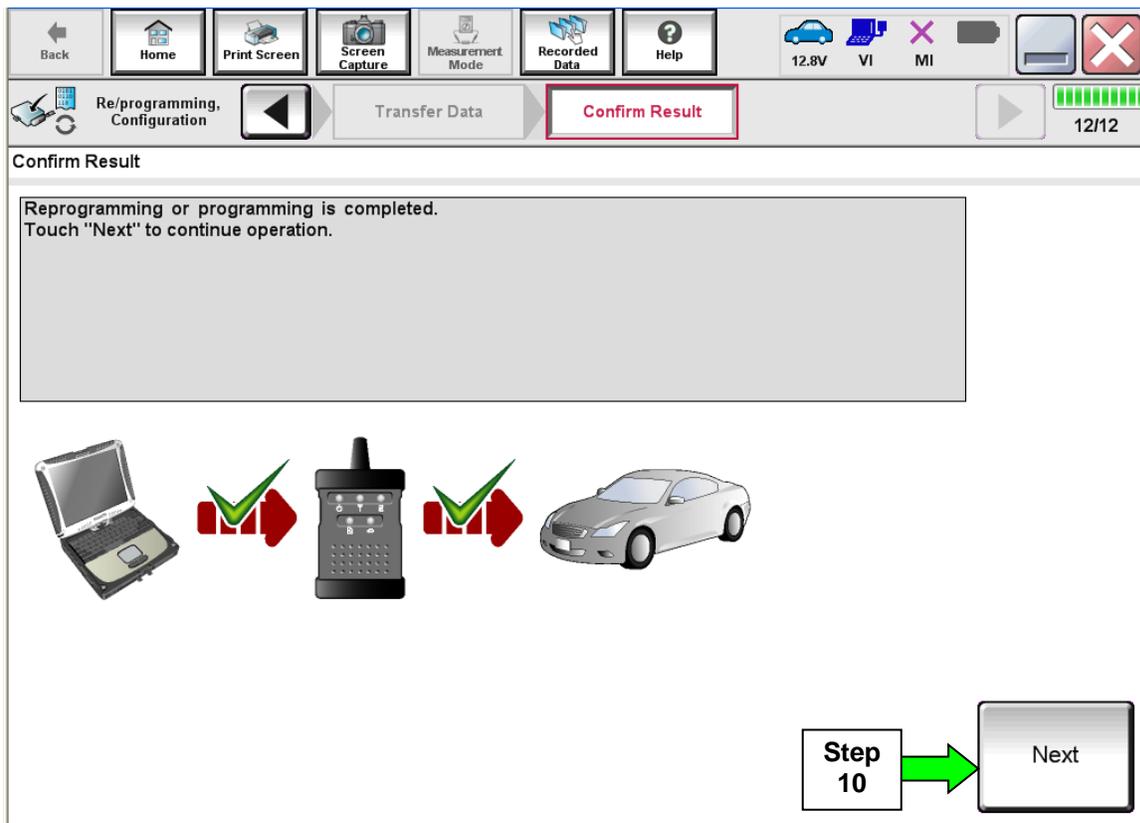
8. When the screen in Figure 4 displays, reprogramming is complete.

**NOTE:** If the screen in Figure 4 does not display (indicating that reprogramming did not complete), refer to ECM recovery on the next page.

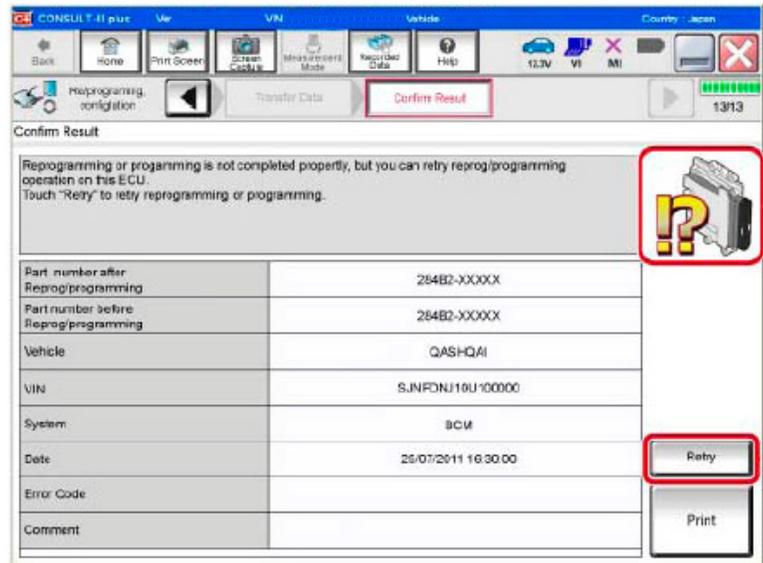
Figure 5

If reprogramming does not complete and the “!” icon displays as shown in Figure 5:

- Check battery voltage (12.0 - 15.5 V).
- Ignition is ON, engine OFF.
- External Bluetooth® devices are OFF.
- All electrical loads are OFF.
- **Select retry and follow the on screen instructions.**
- **“Retry” may not go through on first attempt and can be selected more than once.**

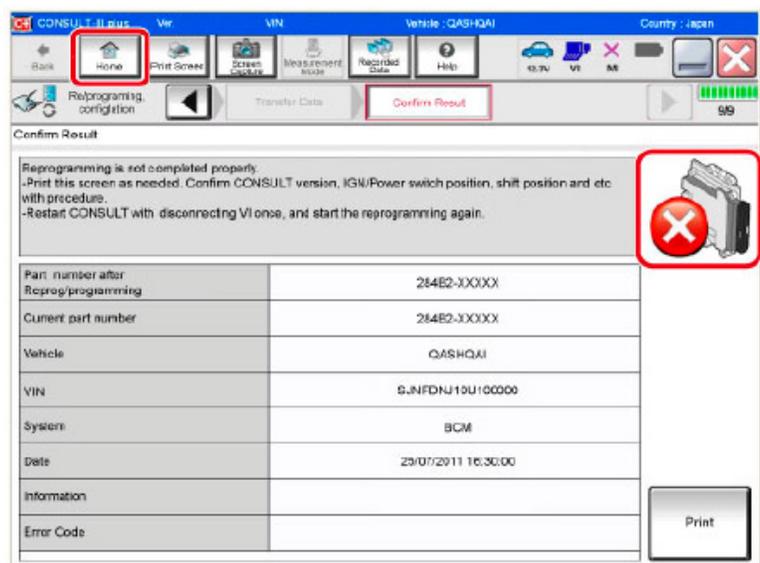
Figure 6

If reprogramming does not complete and the “X” icon displays as shown in Figure 6:

- Check battery voltage (12.0 - 15.5 V).
- CONSULT A/C adapter is plugged in.
- Ignition is ON, engine OFF.
- Transmission is in Park.
- All C-III plus / VI cables are securely connected.
- All C-III plus updates are installed.
- **Select Home, and restart the reprogram procedure from the beginning.**

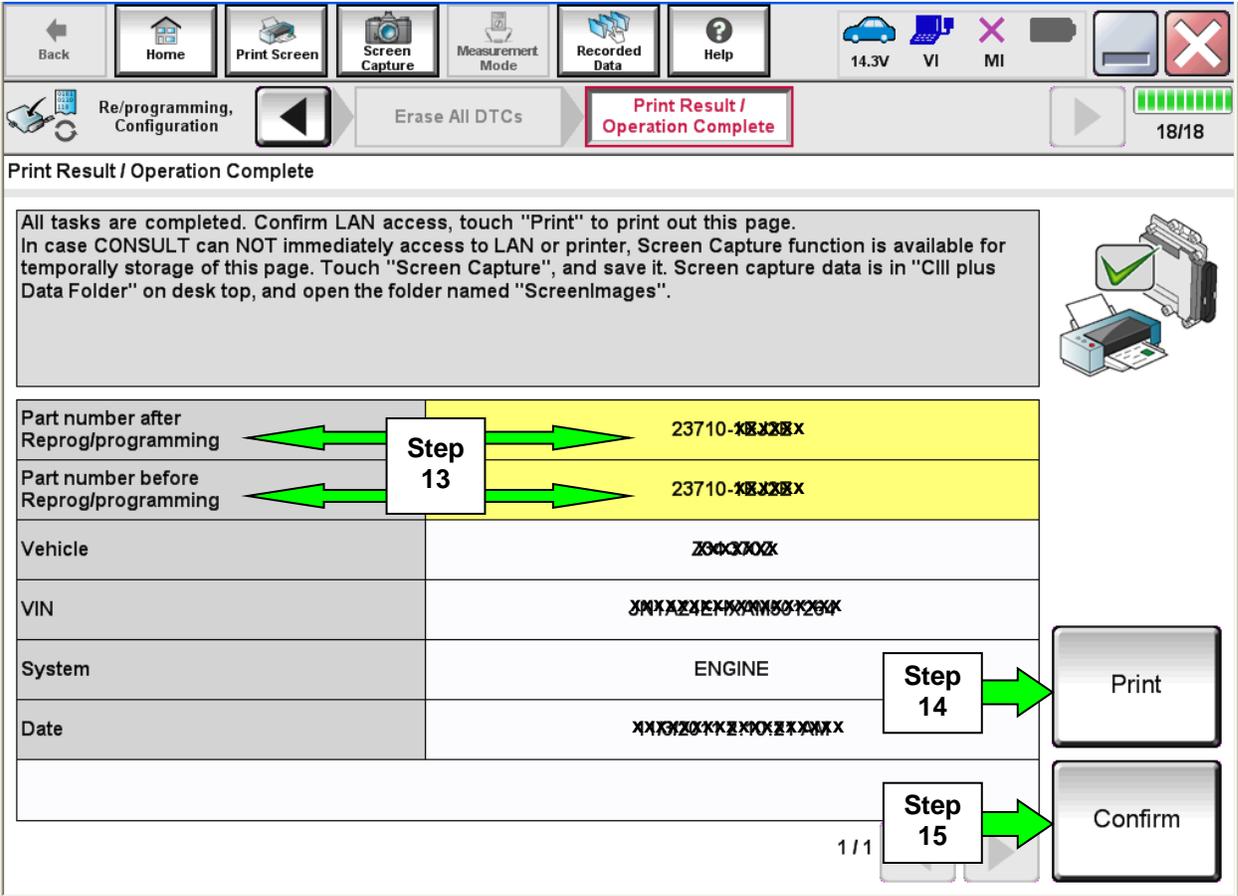
- 12. When the entire reprogramming process is complete, the screen in Figure 7 will display.
- 13. Verify the before and after part numbers are different.
- 14. Print a copy of this screen (Figure 7) and attach it to the repair order for warranty documentation.
- 15. Select **Confirm**.
