TECHNICAL BULLETIN

303-14A: Electronic Engine Controls - TDV6 3.0L Diesel

'Incorrect Diesel Exhaust Fluid (DEF) Quality Detected' Warning Message Displayed On The Instrument Cluster With DTC P2BA9 Stored

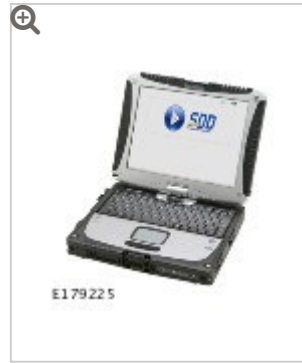
Jaguar Land
Rover-approved
diagnostic tool
with latest SDD
software,
Calibration File

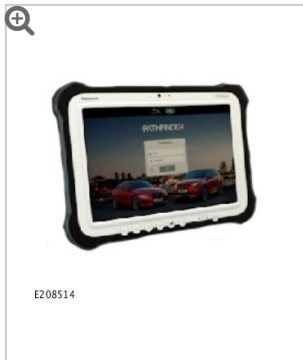
Jaguar Land
Rover-approved
diagnostic tool
with latest
PATHFINDER
software

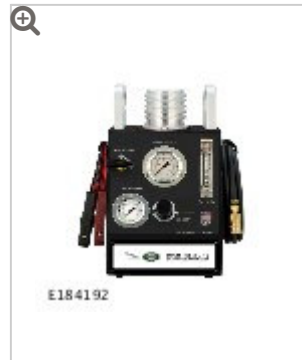
95-0106

Jaguar
Landrover
approved high
pressure
diagnostic leak
detector

-
- 1** Complete a leakage test on the intake system using smoke test equipment (see TOPlx Workshop Manual section 303-00: Engine system general information - General procedures - Leakage test using smoke test equipment).

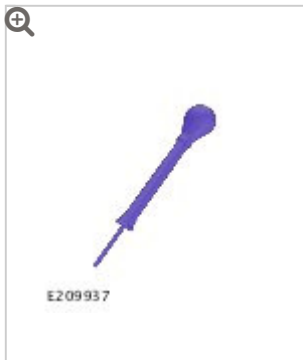
JLR-44-862

Diesel Exhaust
Fluid (DEF)
quality
hydrometer

Using the DEF quality hydrometer, check the DEF is within the acceptable (green) scale.

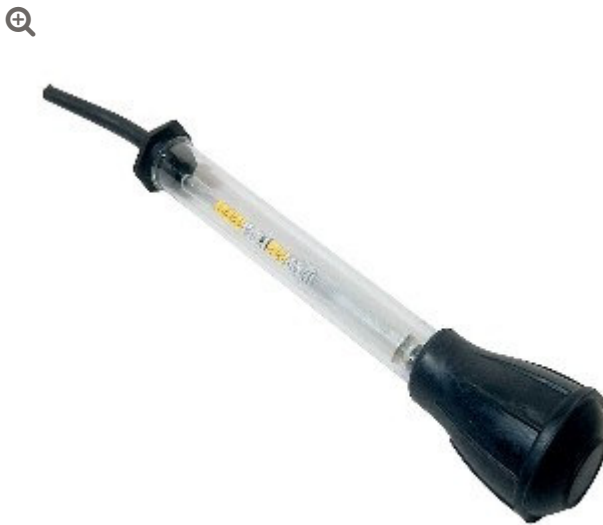
E183165

- If the fluid is in the green scale when tested (on all 3 test case samples),
go to Step 9.
- If the fluid is not in the green scale (on 1 or more of the 3 test case samples), drain and replace the DEF (refer to TOPlx Workshop Manual section 303-08A: General Procedures - Diesel Exhaust Fluid Tank Drain and Refill).
