Subject: AIR BAG PARTS COLLECTION REQUEST OF TAKATA AIR BAG FOR INVESTIGATION OF INFLATOR WITH DESICCANT	Bulletin No: 08-003/17
	Last Issued: 07/26/2017

APPLICABLE MODEL(S)/VINS

2003-2008 Mazda6 (including Mazdaspeed6)

2004-2011 RX-8

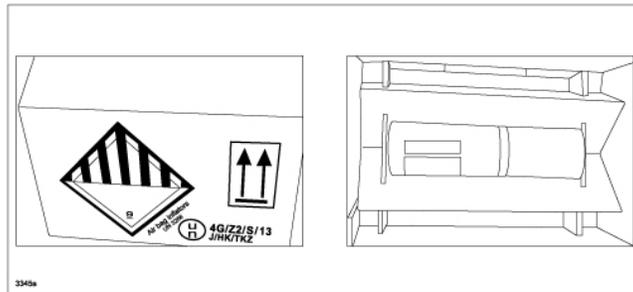
CAUTION:

- Use the same carton which was used to deliver the inflator. It is a specialized box that is internationally accepted for shipping an inflator.
- Pack the old inflator in the box exactly in the same manner as the new inflator was packed.

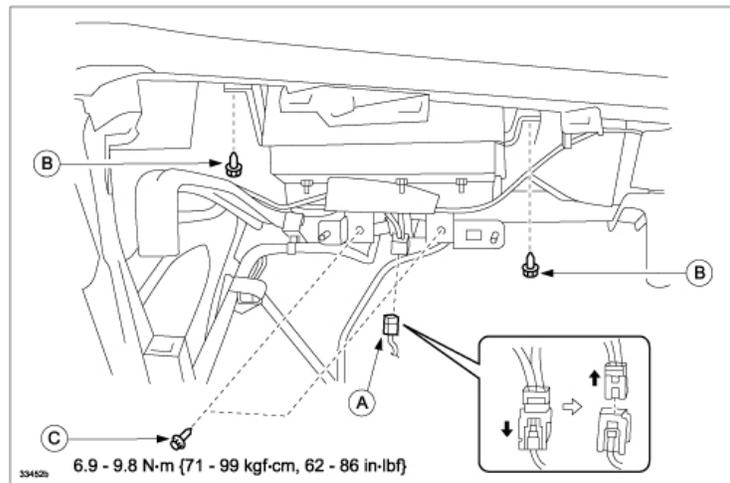
1. Turn the ignition switch OFF.
2. Disconnect the negative battery cable and wait for one (1) minute or more.
3. Remove the following parts:
 - a. Passenger-side front scuff plate
 - b. Passenger-side front side trim
 - c. Dashboard under cover
 - d. Glove compartment
 - e. Passenger-side lower panel
 - f. SIRIUS satellite radio unit (if equipped)
4. Disconnect the connector (A).

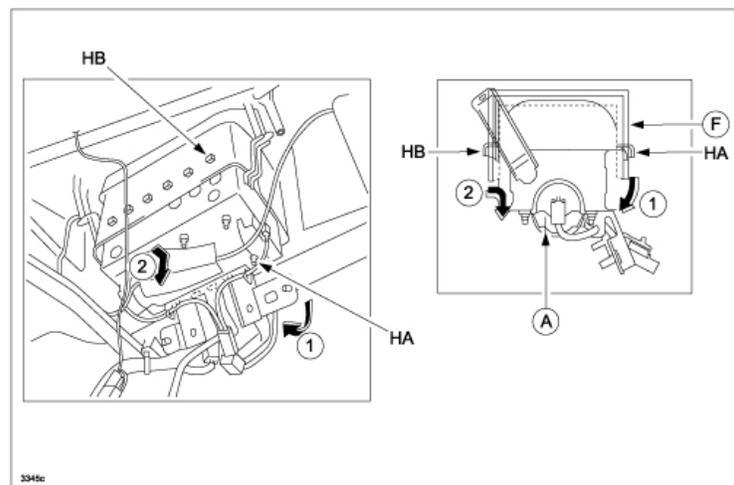
5. Remove the screws (B) and bolt (C).
6. Pull the passenger-side airbag module (A) in the direction of arrow (1) and detach hook A (HA) from the instrument panel (F=Frame).

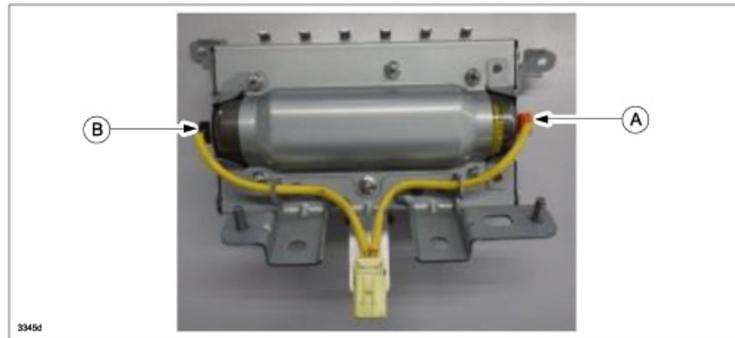
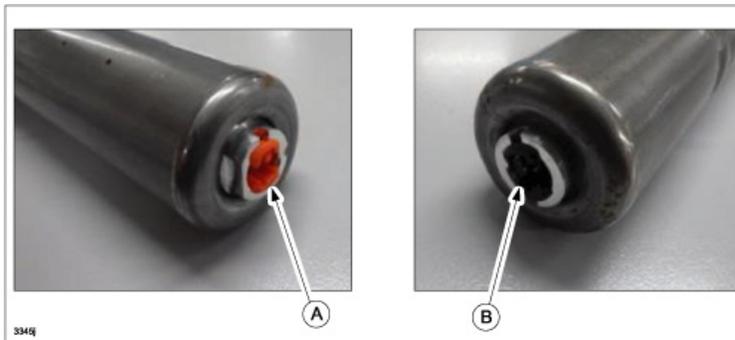
7. Pull the passenger-side airbag module in the direction of arrow (2) and detach hook B (HB) from the instrument panel.

8. Replace the passenger front airbag inflator with a new one, making note of the orange connector (A) and the black connector (B).

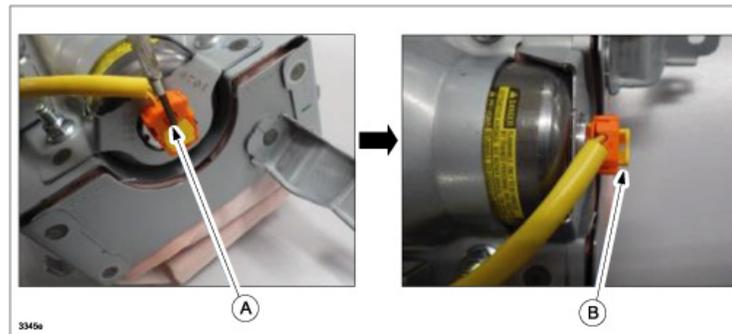
- a. Push up the locking pin at the tip of the orange connector (A) using a thin tool and confirm the lock pin is up (B).

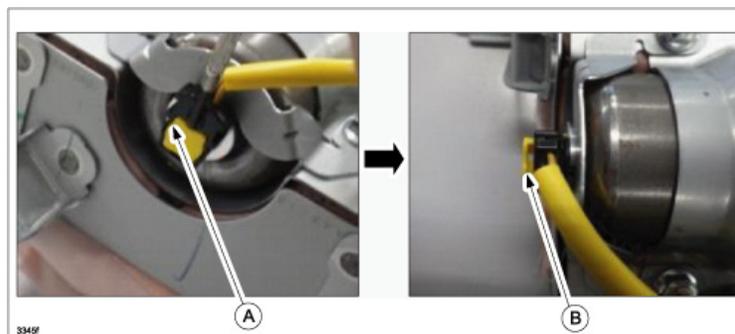
- b. Push up the locking pin at the tip of the black connector (A) using a thin tool and confirm the lock pin is up (B).

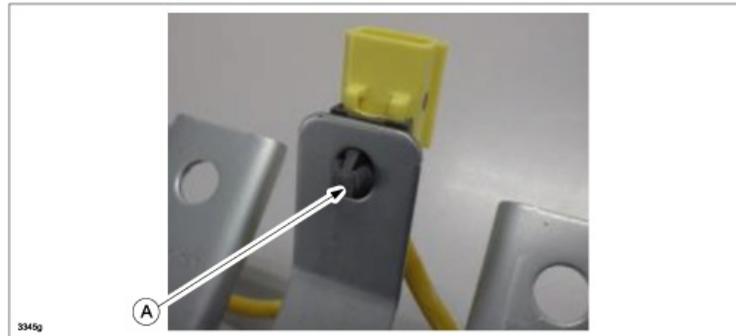
c. Remove the clip (A) of the connector.

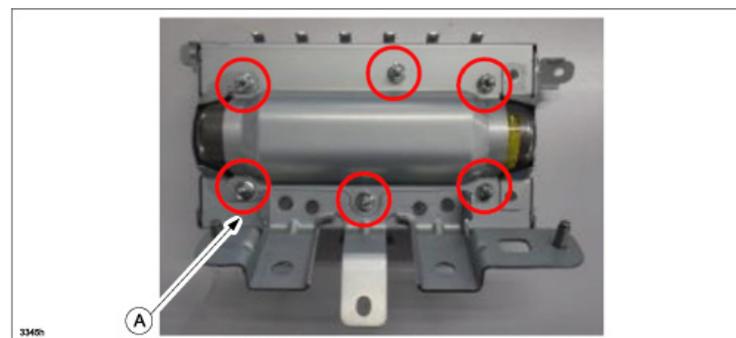
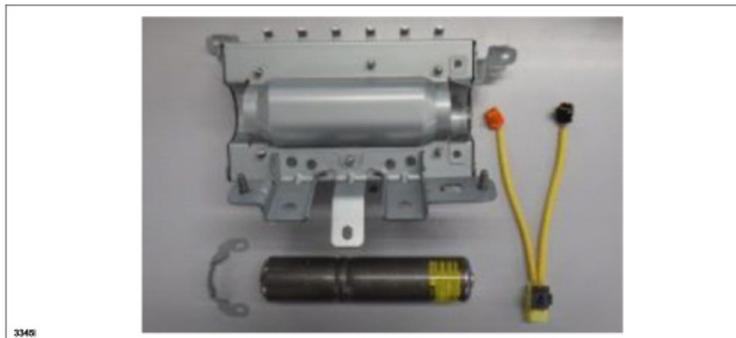
d. Remove the six M5 nuts (A), stopper plate and inflator.

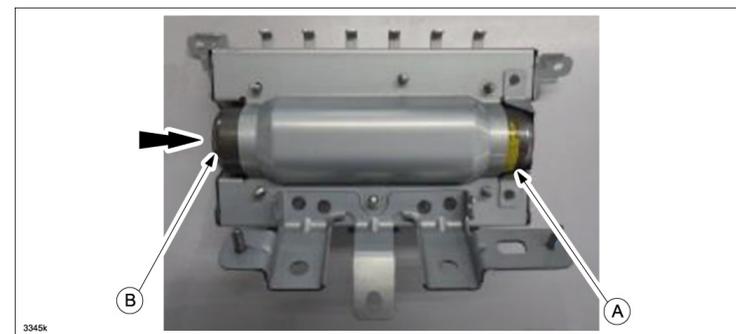
e. Insert the replacement inflator into the retainer in the direction of the arrow, making sure to orient the orange connector (A) and black connector (B) properly before inserting in the retainer.

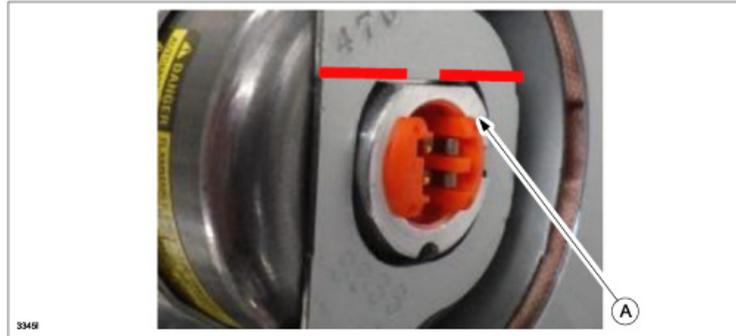
NOTE: The inflator D shape should align with the stopper plate (A).

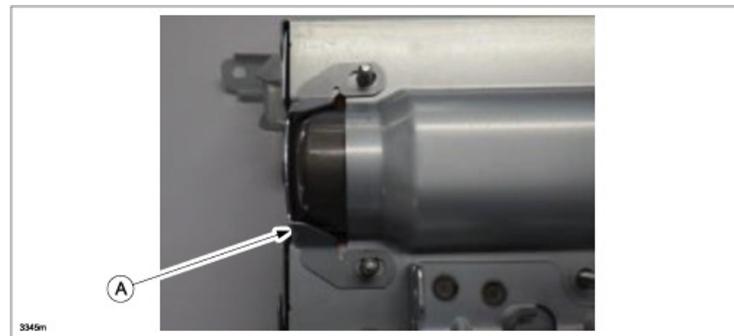
f. Attach the replacement stopper plate (A) to the retainer.

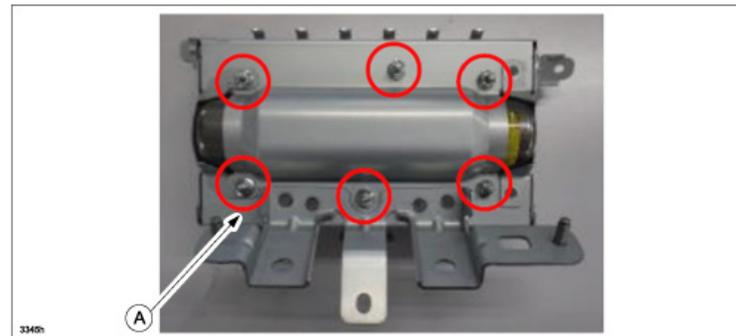
g. Install the six M5 replacement nuts (A).
Tightening torque: 34.5 +/- 3.5 lb-in (3.9 +/- 0.4 Nm)

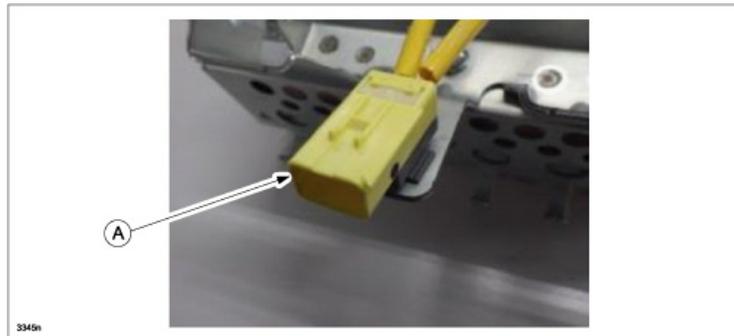
- h. Connect the replacement wire harness at 2 locations, making sure the connectors are fitted properly.
1. Attach the connector (A).

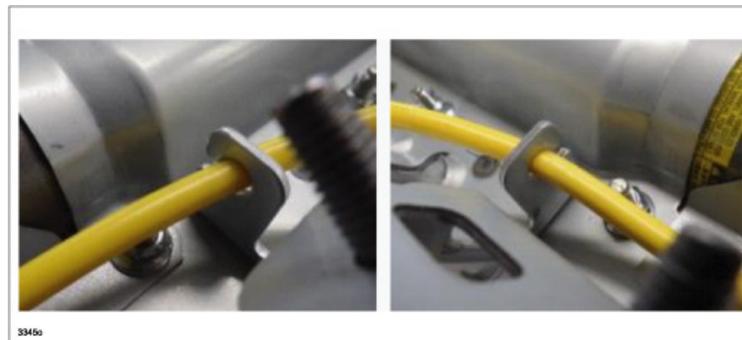
2. Pass the harness through the bracket as shown.

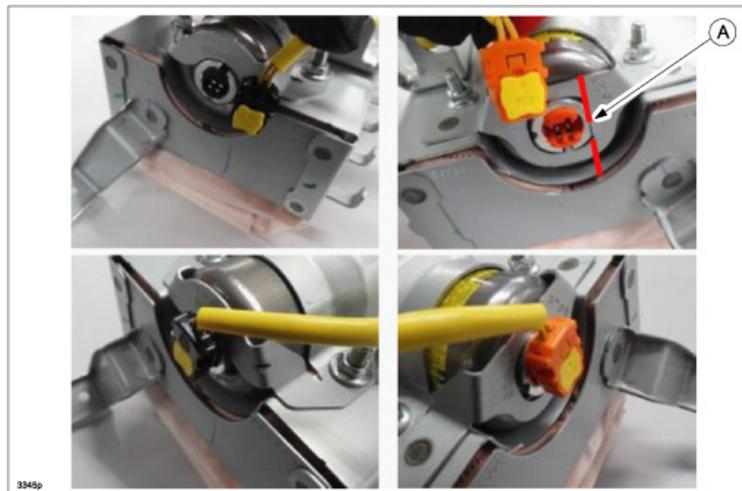
3. Connect the connectors.
