AT17-002

2016 – 2017 QX80; SHIFT SHOCK WITH DOWN SHIFT

APPLIED VEHICLES: 2016 – 2017 QX80 (Z62)
APPLIED VIN // DATE: 2016 vehicles: All
2017 vehicles built before:
4WD - JN8AZ2NC(*)H9 403317 // October 17, 2016
JN8AZ2NE(*)H9 151975 // October 17, 2016
2WD - JN8AZ2ND(*)H9 830175 // October 17, 2016
JN8AZ2NF(*)H9 641079 // October 17, 2016

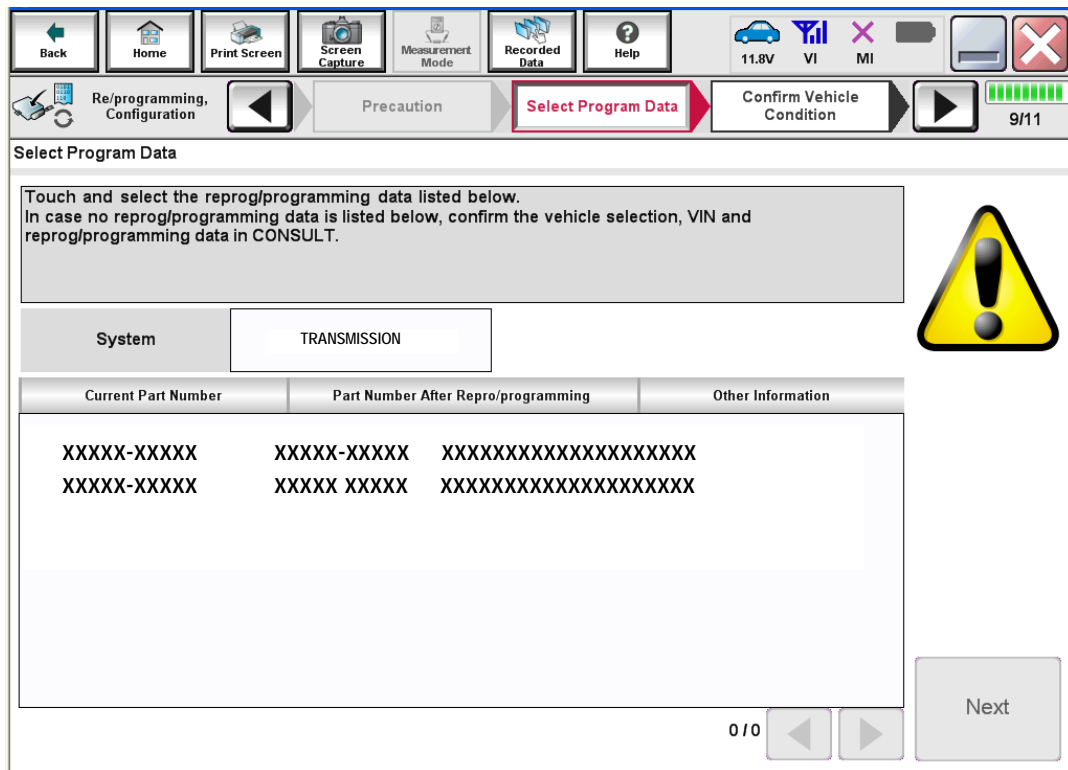
- In some cases, more than one new P/N for reprogramming is available.
 1. If more than one new P/N is available, the screen in Figure 3 displays.
 2. Select and use the reprogramming option that **does not** have the message “Caution! Use ONLY with ITBXX-XXX”.
- If you get this screen and it is blank (no reprogramming listed), it means there is no reprogramming available for this vehicle. Close C-III plus and refer back to ASIST for further diagnosis.
