37K4 UPDATE - DSG Software Update (FED\_EMS) - U.S. ONLY

This update has been proactively released to prevent an inadvertent downshift when activating the cruise control.

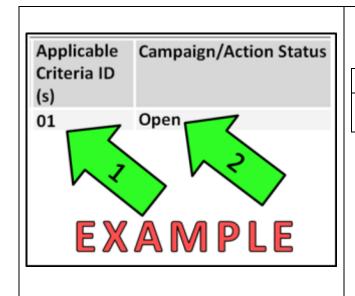
Enter the VIN in Elsa and proceed to the "Campaign/Action" screen

On the date of repair, print this screen and keep a copy with the repair order
