NUMBER: 08-055-17 REV. A

GROUP: 08 - Electrical

Flash: Hands Free Module Software Enhancements

This bulletin involves reprogramming the Hands Free Module (HFM) with the latest available software.

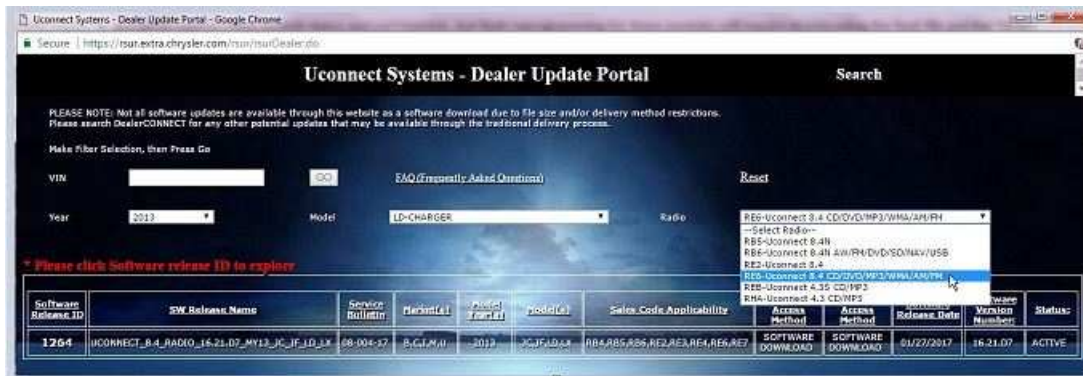
Fig. 1
Dealer Update Portal

- Using wiTECH, identify if an update is required and if so determine the new part number. Record the current part number and the new (update) part number. The vehicle ignition key will need to be in the “RUN” position to read part numbers. The wiTECH application will still be used to check module status and part number, but flash reprogramming for these modules will require downloading the flash file and the “HFM USB Flash” application from Uconnect. The flash file and PC application are bundled in the zip file that is downloaded after entering the required vehicle information. Go to DealerCONNECT>Service>Uconnect Command Center>Uconnect>More Information >Dealer software downloads to download the files. If you don’t use the vehicle VIN for your search, you will need to enter “Year”, “Model” and “Radio”. Any applicable HFM module update will be found under the “Radio” drop down list via the sales code (Fig. 1) .

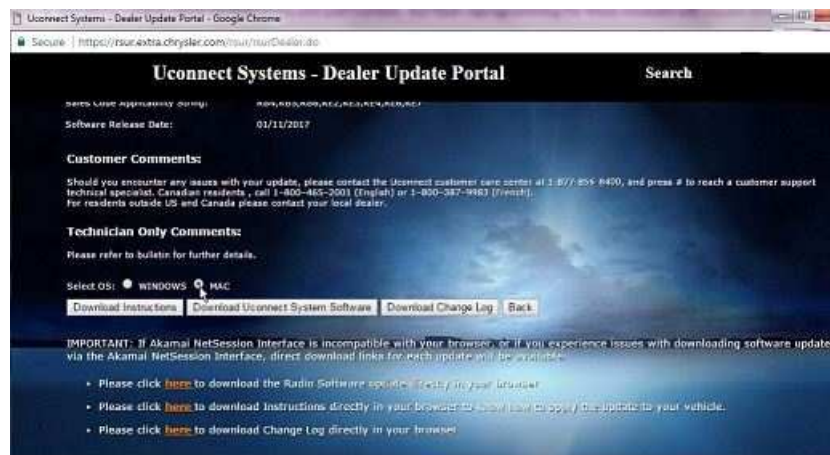
Fig. 2

2. The HFM USB Flash application only runs on Windows PCs, however for “OS” selection, you can choose either “WINDOWS” or “MAC” to download files. If you select “WINDOWS” you will download a self-extracting “.exe” file. If you select “MAC”, you will download a “.zip” file. In either case, after clicking on the downloaded file, you will be able to extract the bundled files (flash file and flash PC application). For this flash, regardless of “OS” selection, you end up with the same files after extraction and you must use a PC running either Windows 7 or Windows 10 (Fig. 2) .

Download Software - Push Windows or MAC Radial-Button

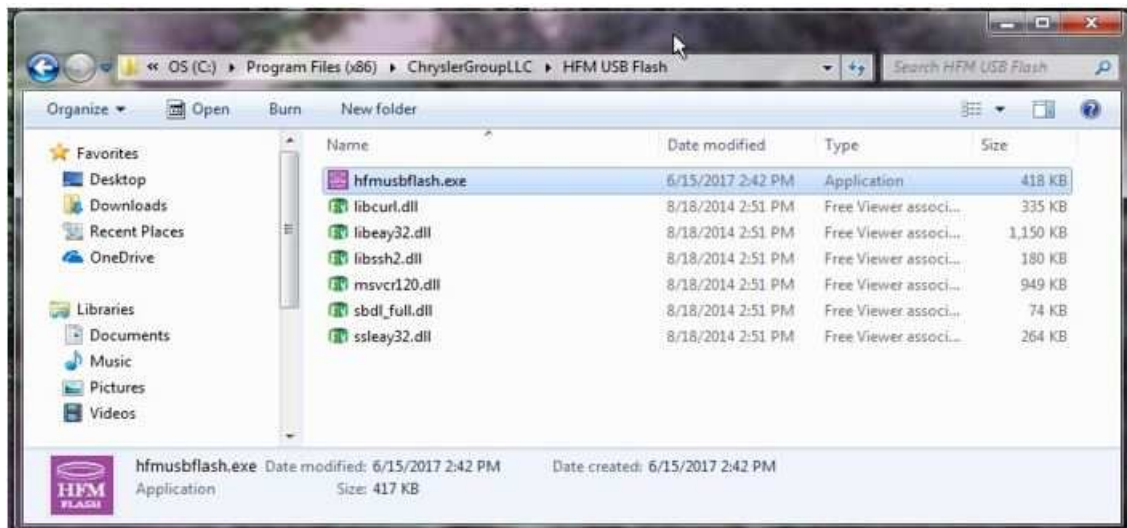
Fig. 3

NOTE: After installation, you will find the application in “C:\Program Files x86)\ChryslerGroupLLC\HFM USB Flash”, where you can create a shortcut to it . Right click on “hfmusbflash.exe” to create a shortcut to your desktop.

Create Shortcut

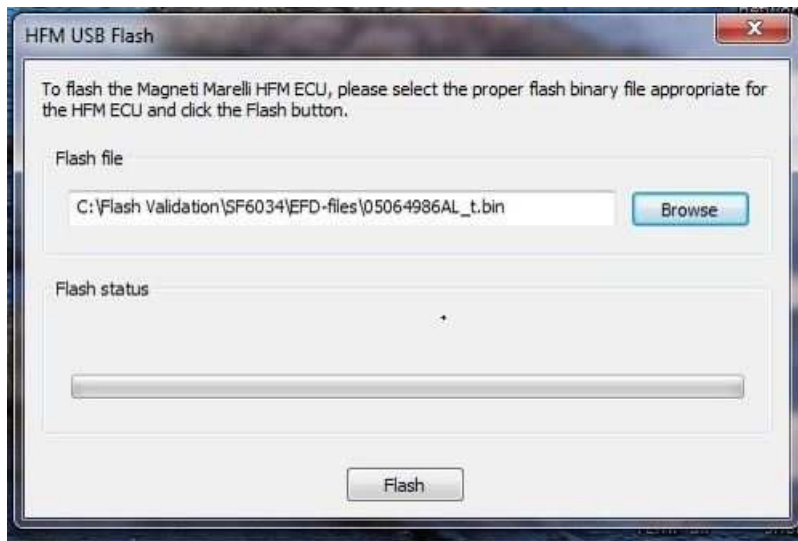
Fig. 4
Flash Status

5. Turn the vehicle ignition key to the "RUN" position and then start the application. You will be prompted to browse for the HFM flash file. Navigate to the location of the flash file that you extracted. The flash file will have a ".bin" extension. Click on the "Flash" button (Fig. 4) .

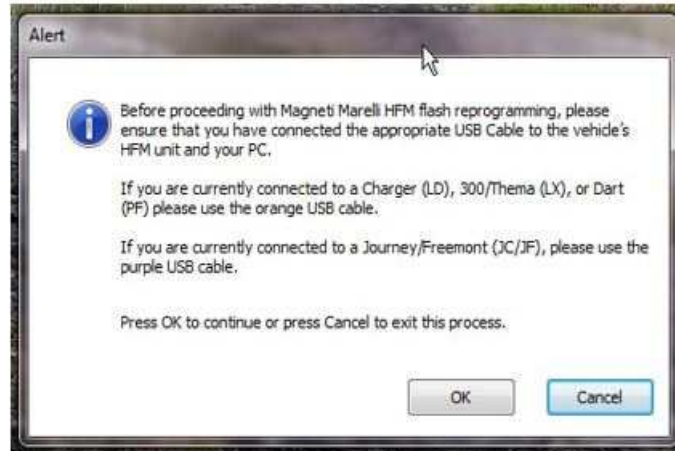
Fig. 6
Cable Warning

7. Magneti-Marelli HFM USB flash (2011-2013) requires special USB cables. Before proceeding, ensure that you have the correct cables available. For LD/LX vehicles, you will need the orange cable (wiTECH essential tool #500). For JC vehicles, you will need the purple cable (wiTECH essential tool #501) (Fig. 6) . Click “OK” button.

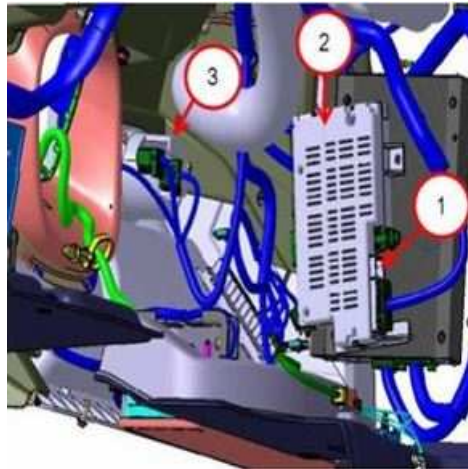
Fig. 7
LD and LX HFM Locations

For LX/LD vehicles, the HFM module is located above the driver's side kick panel. Plug the orange cable into your PC and into the HFM at the connector marked “1” in (Fig. 7) .

- 1 - USB Connector Cavity
 - 2 - Hands Free Module
 - 3 - Headlamp Switch
-

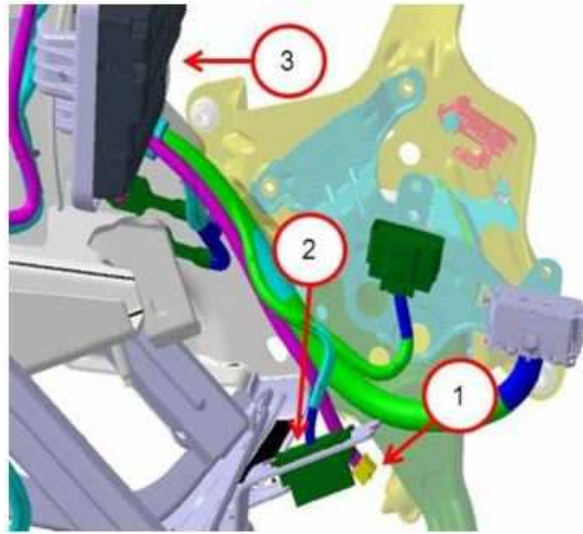
Fig. 8
JC HFM Connections

For JC vehicles, a Delphi 4-way USB connector is located on the driver side, next to the diagnostic connector. Plug the purple cable into your PC and into the connector marked “1” in (Fig. 8) .

- 1 - Delphi 4-Way connector (connect wiTECH USB Cable here)
- 2 - Diagnostics Connector
- 3 - Hands Free Module

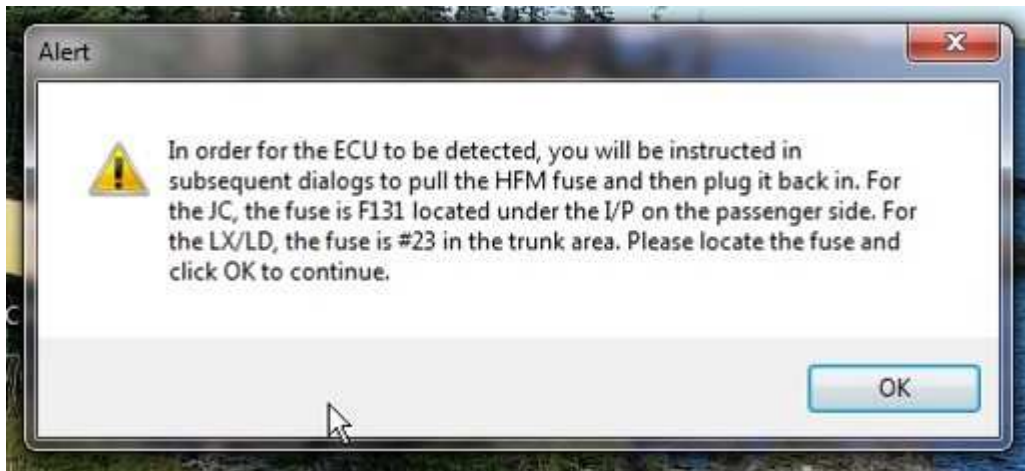
Fig. 9
Fuse Instruction Pop-up

NOTE: The following instructions are for pulling the appropriate fuse so that the ECU can be detected.

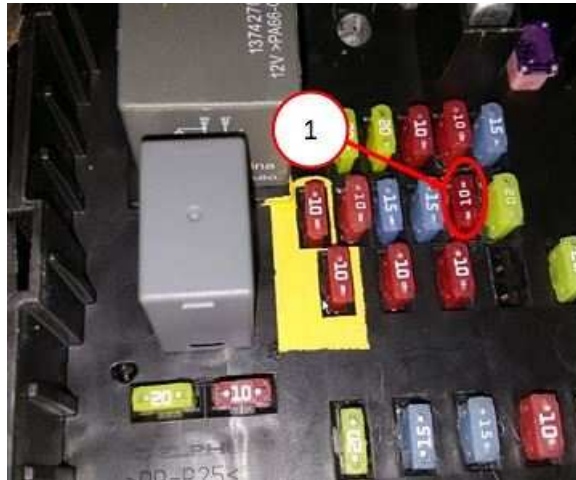
Fig. 10
JC Fuseblock

Locate the fuse panel in preparation to remove the HFM fuse. For JC vehicles, locate fuse #131 on the fuse panel found under the Instrument Panel (I/P) on the passenger side (Fig. 9) .

1 - Fuse #131.

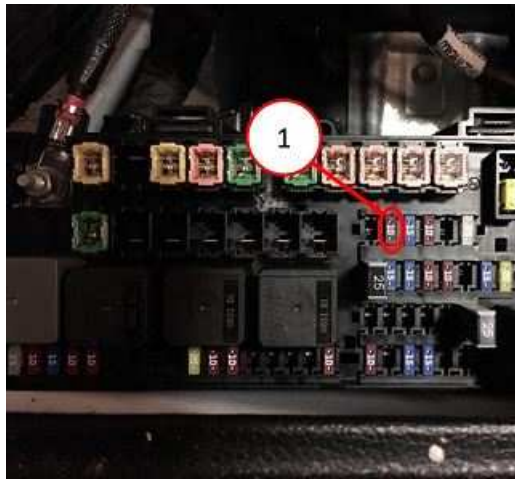
Fig. 11
LX and LD Fuseblock

For LD/LX vehicles, locate fuse #23 on the fuse panel found in the trunk under the floor panel on the passenger side (Fig. 10) .

1 - Fuse #23.

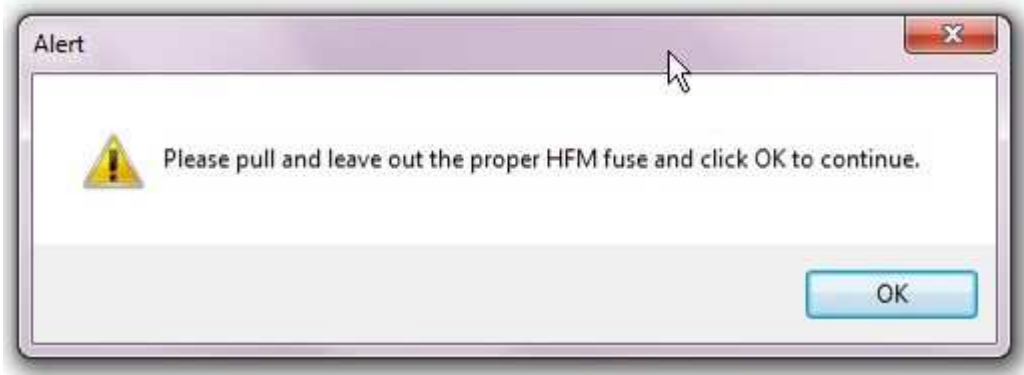
Fig. 12
Pull Fuse Instruction Pop-up

9. Remove the HFM fuse and then click on “OK” (Fig. 12) .

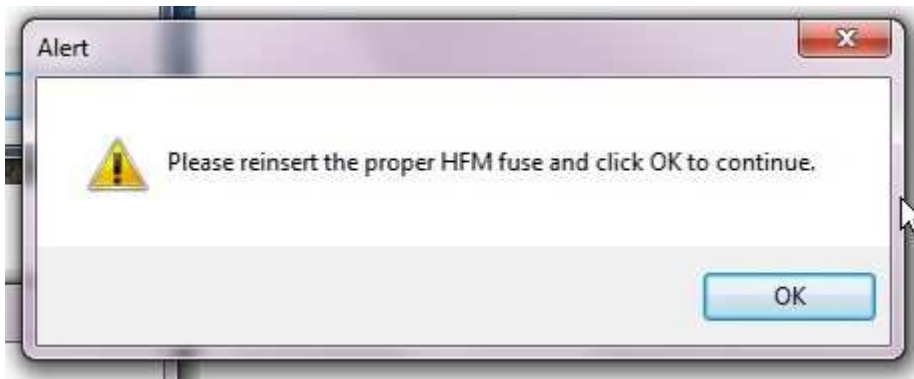
Fig. 13
Re-install Fuse Instruction Pop-up

10. Re-install the HFM fuse and then click on “OK” (Fig. 13) .

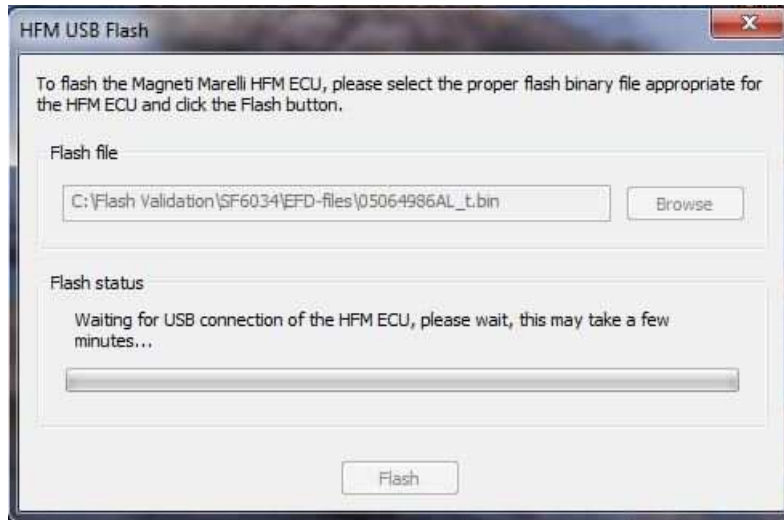
Fig. 14
HFM Status Pop-up (While waiting for connection)

11. It may take a few minutes for the PC to detect the HFM. If so, the following screen is displayed (Fig. 14) .

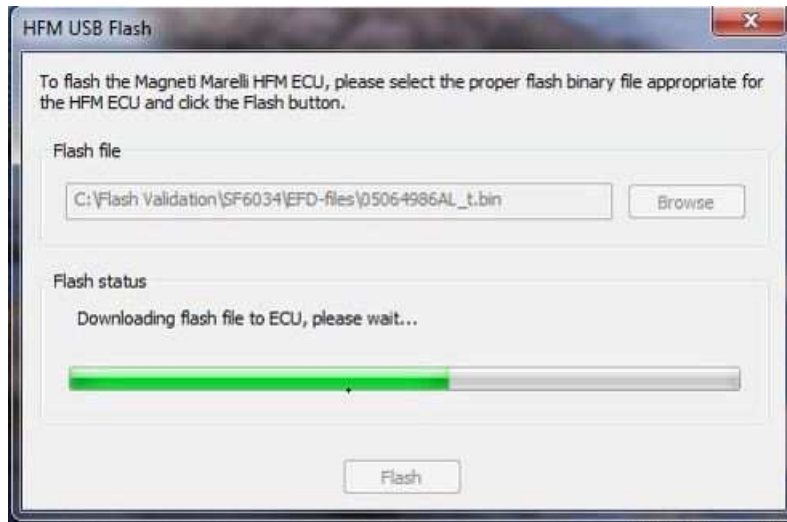
Fig. 15
HFM Status Pop-up (After connection found)

The flash download will begin after the USB-HFM connection is established (Fig. 15) .

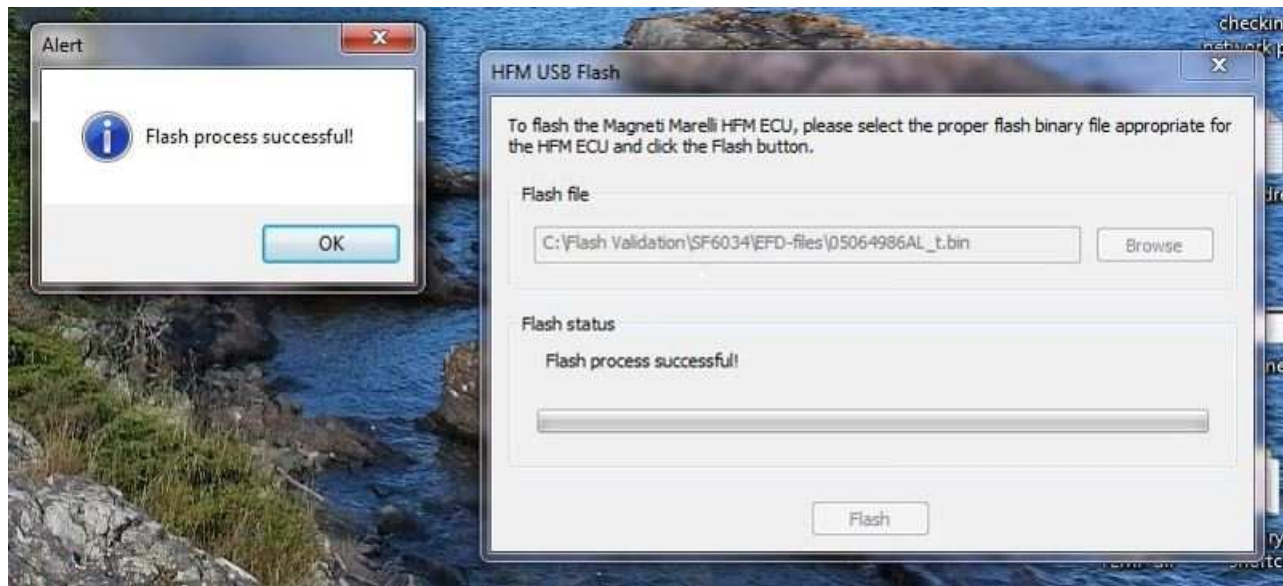
Fig. 16
Flash Successful Pop-up

- When the download and reprogramming is complete, a message will indicate “Flash process successful!” (Fig. 16) .
