## TECHNICAL SERVICE BULLETIN

**SUBJECT:** SERVICE ACTION: OBC UPDATE, INSPECTION  
AND/OR REPLACEMENT (SA306)

This bulletin provides the procedure to update, inspect, and if necessary, replace the On-Board Charger (OBC) on some 2015-17MY Soul EV (PS EV) vehicles, produced from July 15, 2014 through January 15, 2017, which may exhibit a Malfunction Indicator Lamp (MIL) ON with DTCs P1CF1 through P1CF6. This may be due to a battery charge delay with the OBC. To correct this concern, follow the procedure outlined in this bulletin. Before conducting this procedure, verify that the vehicle is included in the list of affected VINs.

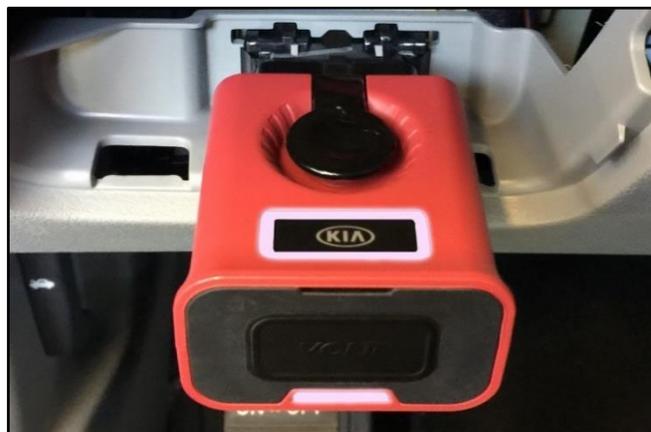
1. Connect the VCI-II to the OBD-II connector located under the driver's side of the instrument panel.

The ECU upgrade function on KDS operates wirelessly. It is not necessary to perform the upgrade via USB cable.

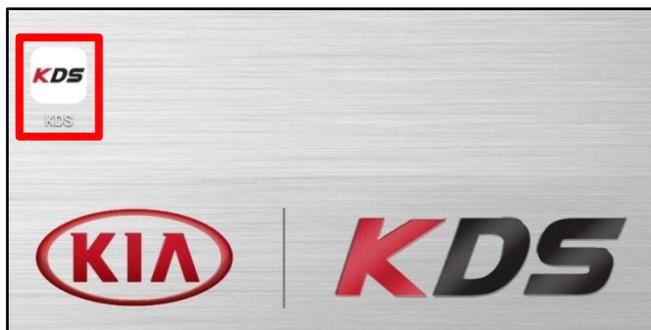
2. With the ignition ON, turn ON the KDS tablet. Select **KDS** from the home screen.

Verify that the vehicle is "ON" and not in "READY" mode before proceeding with the update.

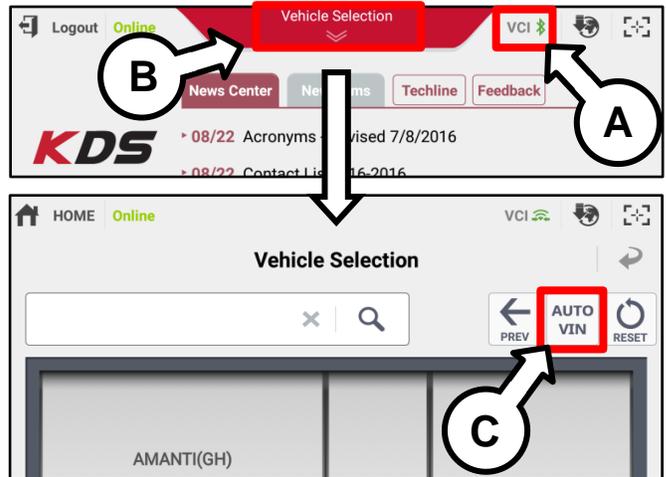
3. Confirm communication with VCI (A) and then configure the vehicle (B) using the **AUTO VIN** (C) feature.

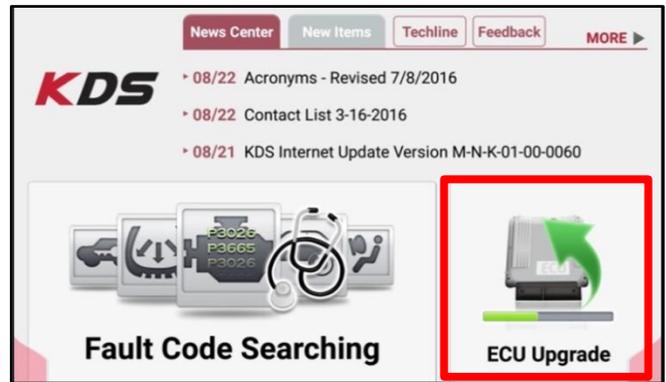
4. Select **ECU Upgrade**.

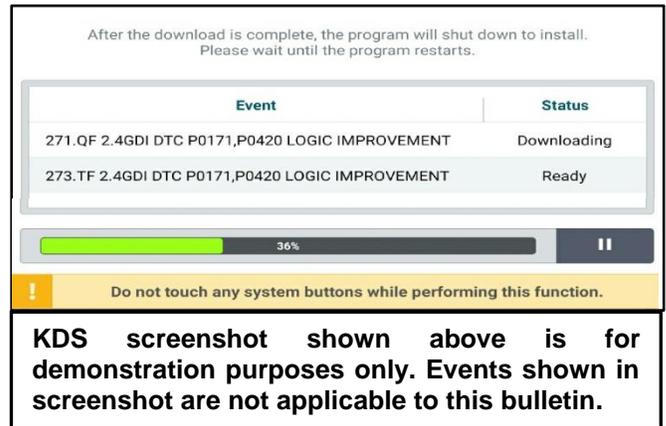
5. The KDS will check the server for recently uploaded events and then automatically download **Upgrade Event #344**.

**\* NOTICE**  
 The vehicle must be identified in Vehicle Selection to download an event for that vehicle.

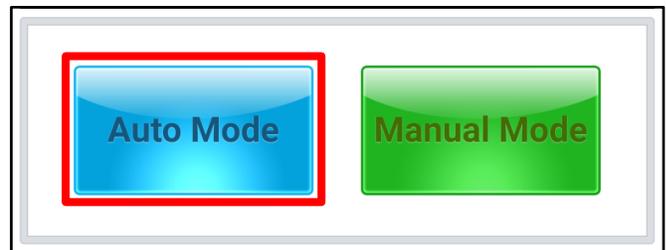
6. Select **Auto Mode**.

**CAUTION**  
 Do NOT attempt to perform a Manual Mode upgrade **UNLESS Auto Mode fails**. Always follow the instructions given on KDS in either Auto or Manual mode.

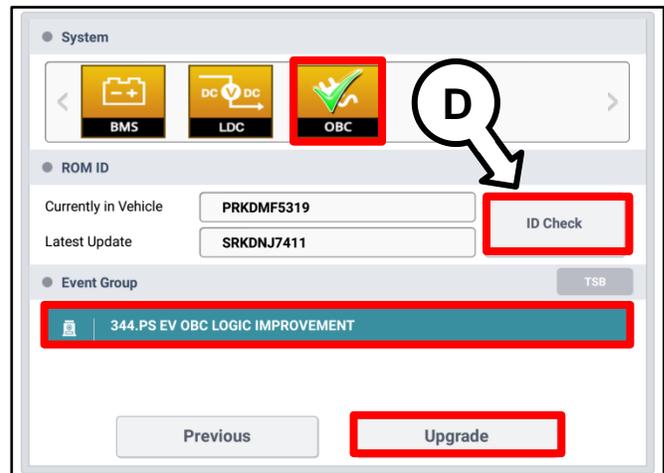
7. Select **OBC** system under the System selection menu.

Touch **ID Check** (D) and confirm that the latest update is available.

Select **Upgrade Event #344** and select **Upgrade** to continue.

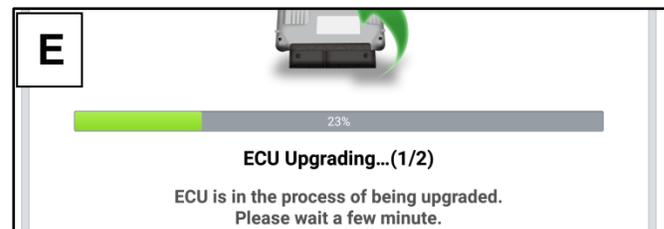
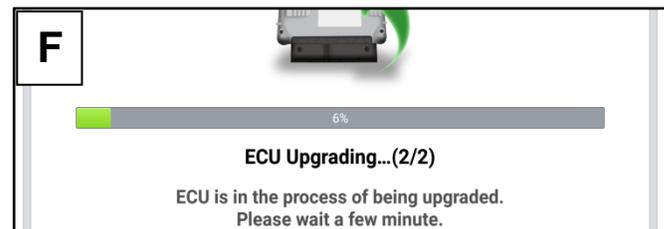
8. The ECU upgrade will begin and the progress of the upgrade will appear on the bar graph. Upgrade part (1/2) (E) will download the upgrade event to the VCI-II. Upgrade part (2/2) (F) will upgrade the ECU.

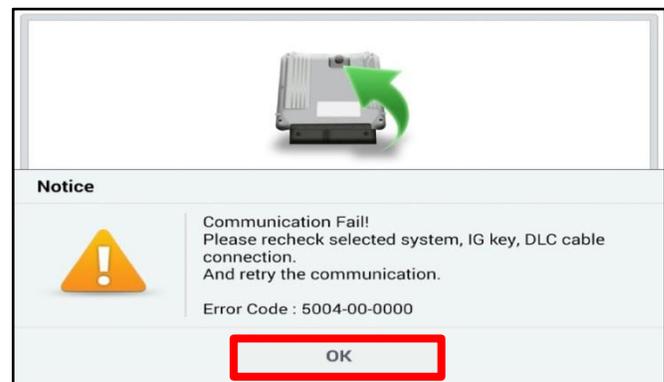
9. If a "Communication Fail" screen appears, verify that the VCI-II and KDS are communicating properly. Touch **OK** and restart the procedure from step 4.

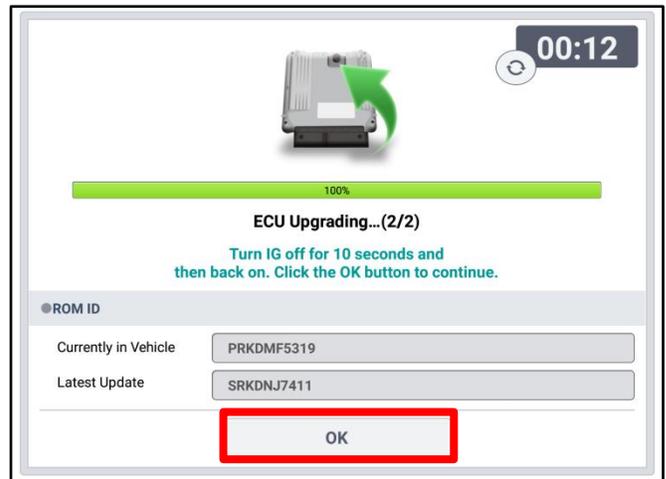
10. When instructed on the KDS, turn the ignition **OFF** for ten (10) seconds then back on. Touch **OK** to continue.

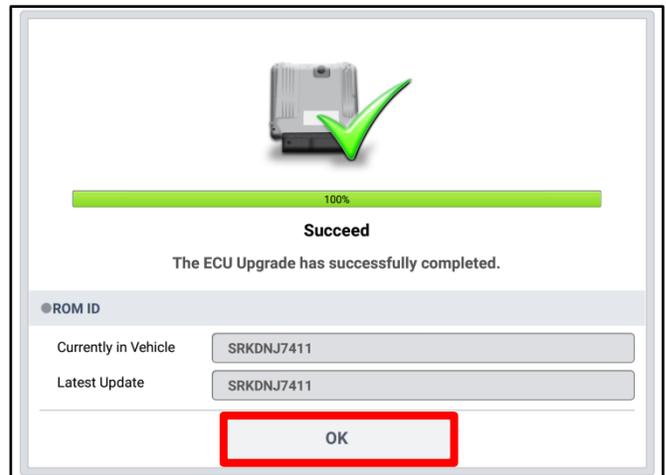
11. Once the upgrade is complete, touch **OK** to finalize the procedure.

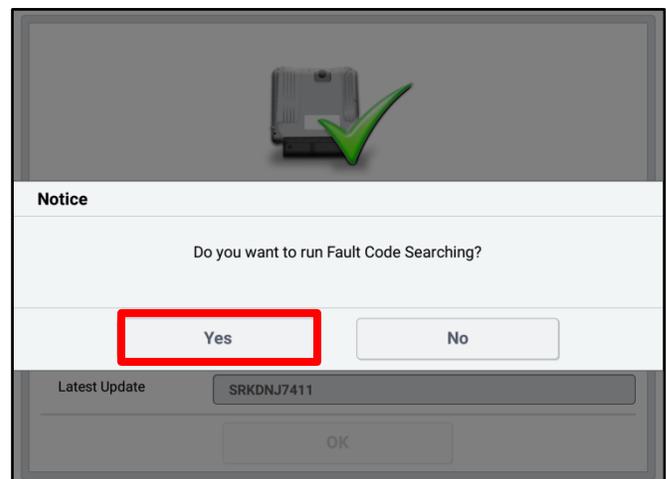
12. When prompted, select **YES** to check for Diagnostic Trouble Codes (DTC) and erase any DTCs stored such as EPS, ESC, and TPMS that may have been set during the upgrade.
