GROUP <b>TRA</b>	MODEL <b>2011-2015MY Optima Hybrid (TF HEV)</b>
	NUMBER <b>068</b>	DATE <b>October 2017</b>
<b>TECHNICAL SERVICE BULLETIN</b>		
SUBJECT: <b>HCU/TCU LOGIC IMPROVEMENT FOR DTC P1744 (400 MESH EQUIPPED TRANSMISSIONS ONLY)</b>

## HCU/TCU LOGIC IMPROVEMENT FOR DTC P1744 (400 MESH EQUIPPED TRANSMISSIONS ONLY)

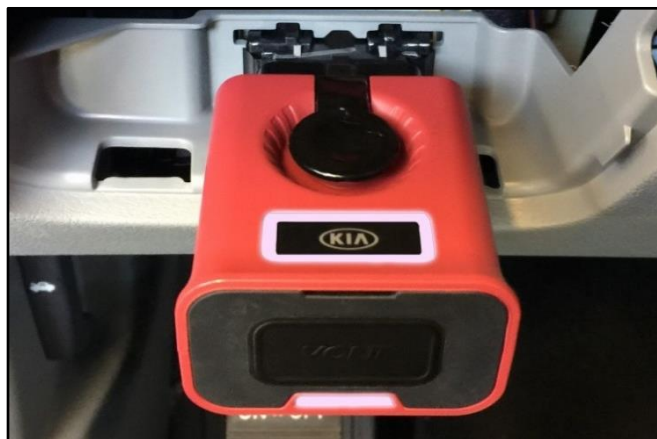
- Prior to performing the ECU upgrade(s), verify that the vehicle is equipped with a 400 Mesh transmission by referring to page 2 of TSB TRA059.
- Connect the VCI-II to the OBD-II connector, located under the driver's side of the instrument panel.

**The ECU upgrade function on KDS is operating wirelessly. It is not necessary to perform the upgrade via USB cable.**

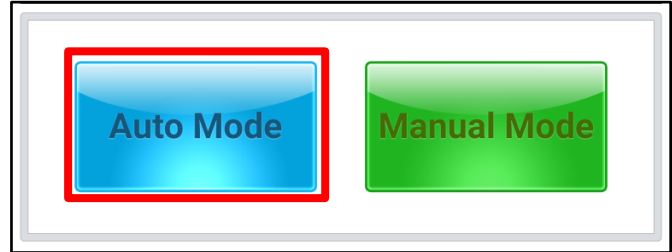
7. Select **Auto Mode**.

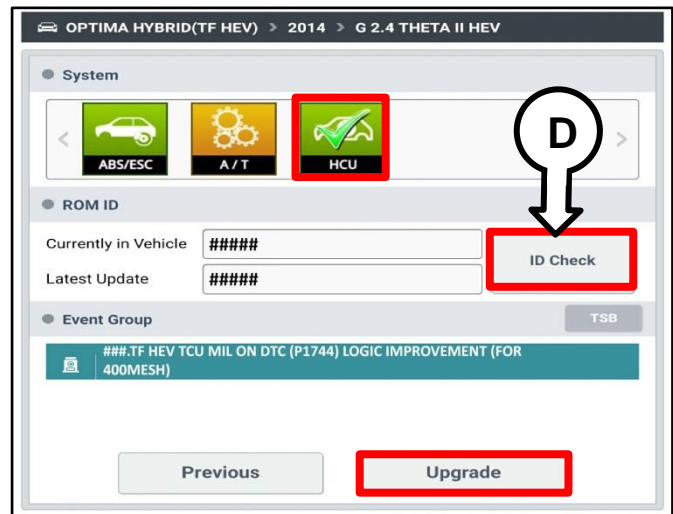
8. Select the **HCU** system under the System selection menu.

Touch **ID Check** (D) and confirm that the latest update is available.

Select **Upgrade Event #335** and select **Upgrade** to continue.

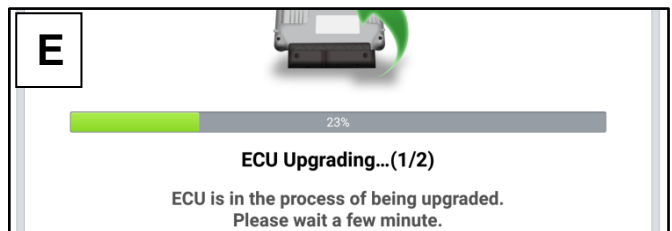
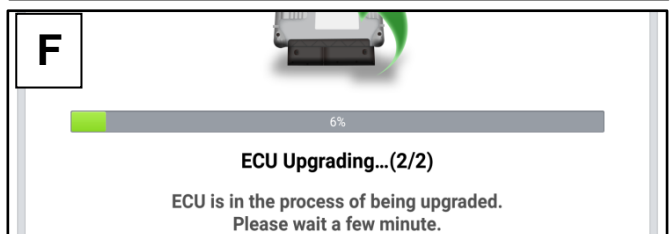
9. The ECU upgrade will begin and the progress of the upgrade will appear on the bar graph. Upgrade part (1/2) (E) will download the upgrade event to the VCI-II. Upgrade part (2/2) (F) will upgrade the ECU.

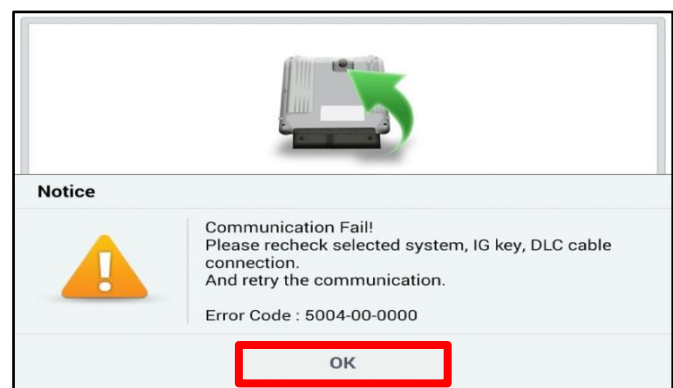
10. If a "Communication Fail" screen appears, verify that the VCI-II and KDS are communicating properly. Touch **OK** and restart the procedure from step 4.

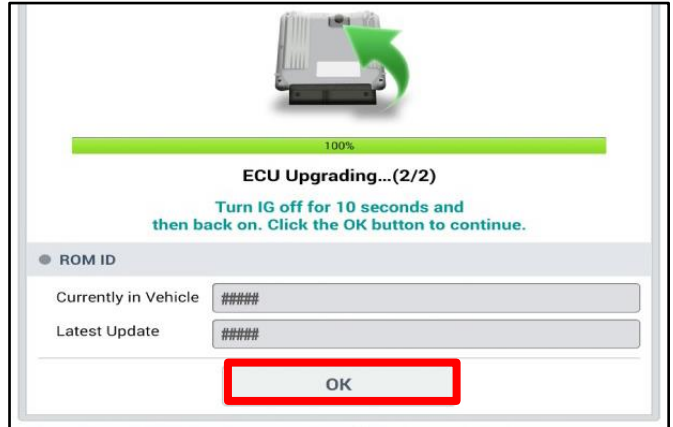
- When instructed on the KDS, turn the ignition **OFF** for ten (10) seconds then back on. Touch **OK** to continue.

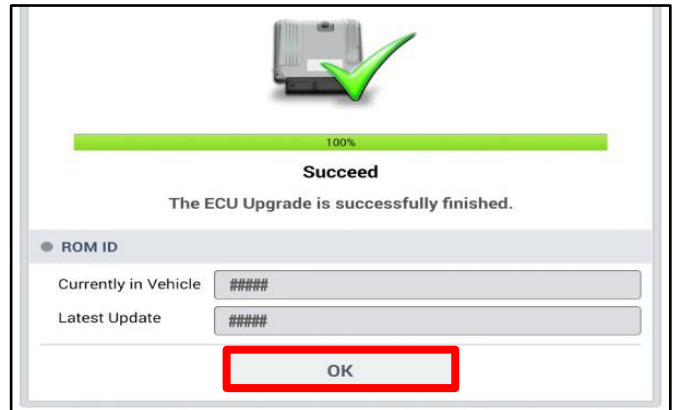
- Once the upgrade is complete, touch **OK** to finalize the procedure.

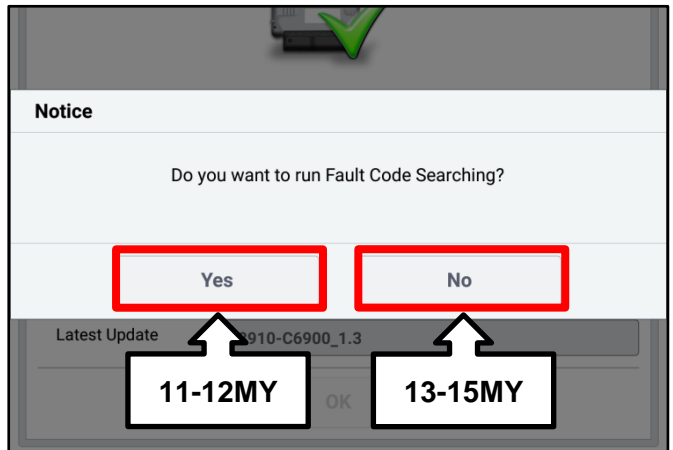
- For 11-12MY vehicles, when prompted, select **Yes** to check for Diagnostic Trouble Codes (DTC) and erase any DTCs stored such as EPS, ESC, and TPMS that may have been set during the upgrade. Proceed to step 15.

For 13-15MY vehicles, when prompted, select **No** for the Diagnostic Trouble Codes (DTC) check, then return to the KDS Home Page and proceed to the next step.

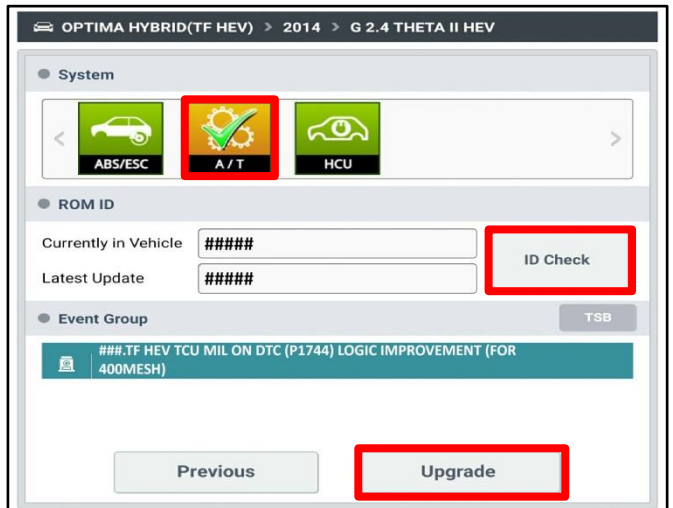
- For 13-15MY vehicles, repeat steps 4-12 and perform **Upgrade Event #336** with the **A/T** system selected under the System selection menu.

When prompted, select **YES** to check for Diagnostic Trouble Codes (DTC) and erase any DTCs stored such as EPS, ESC, and TPMS that may have been set during the upgrade.

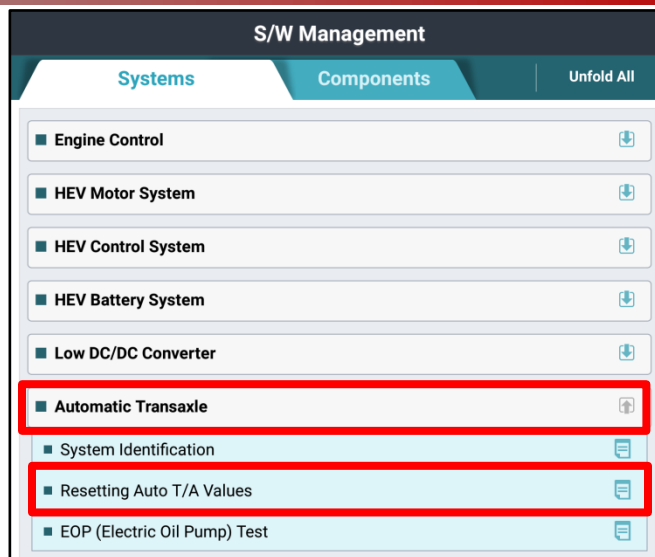
15. After completion of the upgrade(s), reset the TCU adaptive values in S/W Management → Automatic Transaxle → Resetting Auto T/A Values.

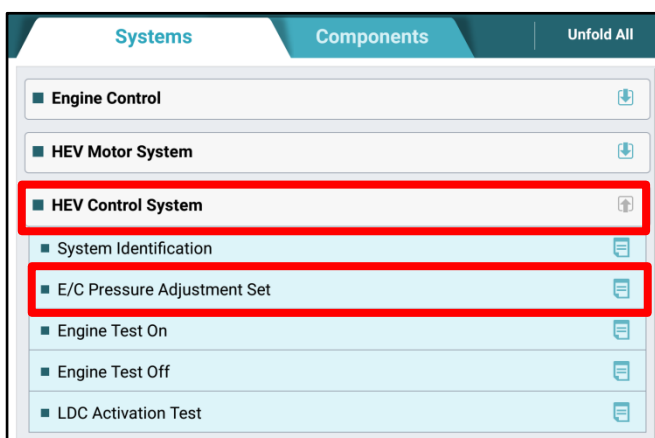
16. Perform an Electronic Clutch Fluid Pressure Calibration by returning to the KDS home screen then selecting S/W Management → HEV Control System → E/C Pressure Adjustment.
