# Techstream ECU Flash Reprogramming Procedure

**Service Category** Engine/Hybrid System

**Section** Engine Control

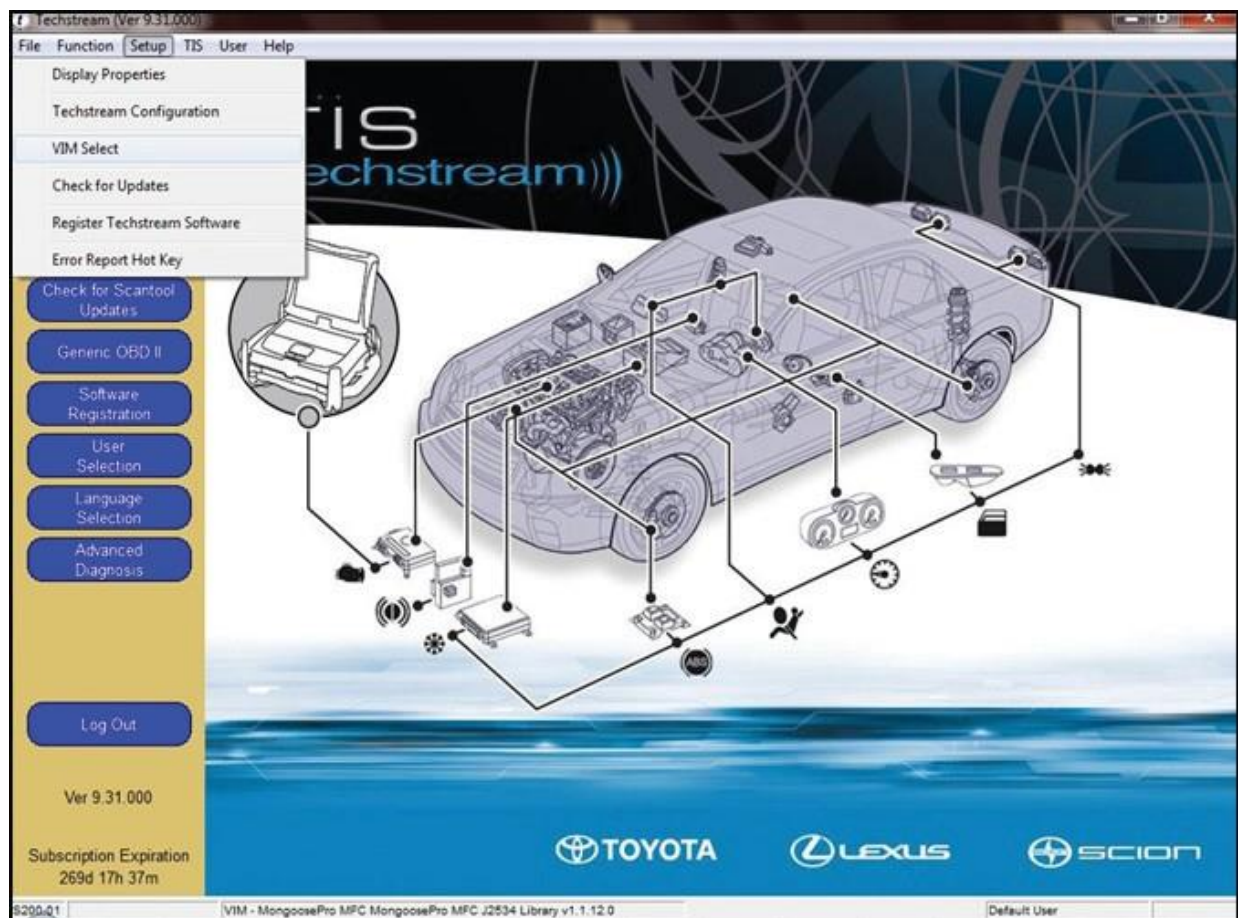
**Figure 1.**

1. Select *Setup* from the Techstream main menu screen.
2. Select *VIM Select* from the “Setup” dropdown menu.

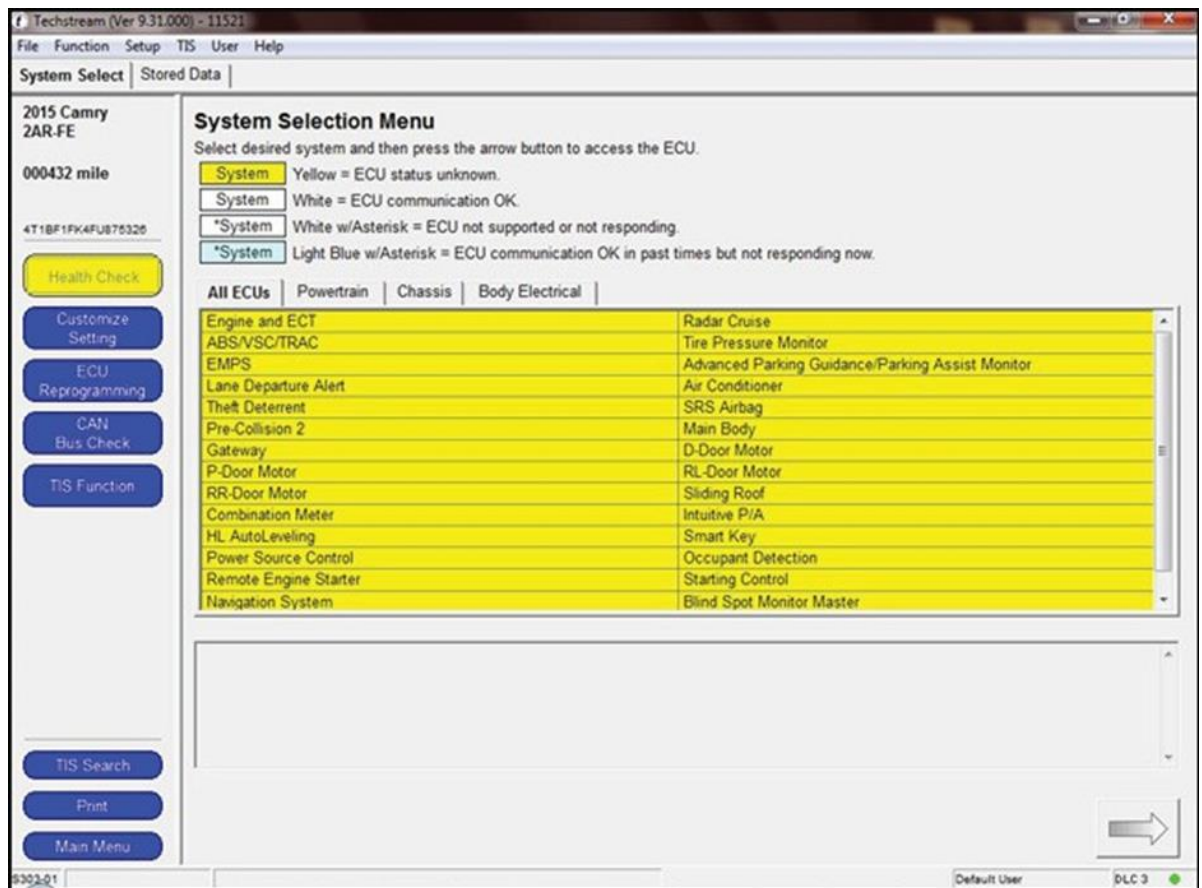
**Figure 2.**

1. Verify the vehicle's applicability for recalibration and locate the desired calibration file.
  - A. Connect Techstream and establish a vehicle connection.
  - B. Click the *Health Check* button on the "System Select" tab.

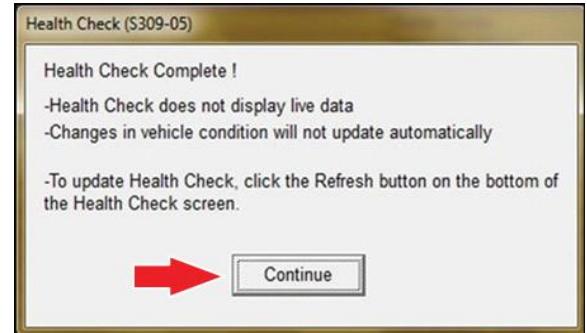
Figure 4.

- E. Click *Continue* to view the Health Check results.

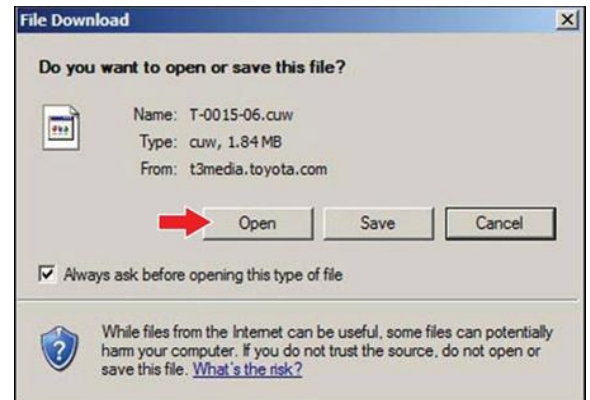
Figure 9.

- B. Click *Open* to load calibration file information.

Techstream downloads calibration files as needed to ensure the latest calibration file is used. Do NOT save calibrations locally on the hard drive or other media.

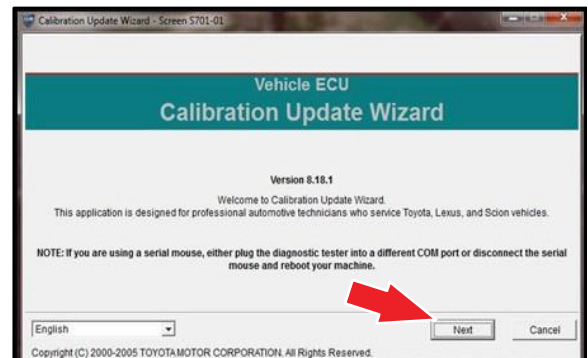
Figure 10.

- C. Click *Next* to start the calibration update process.

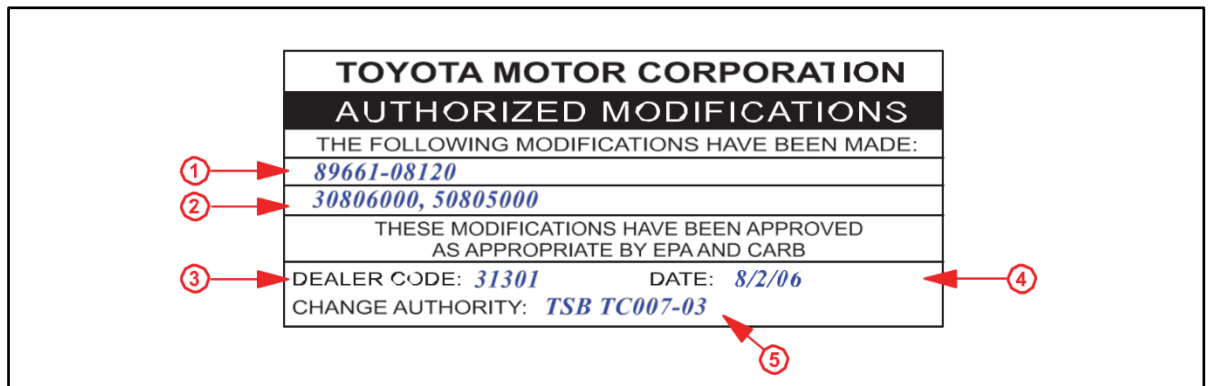
Figure 22.

4. Attach the Authorized Modification Label.
  - A. Using a permanent marker or ballpoint pen, complete the Authorized Modification Label and attach it to the vehicle. The Authorized Modification Label is available through the MDC, P/N 00451-00001-LBL.

<b>1</b>	<b>Replacement ECU Part Number</b>
<b>2</b>	<b>Calibration ID(s)</b>
<b>3</b>	<b>Dealer Code</b>

<b>4</b>	<b>Date Completed</b>
<b>5</b>	<b>Service Bulletin or Campaign Number</b>
