JTB00552NAS4

**TECHNICAL BULLETIN**

415-01: Information and Entertainment Systems

InControl© Touch Pro™ Features May Not Function As Expected (Additional Updates)

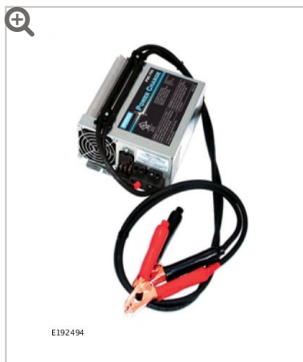
Jaguar Land Rover-approved Midtronics battery power supply

- Battery support unit: it is extremely critical to use a battery support unit and have a vehicle with a battery that has a good state of health to start. The battery support unit must also be in proper working condition to be able to supply 13v consistently. If the voltage is compromised during the installation of software, the IMC may switch off.

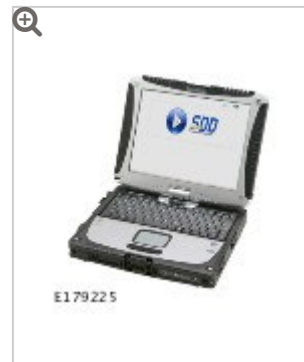
Jaguar Land Rover-approved diagnostic tool with latest SDD software, Calibration File, and InControl© Touch Pro™ Software

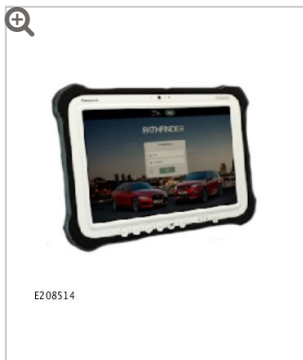
Jaguar Land Rover-approved diagnostic tool with latest PATHFINDER software

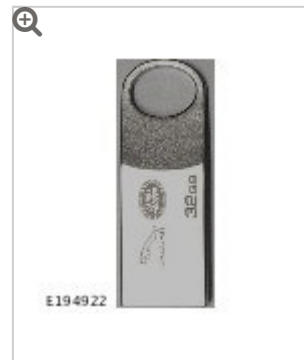
**DTSE9G2  
/32GB**

Jaguar Land Rover-approved USB memory device
