LTB00837NAS3

TECHNICAL BULLETIN

307-01: Automatic Transmission/Transaxle

Transmission Cover Gasket Leak

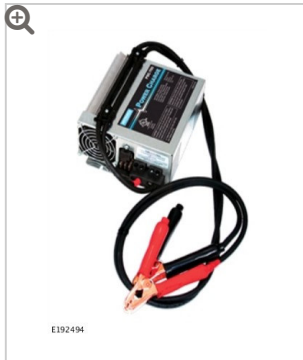
Jaguar Land
Rover-approved
Midtronics
battery power
supply

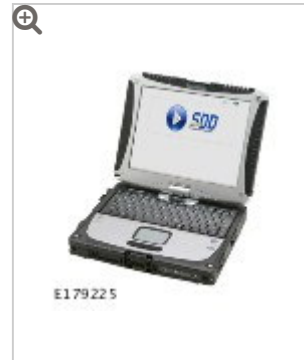
Jaguar Land
Rover-approved
diagnostic tool
with latest SDD
software,
Calibration File
(up to 2017MY)

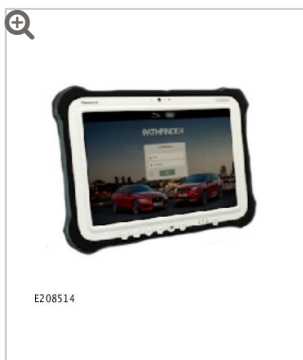
Jaguar Land
Rover-approved
diagnostic tool
with latest
PATHFINDER
software (from
2018MY)
