# Emissions Recall

## Code: 23U4

| Subject | 2.0L TDI Engine (GEN 2 – Automatic Transmission)<br>Emissions Modification – <u>USA ONLY</u> |

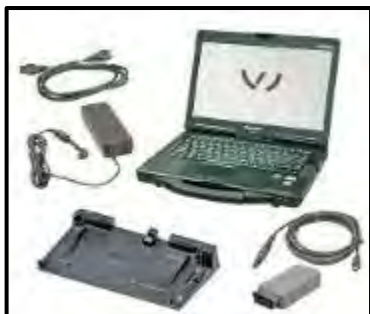
- VAS6150X – Diagnostic Tester (or equivalent)
- VAS5054X – Remote Diagnosis Head (or equivalent)

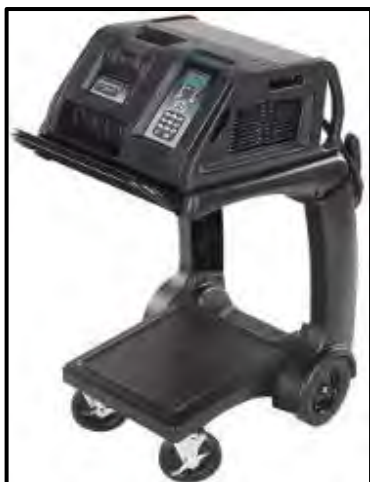
- GRX3000VAS – Battery Tester/Charger (or equivalent)

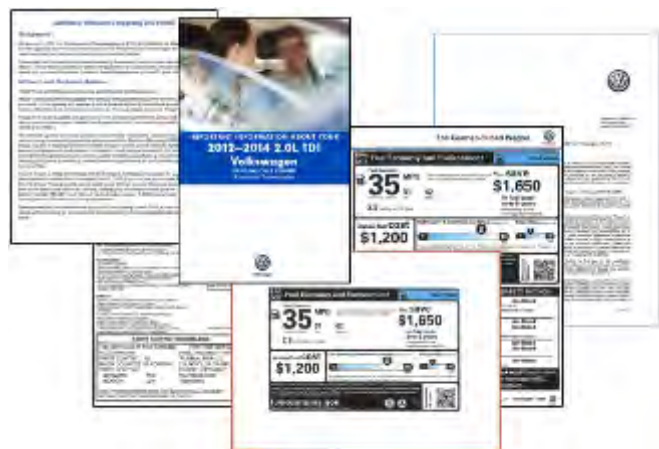
- Check for other Open campaign actions <red arrow above>.
- Other Open campaign actions must be completed prior to releasing the vehicle to the customer.

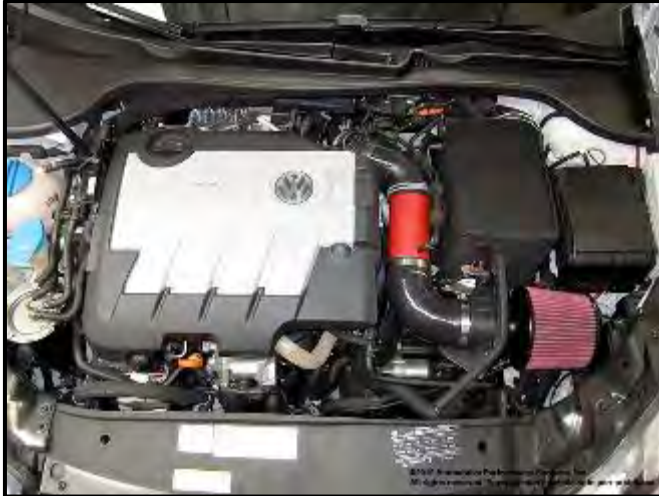
- Perform a visual inspection of the intake, exhaust, and emissions systems.
  - o If the visual inspection of the intake, exhaust, or emissions equipment reveals damage or concerns, **STOP**, create a VTA ticket and contact the Volkswagen Technicians Helpline.
  - o If the visual inspection of the intake, exhaust, or emissions equipment reveals no damage or concerns, continue the work procedure.

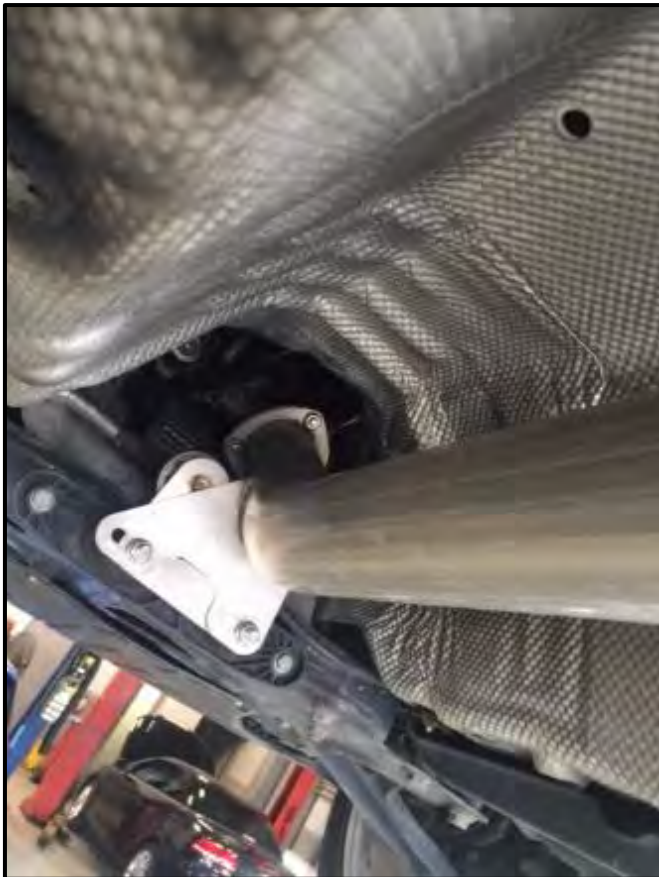
- Check for vehicle modifications from original equipment.
  - o If vehicle modifications from original equipment related to emissions components are found, **STOP**, create a VTA ticket and contact the Volkswagen Technicians Helpline.
  - o If vehicle modifications from original equipment related to emissions components are not found, continue the work procedure.

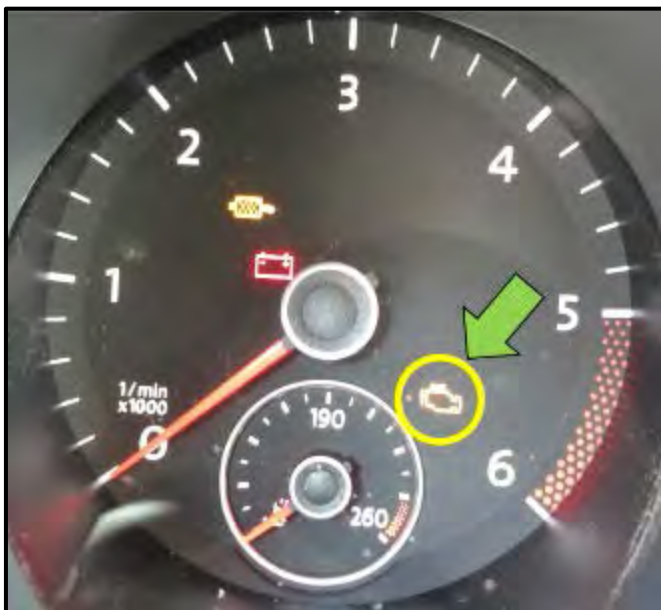
- Check for illumination of the MIL <arrow>.
  - o If MIL is illuminated, **STOP**, create a VTA ticket and contact the Volkswagen Technicians Helpline.
  - o If MIL is not illuminated, continue the work procedure.

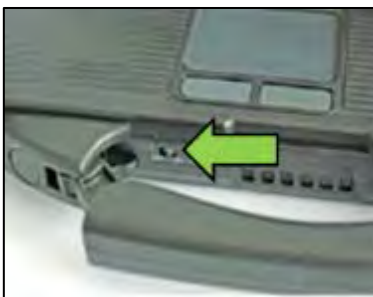
**VAS 6150 & VAS 6150A**  
(Front panel behind handle)

- Performing a software update using a Bluetooth connection increases the risk of losing connection during the update, which could result in damage to the control module. It also greatly increases the time required to perform the update. Requests for additional time or parts will be denied if the GFF log shows the update was performed using Bluetooth.
- ✓ **The Bluetooth function of the scan tool is physically switched off <see pictures below>.**

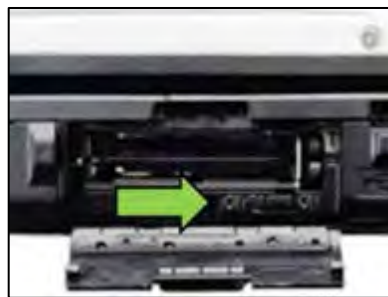
**VAS 6150B**  
(Right side behind WIRELESS door)

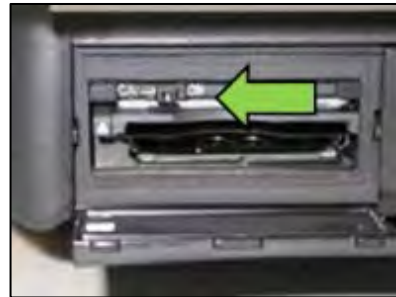
**VAS 6150C**  
(Left side behind SC/EX door)

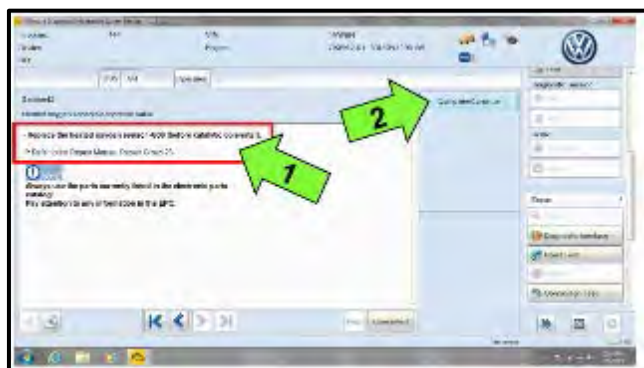
- Once the GFF scan is complete, select "Special functions".
- Select the test plan "**Adapt software, diesel, exhaust EA189 action 23XX**" <as shown>.
- Select "Perform test" <arrow>.

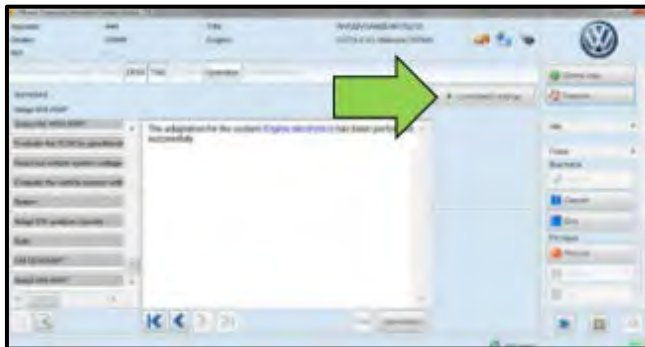
- Observe flash process and follow any on-screen prompts to complete the test plan.

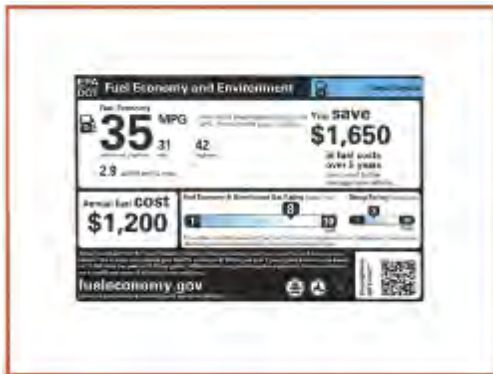
- Remove original Monroney Label and discard.
- Install new Monroney Label <example pictured left> on the rear passenger side window <example pictured below>.

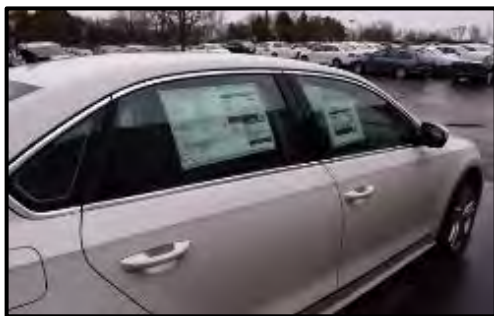
- Install new Fuel Economy Label <example pictured left> to the right of the new Monroney Label. If necessary, use the passenger front window <examples pictured below>.

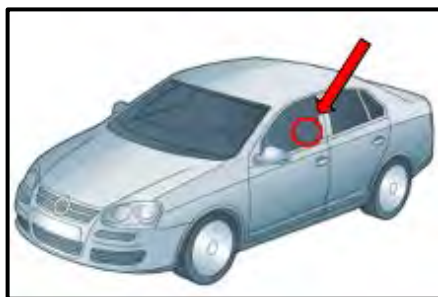
- Example of properly installed labels.

- Place the "more information" permanent window sticker <pictured left> on the front driver-side window in the lower right corner of the window <arrow>. Install the sticker from the inside of the window.
