# Emissions Recall

## Code: 23U4

| <b>Subject</b> | <b>2.0L TDI Engine (GEN 2 – Automatic Transmission)</b><br><b>Emissions Modification – <u>USA ONLY</u></b> |

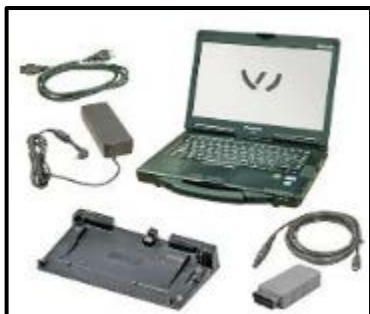
- VAS6150X – Diagnostic Tester (or equivalent)
- VAS5054X – Remote Diagnosis Head (or equivalent)

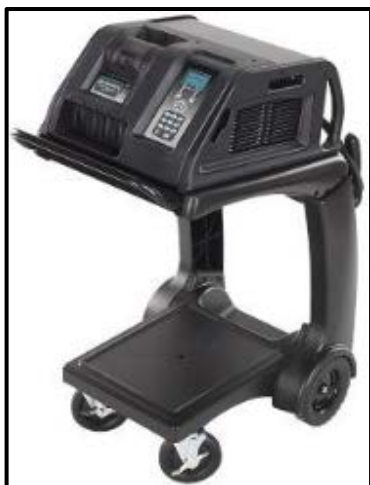
- GRX3000VAS – Battery Tester/Charger (or equivalent)

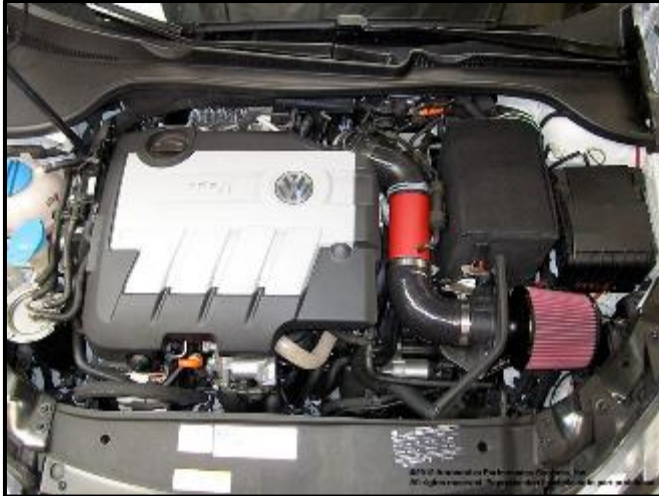
- Perform a visual inspection of the intake, exhaust, and emissions systems.
  - o If the visual inspection of the intake, exhaust, or emissions equipment reveals damage or concerns, **STOP**, create a VTA ticket and contact the Volkswagen Technicians Helpline.
  - o If the visual inspection of the intake, exhaust, or emissions equipment reveals no damage or concerns, continue the work procedure.

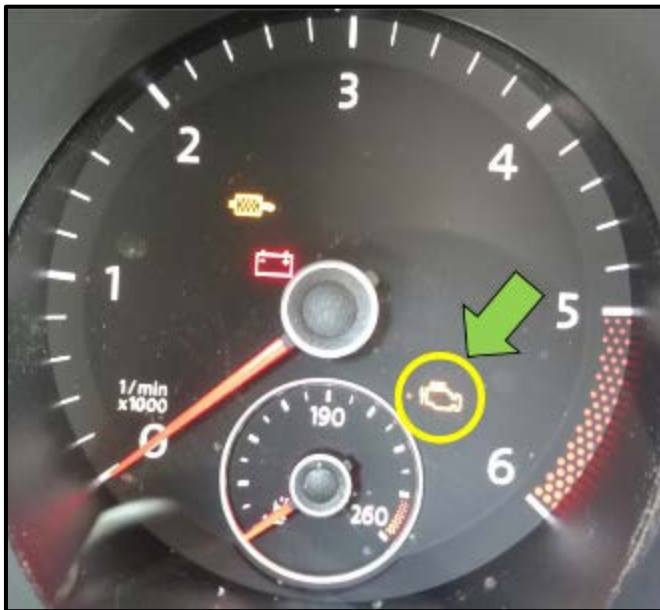
- Check for illumination of the MIL <arrow>.
  - If MIL is illuminated, **STOP**, create a VTA ticket and contact the Volkswagen Technicians Helpline.
  - If MIL is not illuminated, continue the work procedure.

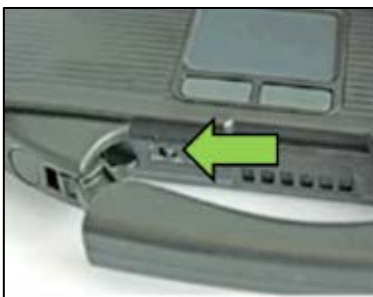
**VAS 6150 & VAS 6150A**  
(Front panel behind handle)

- Performing a software update using a Bluetooth connection increases the risk of losing connection during the update, which could result in damage to the control module. It also greatly increases the time required to perform the update. Requests for additional time or parts will be denied if the GFF log shows the update was performed using Bluetooth.
- ✓ **The Bluetooth function of the scan tool is physically switched off <see pictures below>.**

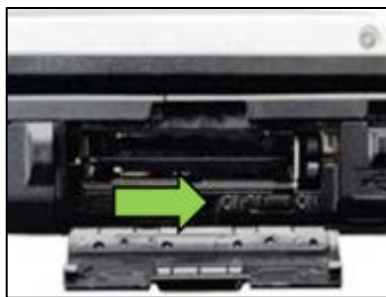
**VAS 6150B**  
(Right side behind WIRELESS door)

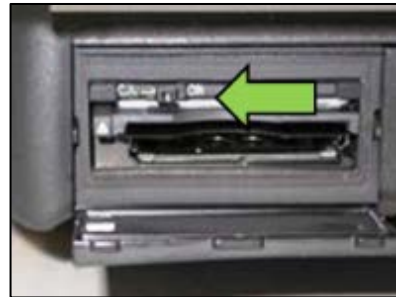
**VAS 6150C**  
(Left side behind SC/EX door)

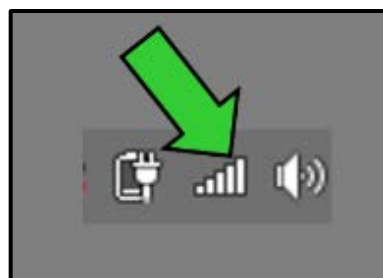
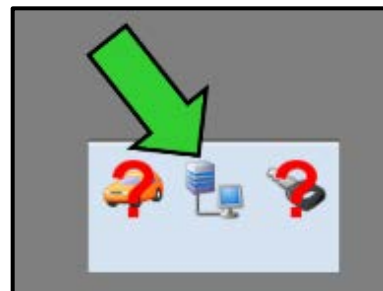
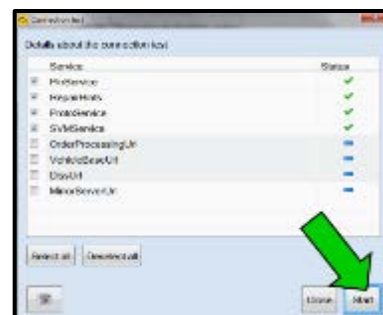
- ✓ Verify your network connection <arrow> either thru LAN or WIFI by checking the connection icon (lower right of the home screen).
- ✓ Check the icon <arrow> within the ODIS software that you have a connection.
- ✓ Within the Connection Tab, verify that the Connection type(s) display “Internet” <as shown>.
- ✓ Start a connections test <arrow> and verify that all connections pass.

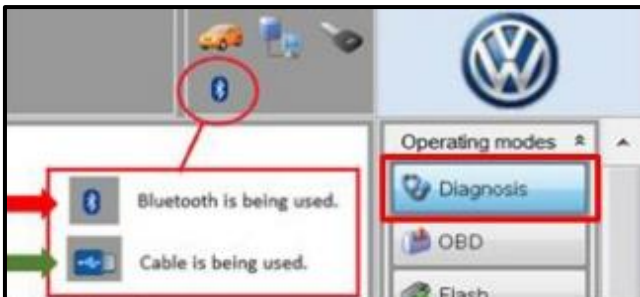
- Confirm that scan tool is communicating with the diagnostic head by USB <Green Arrow>.
  - If the Bluetooth symbol is shown <Red Arrow> then disconnect the diagnostic head from the vehicle and reconnect the USB cable to the diagnostic head and then reattach to the vehicle.
- Upon ODIS startup, verify the "Diagnosis" operating mode is selected <as shown>.

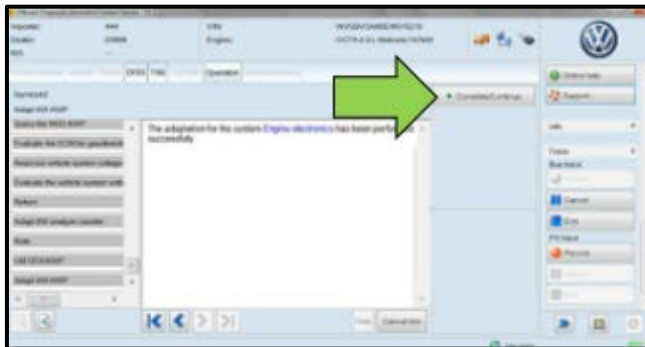
- Observe flash process and follow any on-screen prompts to complete the test plan.

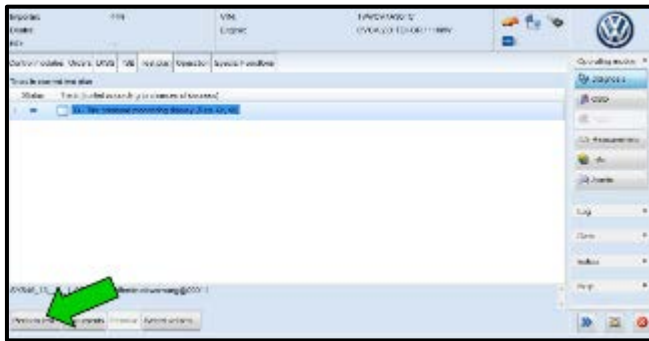
When exiting GFF, it is important to select "No" <arrow>.

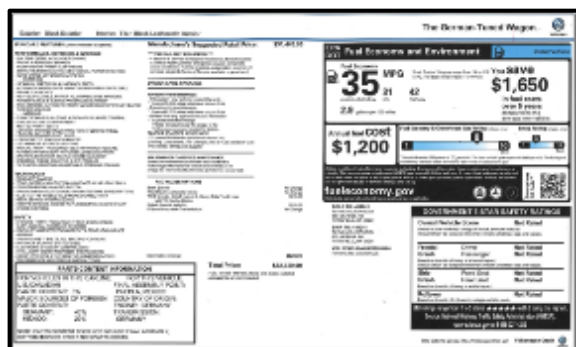
- Remove original Monroney Label and discard.
- Install new Monroney Label <example pictured left> on the rear passenger side window <example pictured below>.

Monroney Labels are VIN-specific. Obtain new label as required from Sales department, Service Manager, General Manager, or other authorized dealer personnel.

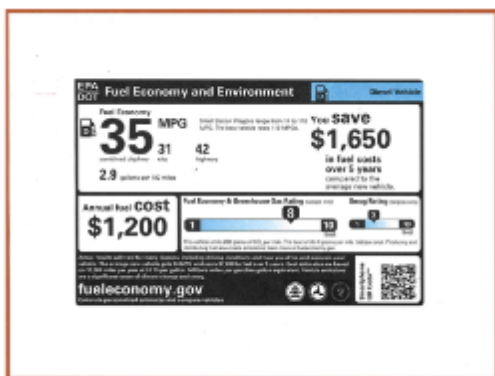
- Install new Fuel Economy Label <example pictured left> to the right of the new Monroney Label. If necessary, use the passenger front window <examples pictured below>.

Fuel Economy Labels are VIN-specific. Obtain new label as required from Sales department, Service Manager, General Manager, or other authorized dealer personnel.

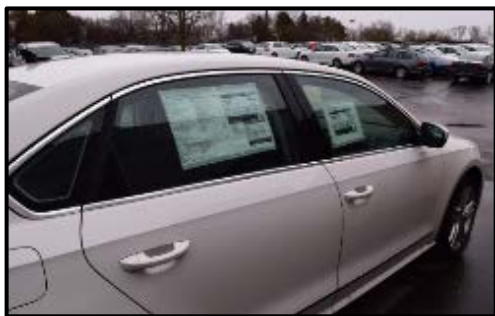
- Example of properly installed labels.
