Emissions Recall Code: 23U3

2.0L TDI Engine (GEN 1) Emissions Modification – Customer Only (Retail Sold) <u>USA ONLY</u>

Install updated emissions control system parts and software, install a TDI Emissions Modification – Proof of Completion Label and install a Supplemental Vehicle Emissions Control Information Label.

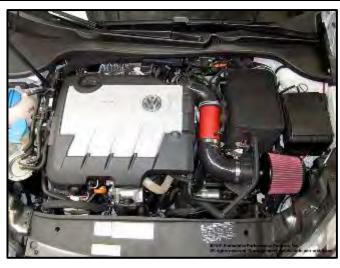
- Perform a visual inspection of the intake, exhaust, and emissions systems.
 - If the visual inspection of the intake, exhaust, or emissions equipment reveals damage or concerns, STOP, create a VTA ticket and contact the Volkswagen Technicians Helpline.
 - If the visual inspection of the intake, exhaust, or emissions equipment reveals no damage or concerns, continue the work procedure.

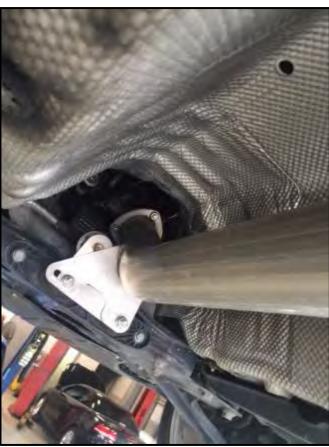
- Check for vehicle modifications from original equipment.
 - If vehicle modifications from original equipment related to emissions components <u>are</u> found, **STOP**, create a VTA ticket and contact the Volkswagen Technicians Helpline.
 - If vehicle modifications from original equipment related to emissions components are <u>not</u> found, continue the work procedure.

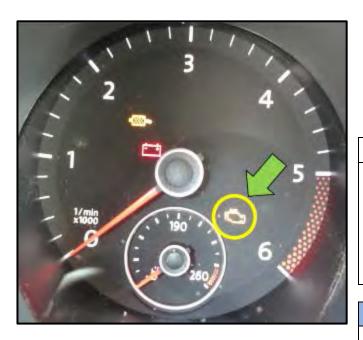
- Check for illumination of the MIL <arrow>.
 - If MIL is illuminated, STOP, create a VTA ticket and contact the Volkswagen Technicians Helpline.
 - If MIL is not illuminated, continue the work procedure.

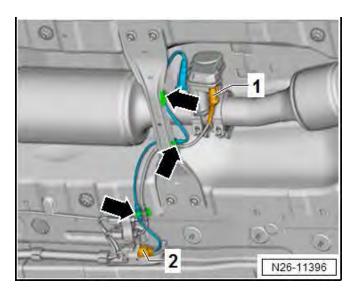
- Disconnect »brown« connector for oxygen sensor after catalytic converter -G130- <2>.
 Remove plug from retainer.
- Open fasteners for heat shield and pull connector
 off exhaust door control unit -J883- and thread wiring out of retainers <arrows>.

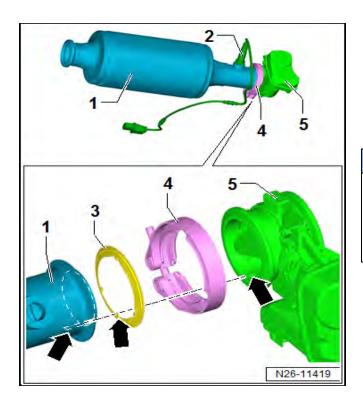
- Screw new oxygen sensor after catalytic converter -G130- <2> into new NOx storage catalytic converter <1> and tighten to 52 Nm using socket, 22 mm -T10491-.
- Set new exhaust door control unit -J883- <5> with new seal <3> on NOx storage catalytic converter <1>. Note notches <arrows>.

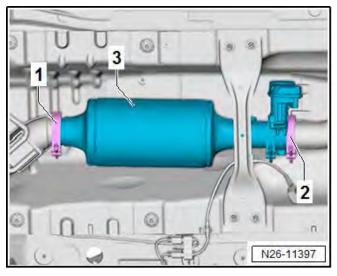
- Set clamp 1K0 253 725 B <2> in place and engage and torque to 7 Nm.
- Set clamp 1K0 253 725 <1> in place and engage. Then tighten to 7 Nm.

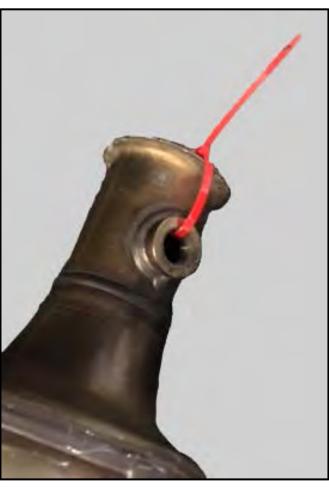
Install the <u>RED</u> validation strap to the NOx catalytic converter <as shown> to confirm that the proper part is being returned for core.

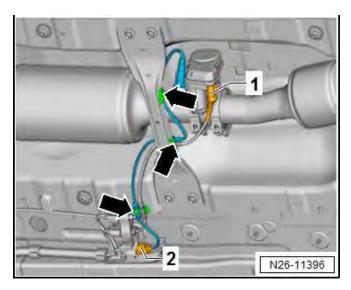
- Connect »brown« connector for oxygen sensor after catalytic converter -G130- <2> and attach to bracket.
- Push connector <1> onto exhaust door control unit. Secure lines in retainers <arrows>.

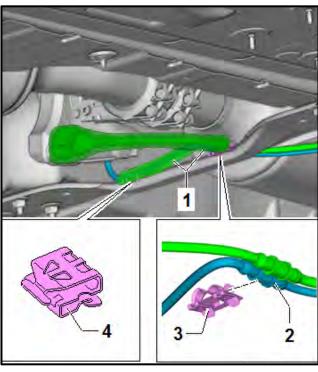
- Wrap new heat insulation mats <1> around wiring and close fasteners.
- Place wires <2> in clips <3 and 4>.

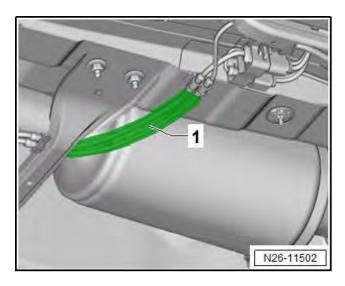
• Wrap new heat insulation mats <1> around wiring and close fasteners.

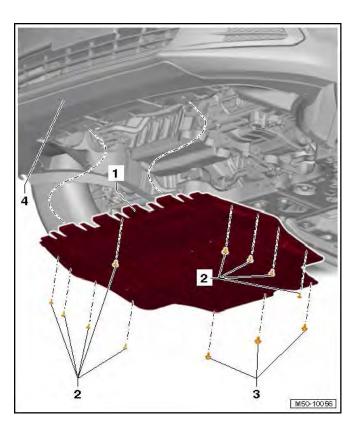
- Remove bolts <2 and 3>.
- Pull noise insulation <1> back, out of front bumper cover <4>.

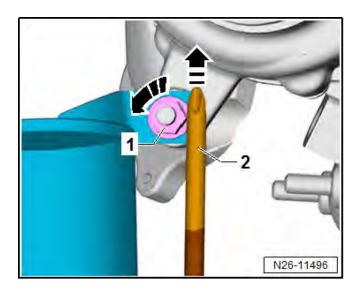
Apply screwdriver <2> on side of nut <1> and unscrew nut while simultaneously pressing up on nut.

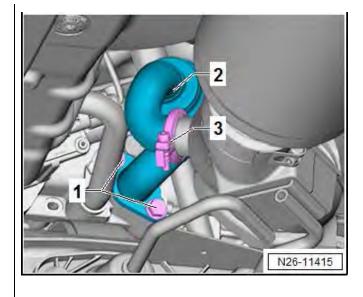
- Set new exhaust gas recirculation filter <2> with new seals in place, screw in bolts <1> and tighten to 9 Nm.
- Position clamp <3> and tighten to 3.5 Nm.

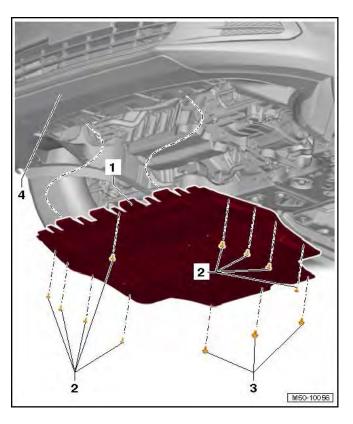
- Push noise insulation <1> forward into front bumper cover <4>.
- Screw in bolts <2> and new bolts <3> and tighten as follows:
 - o Bolt <2>: 2 Nm
 - o Bolt <3>: 6 Nm (renew)

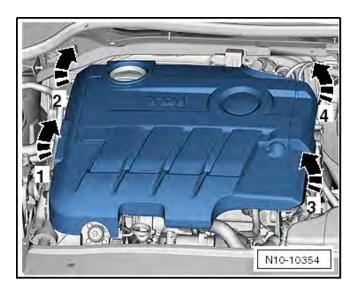
Pull engine cover up out of fastening elements near <arrows> in order shown. To do this, grip as far as possible beneath engine cover.

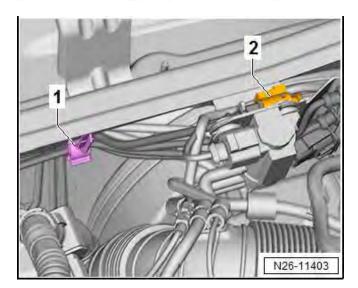
- Disconnect »brown« connector for exhaust gas temperature sender 3 -G495- <2> (secured behind bracket).
- Thread lines out of brackets <1> on plenum chamber bulkhead and on turbocharger.

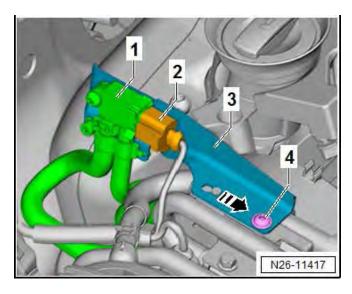
- Pull connector <2> off differential pressure sensor -G505- <1>.
- Remove securing bolt <4>, remove bracket <3> with differential pressure sensor -G505- <1> in <direction of arrow> and move aside. Control lines remain connected.

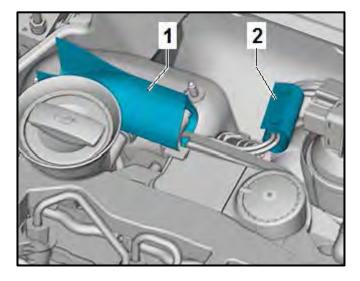
- Open fasteners on heat insulation <1> for exhaust pressure sensor 1 -G450-.
- Open heat insulation <2> for wiring and remove.

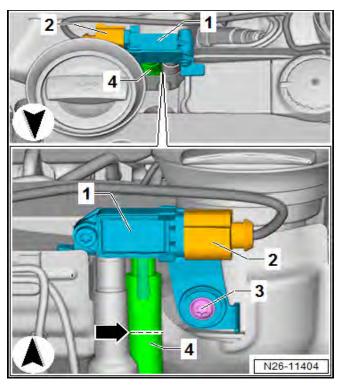
- Pull connector <2> off exhaust pressure sensor 1
 -G450- and remove securing bolt <3>.
- Cut control line <4> to exhaust gas recirculation cooler with an appropriate tool (e.g. utility knife) at the line <arrow> indicated in figure.
- Move bracket with exhaust pressure sensor 1
 -G450- aside (control line to particulate filter remains connected).

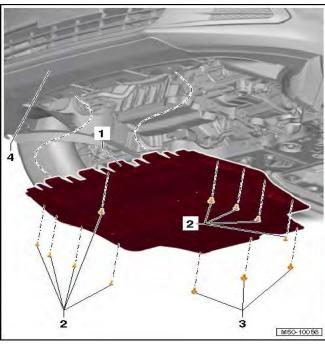
- Remove bolts <2 and 3>.
- Pull noise insulation <1> back, out of front bumper cover <4>.

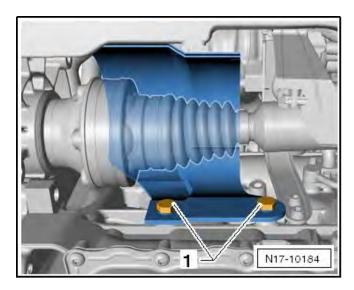
Unscrew bolts <1> and remove heat shield for right drive shaft.

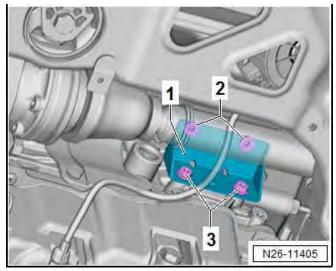
Unscrew securing nuts above bracket <2> with ratchet wrench -T10384-. In some cases, the bracket cannot be removed until the particulate filter has been detached.

Remove nuts <2 and 3> and remove lower bracket for particulate filter <1>.

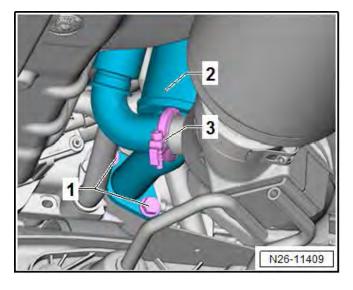
• Open clamp <3> and remove it.

The exhaust gas recirculation filter <2> is removed after the particulate filter has been removed.

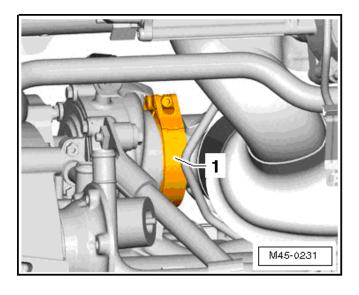
Position of clamp <1> may vary. If necessary, use 5 mm bit with ball head (e.g. T10058).

Loosen and remove clamp <1> connecting turbocharger and particulate filter.

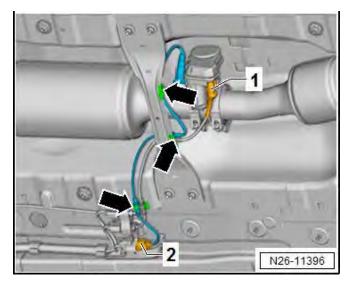
- Disconnect »brown« connector for oxygen sensor after catalytic converter -G130- <2>.
 Remove plug from retainer.
- Open fasteners on heat shield, pull connector
 <1> off exhaust door control unit -J883- and thread wiring out of retainers <arrows>.

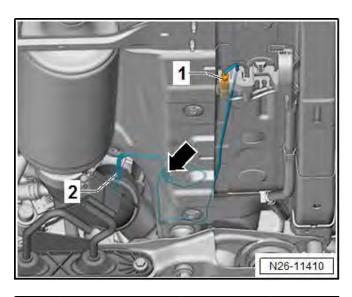
Disconnect connector <1>. Take electrical wire from exhaust gas temperature sensor 4 -G648-<2> on heat shield out of clip <arrow> and bracket and move to side.

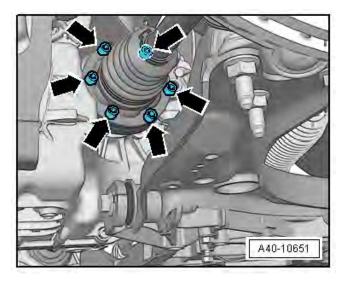
Remove bolts <arrows> and remove right drive shaft from transmission. Rest drive shaft on front axle.

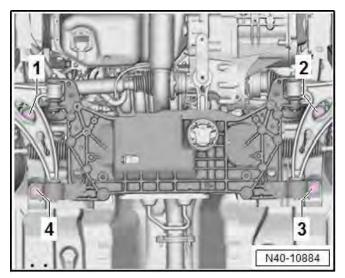
To fix the position of the subframe, the locating pins -T10096- must be screwed one at a time into positions <1, 2, 3 and 4>.

The locating pins -T10096- may be tightened only to max. 20 Nm, or the threads of the locating pins will be damaged.

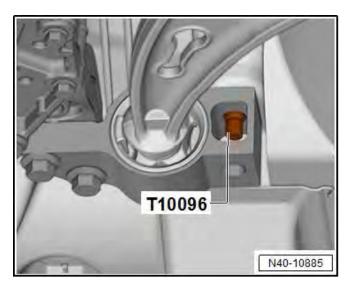
One at a time, remove securing bolts on mounting bracket and replace them with locating pins -T10096- on both sides. Tighten locating pins to 20 Nm.

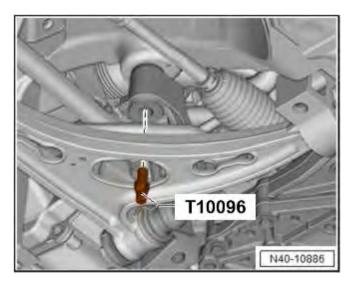
One at a time, replace bolts in brackets with locating pins -T10096-. Tighten locating pins to 20 Nm.

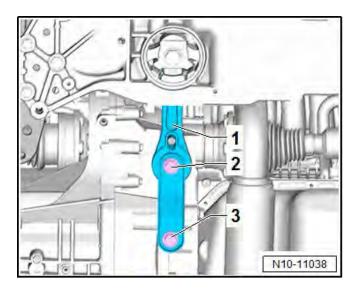
• Remove bolts <2 and 3> for pendulum support <1> from gearbox.

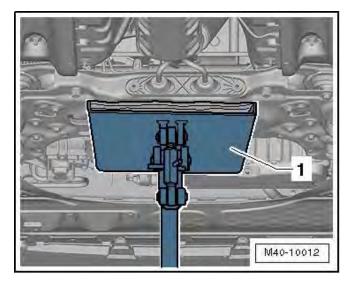
Place engine and gearbox jack -VAS 6931- <1> under subframe.

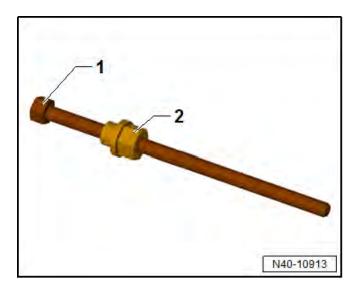
Screw nuts -3346/3- <2> by hand as shown onto spindles -3346/2- <1> to end of thread as shown.

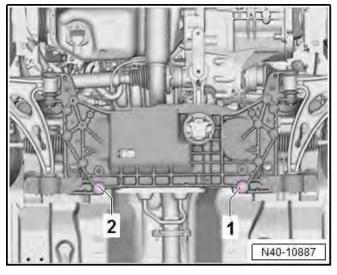
• Unscrew bolts <1 and 2>.

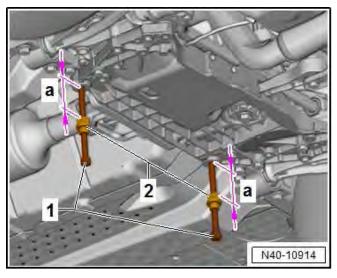
Screw in spindles 3346/2 by hand until distance
 <a> equals 90 mm.

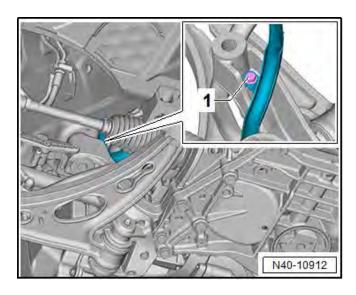
Lower subframe about 5cm and remove bolt <1>
 on the wire harness bracket for steering gear.

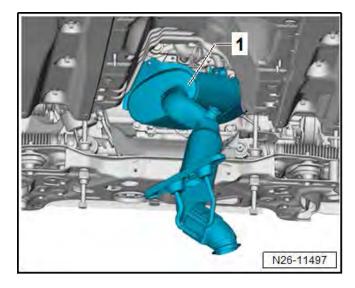
With the help of a second technician, remove particulate filter. Do this by turning the particulate filter <1> out of center tunnel. Note electrical wiring and components when doing this.

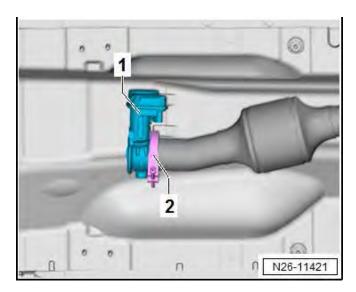
Open clamp <2> and remove exhaust door control unit <1>.

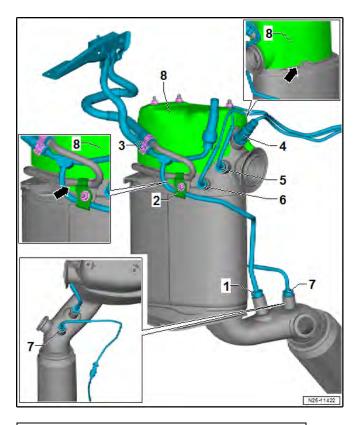
Before the installation of the newly assembled filter, place the new and old assembly side-by-side for comparison.

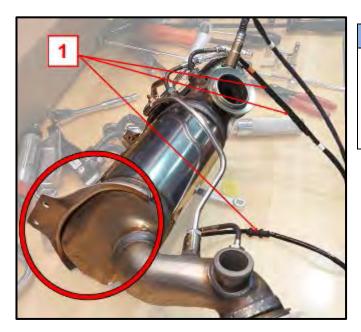
When "bench-installing" the exhaust gas temperature sensors to the DPF, the edge of the lower bracket <circle> can damage the sensor wires <1> if they are allowed to get underneath the bracket while positioning the DPF. Pay special attention to the sensor wiring to prevent damage to these sensors.

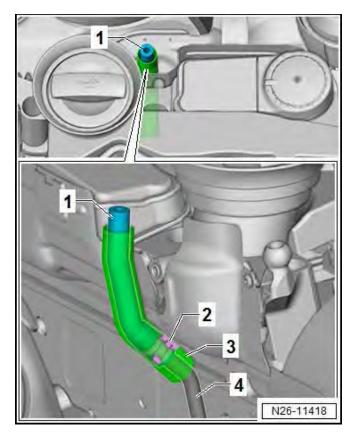
Renewing hose for control line exhaust pressure sensor 1 -G450-

- Remove heat shield <3>.
- Open clamp <2> and pull hose which was cut during removal <1> from control line <4>.
- Renew hose <1> and tighten clamp <2>. Push heat insulation <3> over hose and clamp.

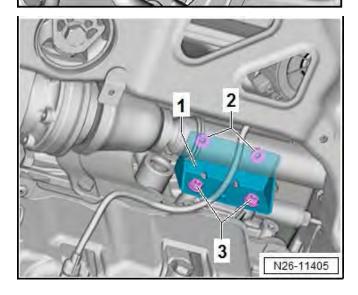
Unlike the production bracket, the supplied bracket no longer has threaded studs. It must be screwed to the particulate filter using the supplied bolts, and the nuts must be screwed on from below. The ball indentation on the bracket faces the crankcase.

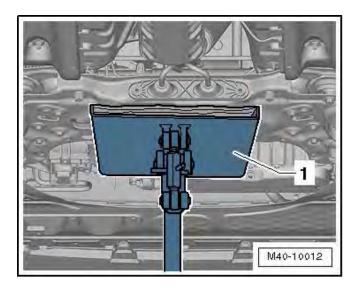
Installing subframe:

Position engine and gearbox jack -VAS 6931under subframe.

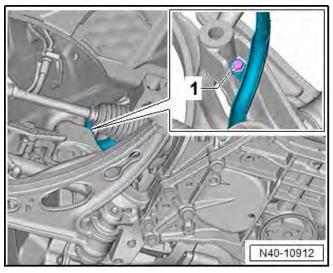
- Raise subframe about 5 cm, screw in bolt <1> on the wire harness bracket for steering gear and tighten to 3 Nm.
- Carefully raise subframe to installation position taking locating pins into consideration.

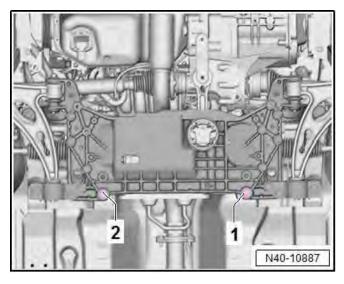
Remove spindles -3346/2-, screw in new bolts (M12 x 110 mm) at positions <1 and 2>, tighten to 70 Nm and turn an additional 90°.

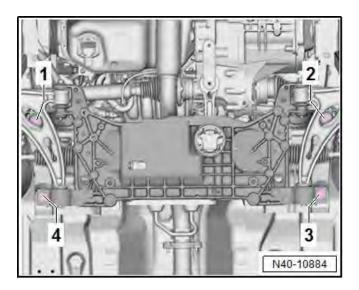
- Remove locating pins one at a time and replace them with new bolts (M12 x 90 mm).
- Tighten bolts to 70 Nm, then tighten them an additional 90°.
- Take load off engine and gearbox jack
 -VAS 6931- and remove it from work area.

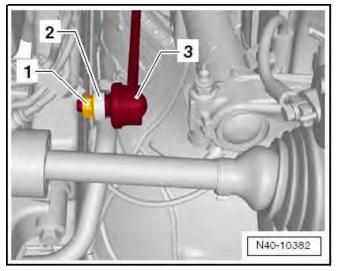
Guide coupling rods <3> on left and right into anti-roll bar, screw on new hexagon nuts <1> and tighten to 65 Nm.

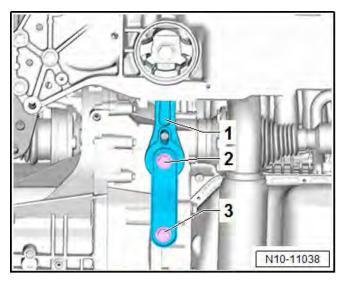
Screw in new bolts <2 and 3> for pendulum support <1>, tighten them to 50 Nm and then tighten and additional 90°.

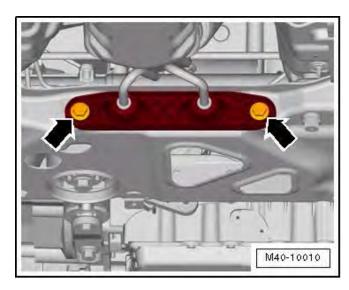
• Screw new bolts <arrows> loosely into exhaust system bracket on subframe.

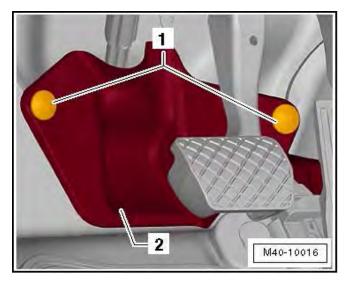
Position footwell trim <2> and hand-tighten bolts <1>.

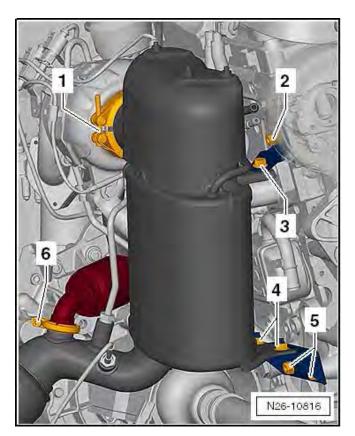
M40-10010

Tightening order for particulate filter:

Α	Position particulate filter with new seal on turbocharger and secure clamp <1> loosely.		
В	Screw in bolts <2 to 5> loosely by hand.		
	Particulate filter and retainer must be able to move		
С	Tighten clamp <1>	7 Nm	
D	Tighten nuts <5>	23 Nm	
Е	Tighten nuts <4>	23 Nm	
F	Tighten nut <2>	23 Nm	
G	Tighten nut <3>	23 Nm

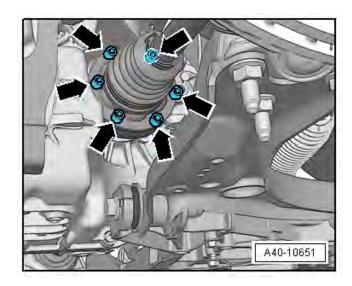
The lengths of the driveshaft/gearbox connecting bolts differ depending on gearbox:

- Manual gearbox = M10x52 mm (N 909 911 02)
- Dual clutch gearbox (DSG) = M10x23 mm (N 909 910 02)
 - Position right drive shaft and screw in new bolts <arrows>. Tighten bolts initially to 10 Nm, then tighten further to 70 Nm using a crisscross pattern.

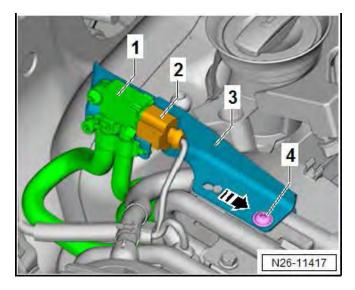
- Position bracket <3> with differential pressure sensor -G505- <1> opposite <direction of arrow>, screw in new securing bolt <4> until head makes contact and tighten to 4 Nm.
- Push connector <2> onto differential pressure sensor -G505- <1>.

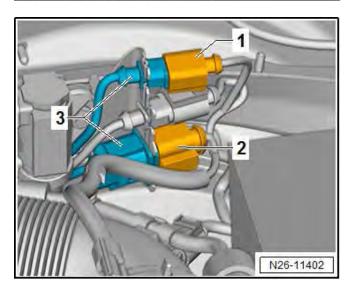
Connect »orange« connector for exhaust gas temperature sensor 2 -G448- <1> and »black« connector for heated oxygen sensor -G39- <3> on plenum chamber bulkhead and secure wiring <3> in retainer.

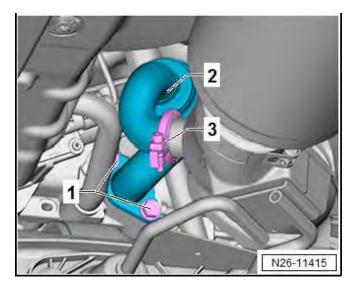
Installing exhaust gas recirculation filter:

- Set exhaust gas recirculation filter with new seals in place, screw in bolts <1> and tighten to 9 Nm.
- Position clamp <3> and tighten to 3.5 Nm.

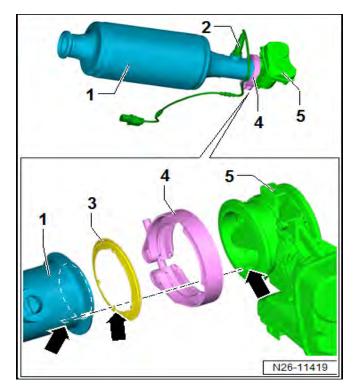
Installing NOx storage catalytic converter with exhaust door control unit -J883-

Screw oxygen sensor after catalytic converter
 -G130- <2> into NOx storage catalytic converter
 >1> and tighten to 52 Nm.

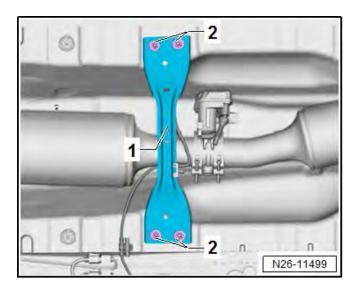
• Set front tunnel cross-piece <1> in place, screw on hexagon nuts <2> and tighten to 20 Nm.

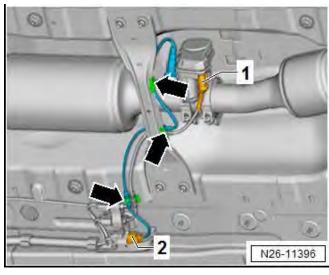
- Connect »brown« connector for oxygen sensor after catalytic converter -G130- <2> and attach to bracket.
- Push connector <1> onto exhaust door control unit. Secure lines in retainers <arrows>.

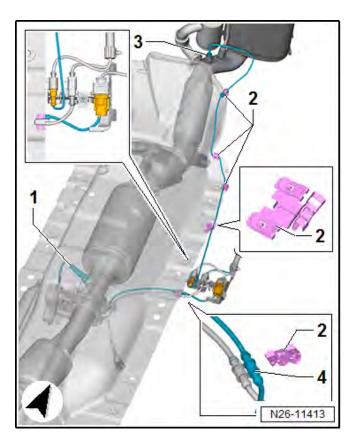
Routing electrical wiring on underbody:

Place electrical wiring from oxygen sensor after catalytic converter -G130- <1> and exhaust gas temperature sensor 4 -G648- <3> in clips <2> on heat shield as shown. Connect connector and secure in bracket.

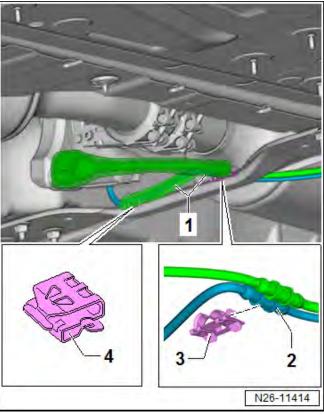
- Wrap new heat insulation mats <1> around wiring and close fasteners.
- Place wires <2> in clips <3 and 4>.

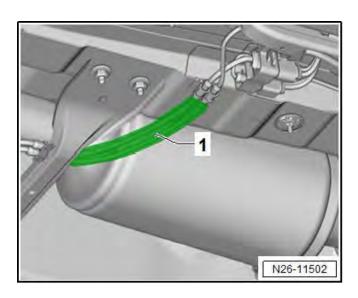
• Wrap new heat insulation mat <1> around wiring and close fasteners.

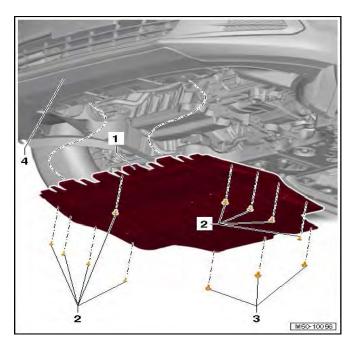
- Push noise insulation <1> forward into front bumper cover <4>.
- Screw in bolts <2> and new bolts <3> and tighten as follows:
 - o Bolt <2>: 2 Nm
 - Bolt <3>: 6 Nm (renew)

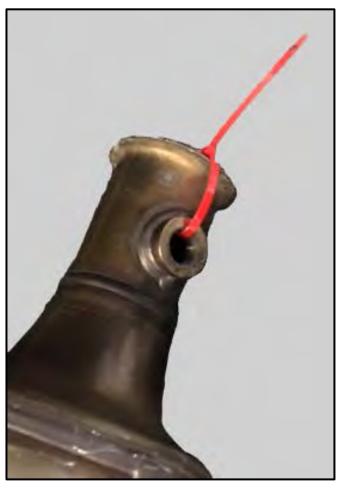
Install the <u>RED</u> validation strap to the NOx catalytic converter <as shown> to confirm that the proper part is being returned for core.

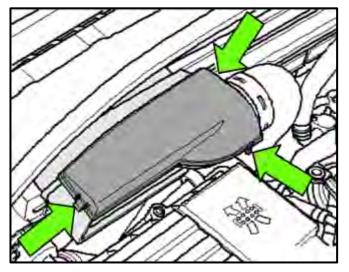
Replace Glow Plug Control Module:

- Switch ignition off and remove key
- Open hood.
- Carefully remove engine cover.
- Release the tabs <arrows> and remove the cover on the air intake.

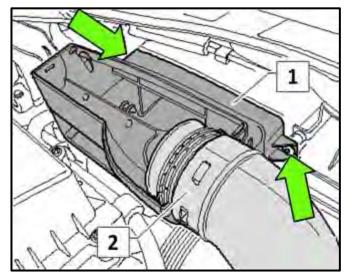
Remove the screws <arrows> for the air intake guide <1> and pull the guide hose <2> out of the air intake guide <1>.

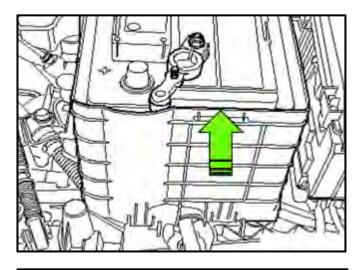
Remove the battery cover in the direction of <arrow>.

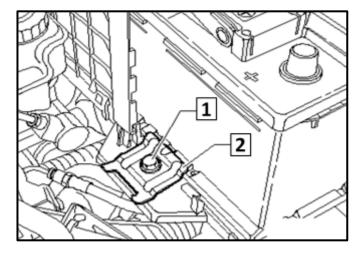
Remove the bolt <1> and then remove the clamping plate <2>.

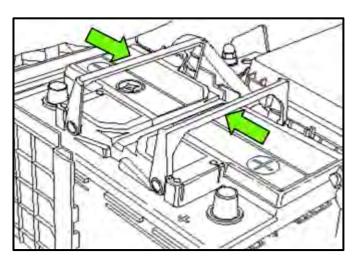
Fold up the handles <arrows> and remove the battery.

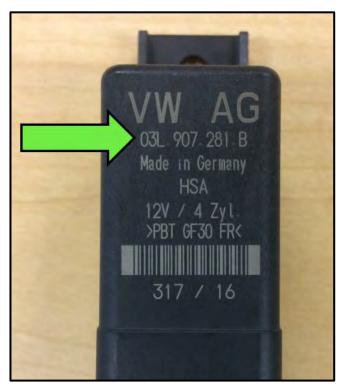
- Inspect, and if required, replace the glow plug control module based upon the part number.
 - If part number "03L 907 281 B" <arrowsis present, continue the work procedure and reinstall the glow plug control module.
 - If part number "03L 907 281 B" <arrow>
 is not present, you are required to
 replace the glow plug control module
 with part number 03L 907 281 B.
 - If the glow plug control module requires replacement, disconnect electrical connector, remove screw with bracket and reinstall onto new glow plug control module with part number 03L 907 281 B.

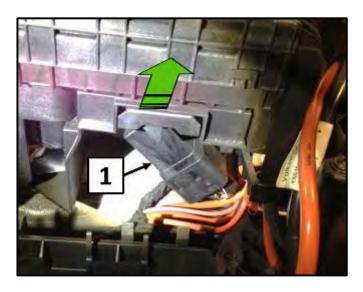
To reinstall, slide glow plug control module <1> into position underneath left engine compartment E-box <in direction of arrow>.

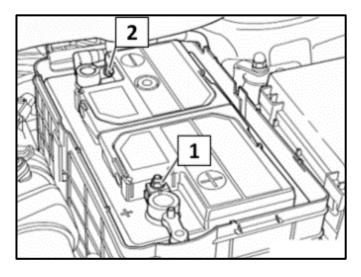
- First, reconnect positive cable to positive terminal on battery and torque screw <1> to 6Nm.
- Second, reconnect negative cable to negative terminal on battery and torque screw <2> to 6Nm.
- Reinstall battery cover.

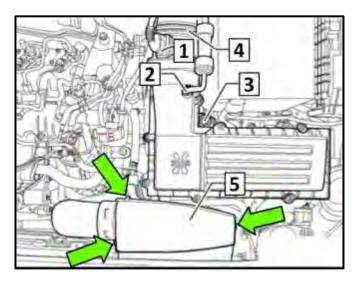
- Reinstall the air filter housing.
- Tighten the bolt <3> for the lower air filter housing.
- Reinstall the air intake tube and close the clamp <4>.
- Reconnect the Mass Airflow Sensor -G70connector <1> and the vacuum line <2>.

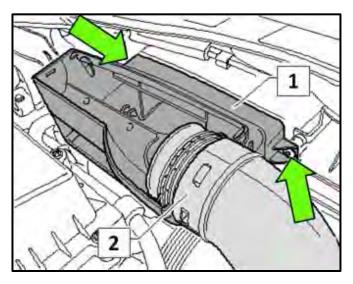
Reinstall the air intake guide <1> and air intake guide hose <2>, then tighten the screws <arrows>.

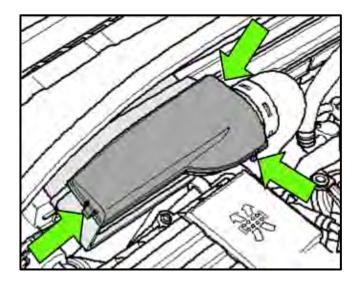
- Reinstall the cover on the air intake and secure tabs <arrows>.
- Reinstall engine cover.
- Switch on ignition.

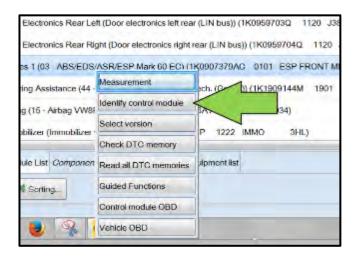
- After the software update is completed and before sending the GFF Log Online:
 - o Select the "Control Module" tab.
 - Scroll down and right click on Address Word 0001/ Engine Control Module.
 - Select "Identify Control Module" <arrow>.

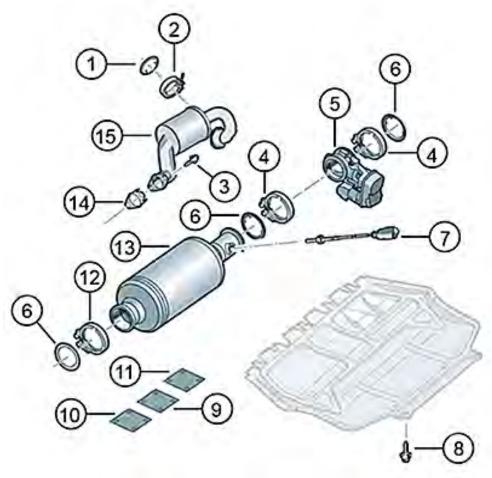
Criteria 01 and 02 - 2.0L Base Kit 1 - 1K0 298 101 A (All Vehicles)

#	Part	Name	Quantity Required Per Vehicle
1	1K0253115AG	Seal	1
2	1K0253725F	Clamp	1
3	N10642103	Bolt (M8x25)	2
4	1K0253725B	Clamp (narrow)	2
5	1K0253691J	Exhaust door control unit -J883-	1
6	1K0253115AE	Seal	3
7	03L906262N	Oxygen sensor after catalytic converter -G130-	1
8	1K0825951	Bolt self-locking (M6x20)	3
8	WHT000729A	Bolt self-locking (M8x20)	3
9	1K0971461D	Heat shield (Cable for Exhaust door control unit –J883-)	1
10	1K0971461E	Heat shield (Cable for Oxygen sensor –G130-)	1
11	1K0971461F	Heat shield (Cable for Oxygen sensor and Exhaust door control unit)	1
12	1K0253725	Clamp	1
13	1K0254402AX	NOx storage catalytic converter	1
14	03G131547H	Seal	1
15	1K0253120B	Exhaust gas recirculation filter	1

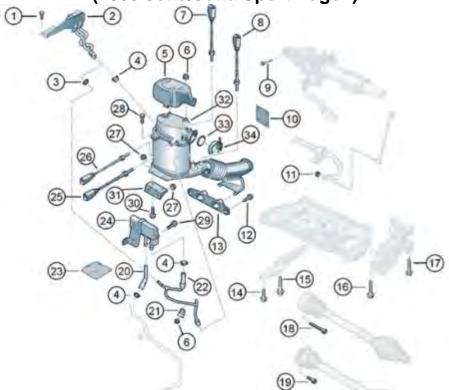
Criteria 01 ONLY - 2.0L Base Kit 2 - 1K0 298 101 X (2009 Jetta/Jetta SportWagen)

#	Part	Name	Quantity Required Per Vehicle
1	N90737105	Bolt	1
2	1K0131552B	Differential pressure sender -G505-	1
3	3C0131483A	Spring clamp	3
4	4B0422379	Spring clamp	1
5	5N0131783	Heat shield	1
6	N02300215	Nut M6	4
7	03L906262B	Oxygen sensor -G39-	1
8	03L906088EG	Exhaust gas temperature sender –G648-	1
9	N01033513	Bolt for U-joint	1
10	5N0971461	Heat shield	1
11	N0150816	Nut	2
12	N10240003	Bolt (M8x32)	2
13	1K0253144BC	Exhaust system bracket	1
14	N91066101	Bolt (M10x35)	1
15	N91167101	Bolt (M10x75)	1
16	WHT000431A	Bolt M12x110	2
17	N91039802	Bolt M12x90	4
18	N90991102	Bolt (M10x52) - Manual Transmission	6
19	N90991002	Bolt (M10x23) - DSG Transmission	6
20	03G131525	Hose for control line	1
21	1K0131649	Retainer	1
22	1K0131552A	Control line	1
23	1K0971461C	Heat shield	1
24	076906051A	Exhaust pressure sensor 1 -G450-	1
25	03L906088T	Exhaust gas temperature sender – G448-	1
26	03L906088J	Exhaust gas temperature sender – G495	1

27	N01508315	Nut M8	4
28	N10653102	Bolt	1
29	N10456201	Bolt M6x25	1
30	N90786502	Bolt	2
31	1K0253463AF	Bracket	1
32	1K0254708GX	Particulate filter	1
33	04L253115A	Seal	1
34	1K0253725	Clamp	1
