GROUP TRA	MODEL 2018MY Optima (JFa) 2.0T Sorento (UMa) 2.0T, 3.3L
	NUMBER 071A (Rev 1, 11/21/2017)	DATE November 2017

TECHNICAL SERVICE BULLETIN

SUBJECT: SERVICE ACTION: 2.0T & 3.3L SHIFT QUALITY LOGIC IMPROVEMENT (SA315A)

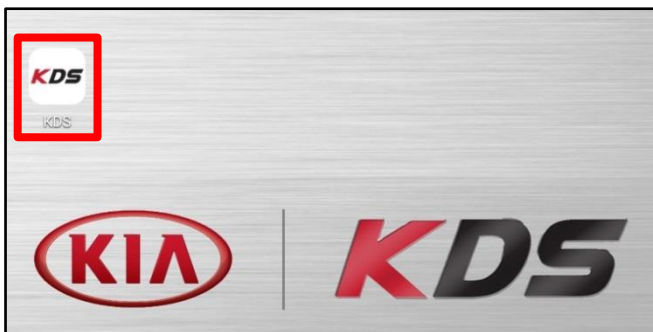
2. With the ignition ON, turn ON the KDS tablet. Select **KDS** from the home screen.

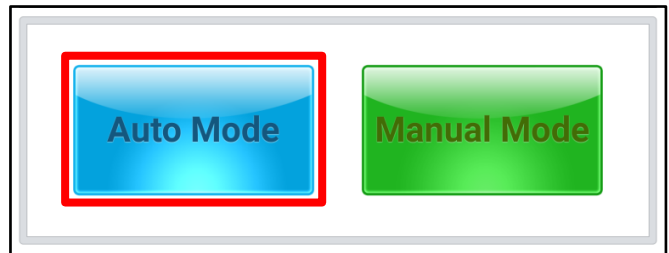
- Select **Auto Mode**.

CAUTION
 Do NOT attempt to perform a Manual Mode upgrade UNLESS Auto Mode fails. Always follow the instructions given on the KDS in either Auto or Manual mode.

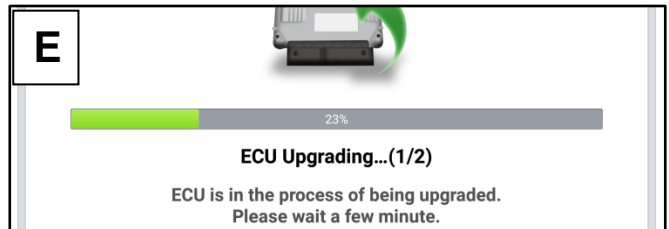
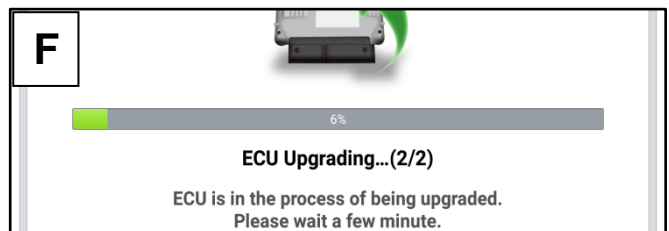
- The ECU upgrade will begin and the progress of the upgrade will appear on the bar graph. Upgrade part (1/2) (E) will download the upgrade event to the VCI-II. Upgrade part (2/2) (F) will upgrade the ECU.

CAUTION
 Do not touch the system buttons (like 'Back', 'Home', 'etc.') while performing ECU Upgrade.

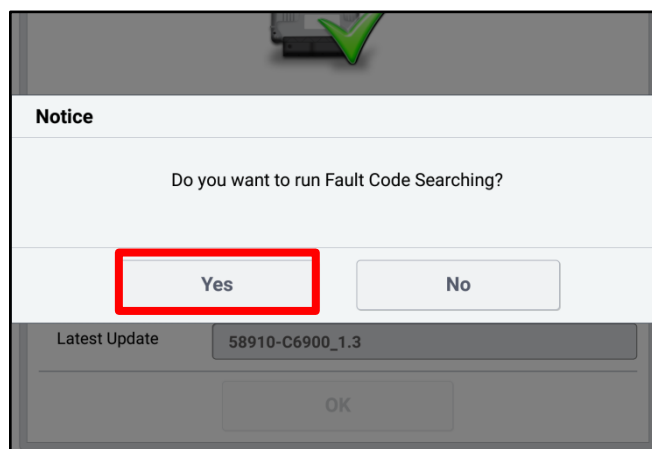
12. When prompted, select **YES** to check for Diagnostic Trouble Codes (DTC) and erase any DTCs stored such as EPS, ESC, and TPMS that may have been set during the upgrade.
