# SERVICE BULLETIN

Classification: AT17-001e	Reference: NTB17-016e	Date: November 15, 2017
------------------------------	--------------------------	----------------------------

## ARMADA, TITAN AND TITAN XD; SHIFT SHOCK, LACK OF POWER, AND/OR RPM FLUCTUATES

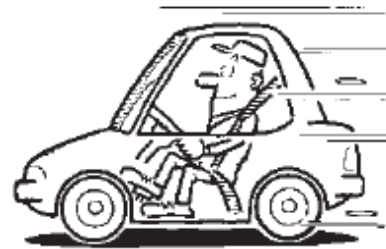
Figure A

- Take the vehicle for a 10 minute drive in order to meet the following Idle Air Volume Learn (IAVL) conditions:
  - Engine coolant temperature: 70 -100°C (158 - 212°F)
  - Battery voltage: More than 12.9V (At idle)
  - Transmission: Warmed up

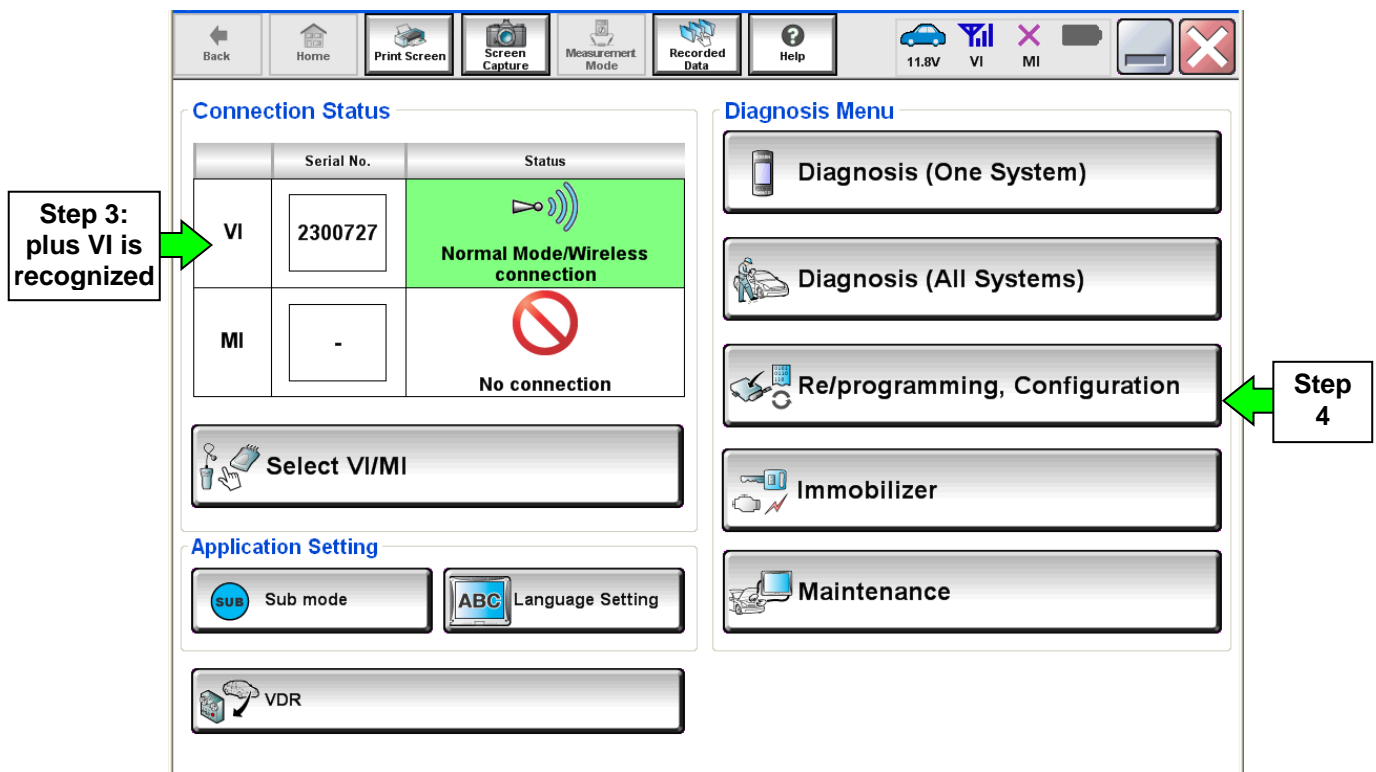
Figure 1

1. Connect the plus VI to the vehicle and open/start C-III plus.
2. Confirm the ignition is ON, with engine OFF.
3. Confirm the plus VI is recognized.
  - The **Serial No.** will display when the plus VI is recognized.
4. Select **Re/programming, Configuration**.

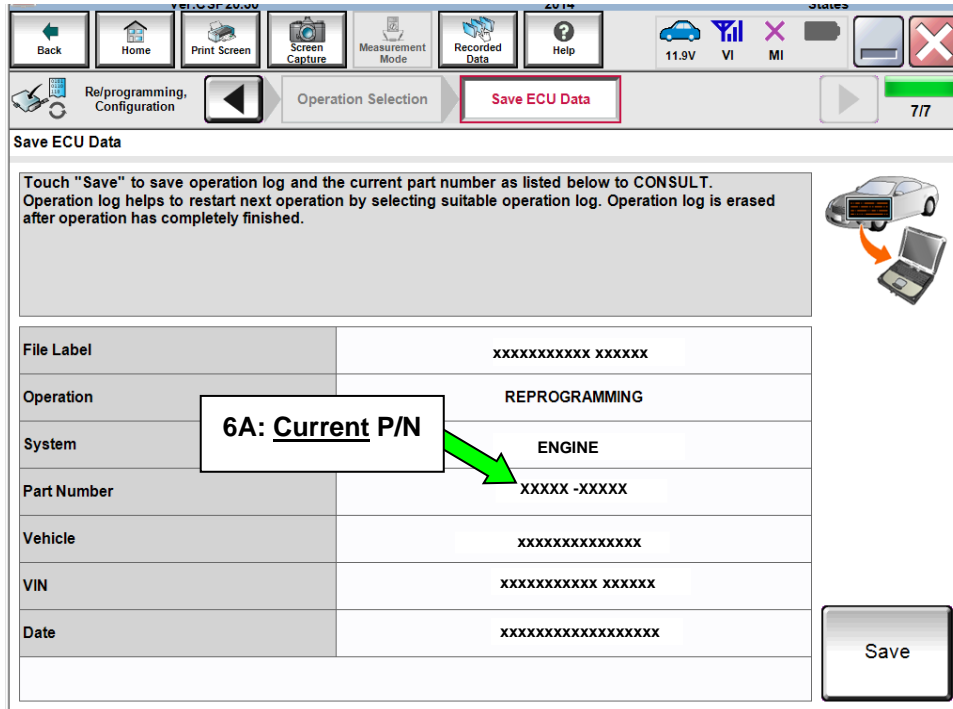
6. When you get to the screen shown in Figure 2, confirm ECM reprogramming applies as follows.

A. Find the ECM **Part Number** and write it on the repair order.

**NOTE:** This is the current ECM Part Number (P/N).

5. Follow the on-screen instructions and navigate C-III plus to the screen shown in Figure 2 on the next page.

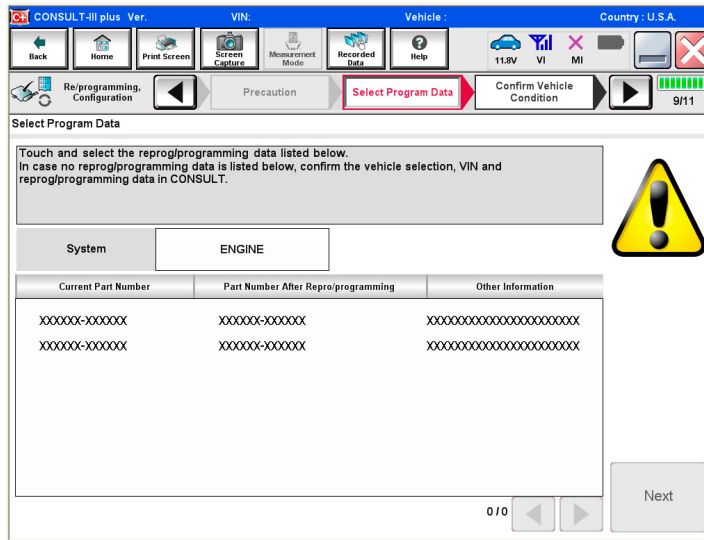
- In some cases, more than one new P/N for reprogramming is available.
  - If more than one new P/N is available, the screen in Figure 3 displays.
  - Select and use the reprogramming option that does **not** have the message “Caution! Use ONLY with NTBXX-XXX”.
- If you get this screen and it is blank (no reprogramming listed), it means there is no reprogramming available for this vehicle. Close C-III plus and refer back to ASIST for further diagnosis.

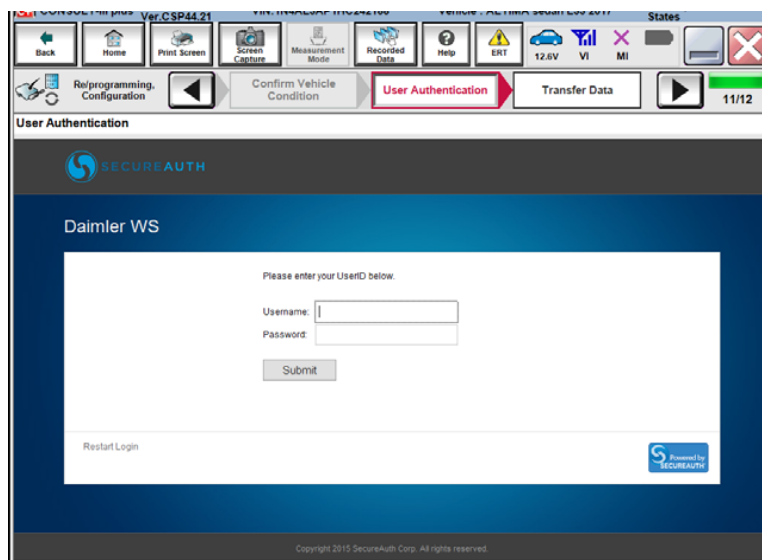
Figure 4

- Before reprogramming will start, you will be required to enter your User Name and Password.
  - The CONSULT PC must be connected to the Internet (Wi-Fi or cable).
  - If you do not know your User Name and Password, contact your Service Manager.

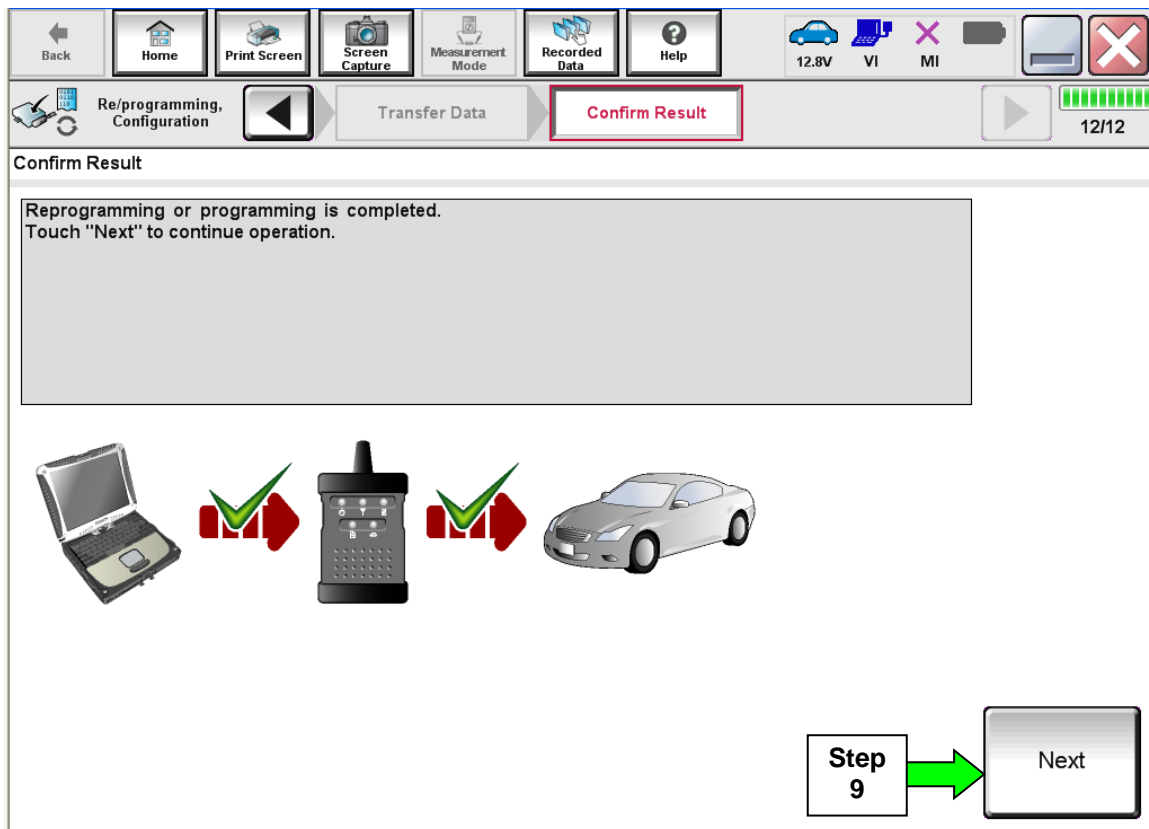
8. When the screen in Figure 5 displays, reprogramming is complete.

**NOTE:** If the screen in Figure 5 does not display (indicating that reprogramming did not complete), refer to ECM Recovery on the next page.

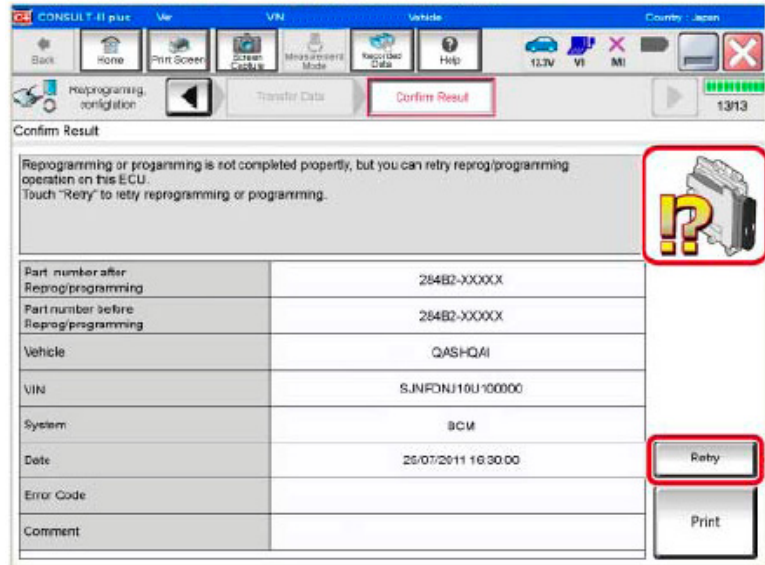
Figure 6

If reprogramming does not complete and the “!?” icon displays as shown in Figure 6:

- Check battery voltage (12.0 - 15.5 V).
- Ignition is ON, engine OFF.
- External Bluetooth® devices are OFF.
- All electrical loads are OFF.
- **Select retry and follow the on screen instructions.**
- “Retry” may not go through on first attempt and can be selected more than once.

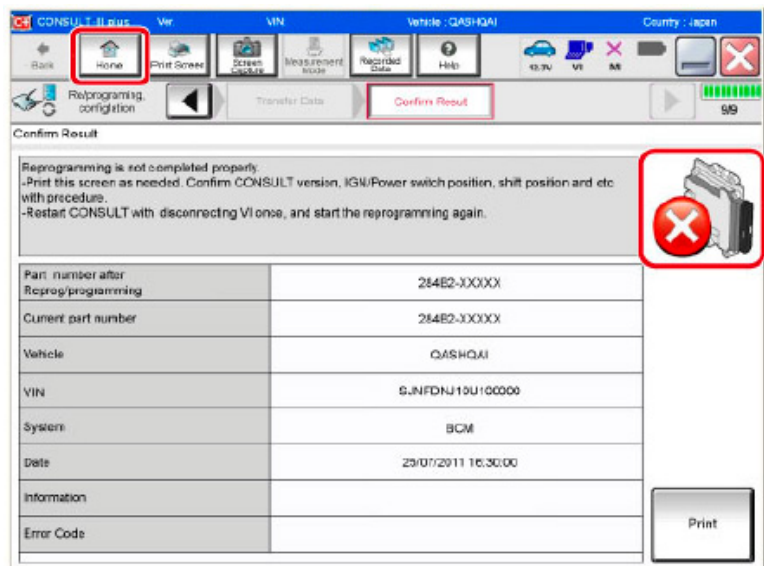
Figure 7

If reprogramming does not complete and the “X” icon displays as shown in Figure 7:

- Check battery voltage (12.0 - 15.5 V).
- CONSULT A/C adapter is plugged in.
- Ignition is ON, engine OFF.
- Transmission is in Park.
- All C-III plus / VI cables are securely connected.
- All C-III plus updates are installed.
- **Select Home, and restart the reprogram procedure from the beginning.**

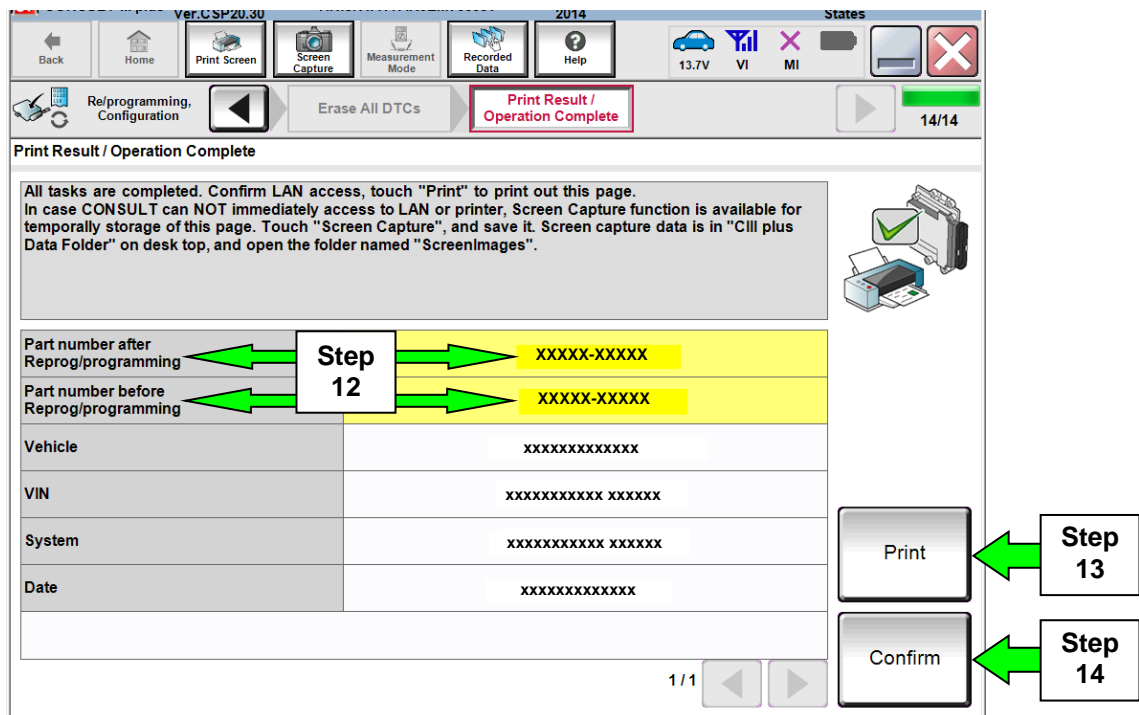
11. When the entire reprogramming process is complete, the screen in Figure 8 will display.
12. Verify the before and after part numbers are different.
13. Print a copy of this screen (Figure 8) and attach it to the repair order for warranty documentation.
14. Select **Confirm**.

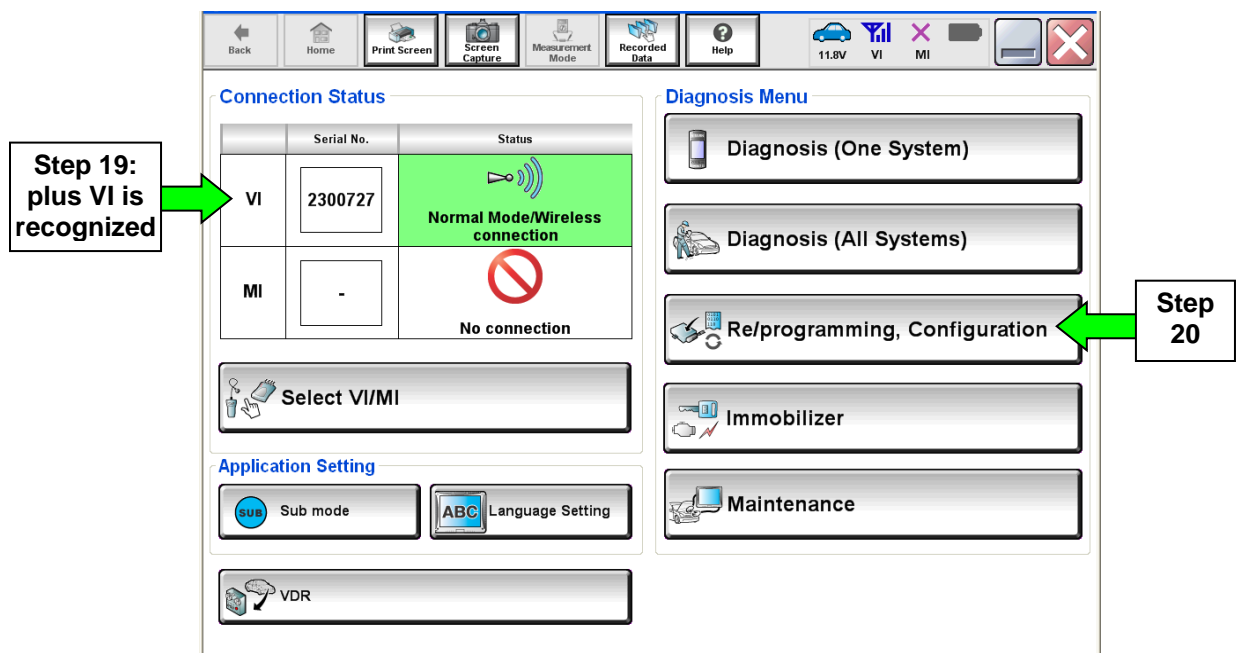
Figure 9

17. Confirm C-III plus is on the Home Screen (see Figure 9).

20. Select **Re/programming, Configuration**.

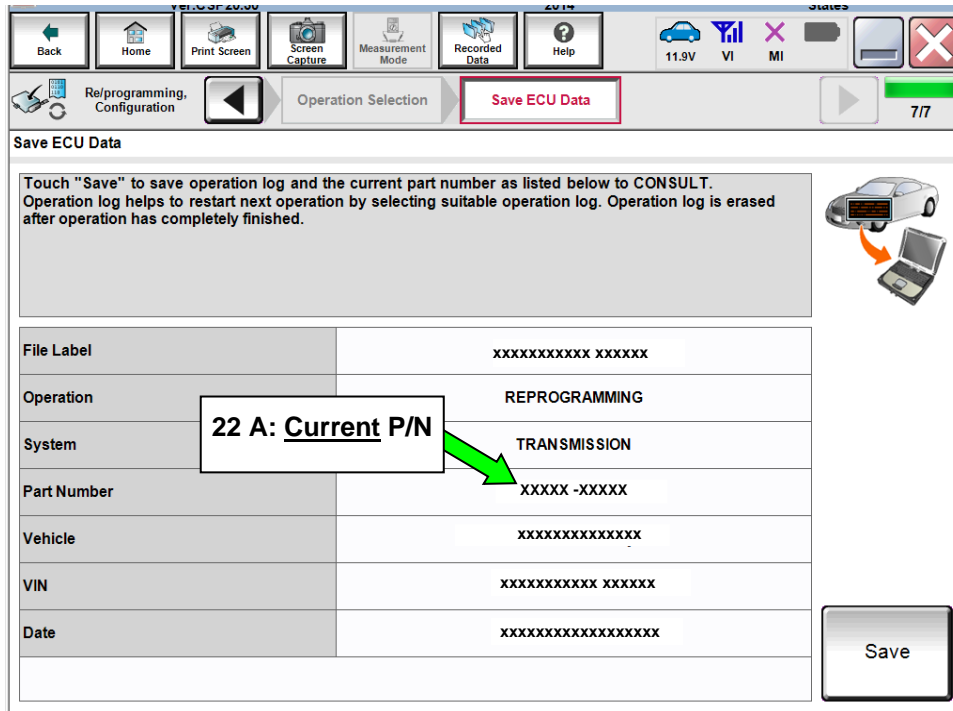
22. When you get to the screen shown in Figure 10, confirm TCM reprogram applies as follows.

A. Find the TCM **Part Number** and write it on the repair order.

**NOTE:** This is the current TCM Part Number (P/N).

21. Follow the on-screen instructions and navigate C-III plus to the screen shown in Figure 10 below.

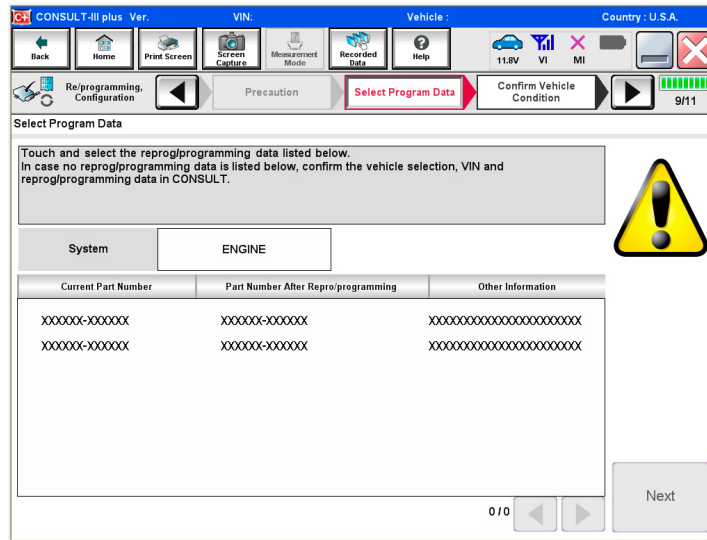
- In some cases, more than one new P/N for reprogramming is available.
  - If more than one new P/N is available, the screen in Figure 11 displays.
  - Select and use the reprogramming option that does not have the message “Caution! Use ONLY with NTBXX-XXX”.
- If you get this screen and it is blank (no reprogramming listed), it means there is no reprogramming available for this vehicle. Close C-III plus and refer back to ASIST for further diagnosis.

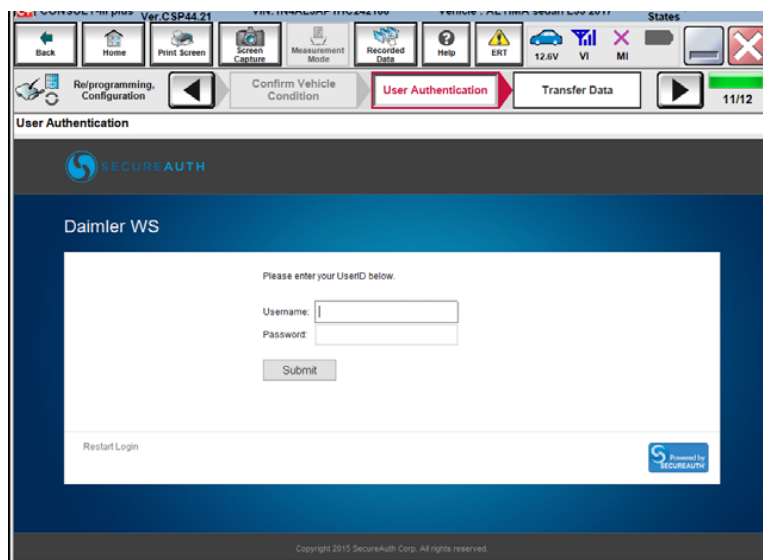
Figure 12

- Before reprogramming will start, you will be required to enter your User Name and Password.
  - The CONSULT PC must be connected to the Internet (Wi-Fi or cable).
  - If you do not know your User Name and Password, contact your Service Manager.

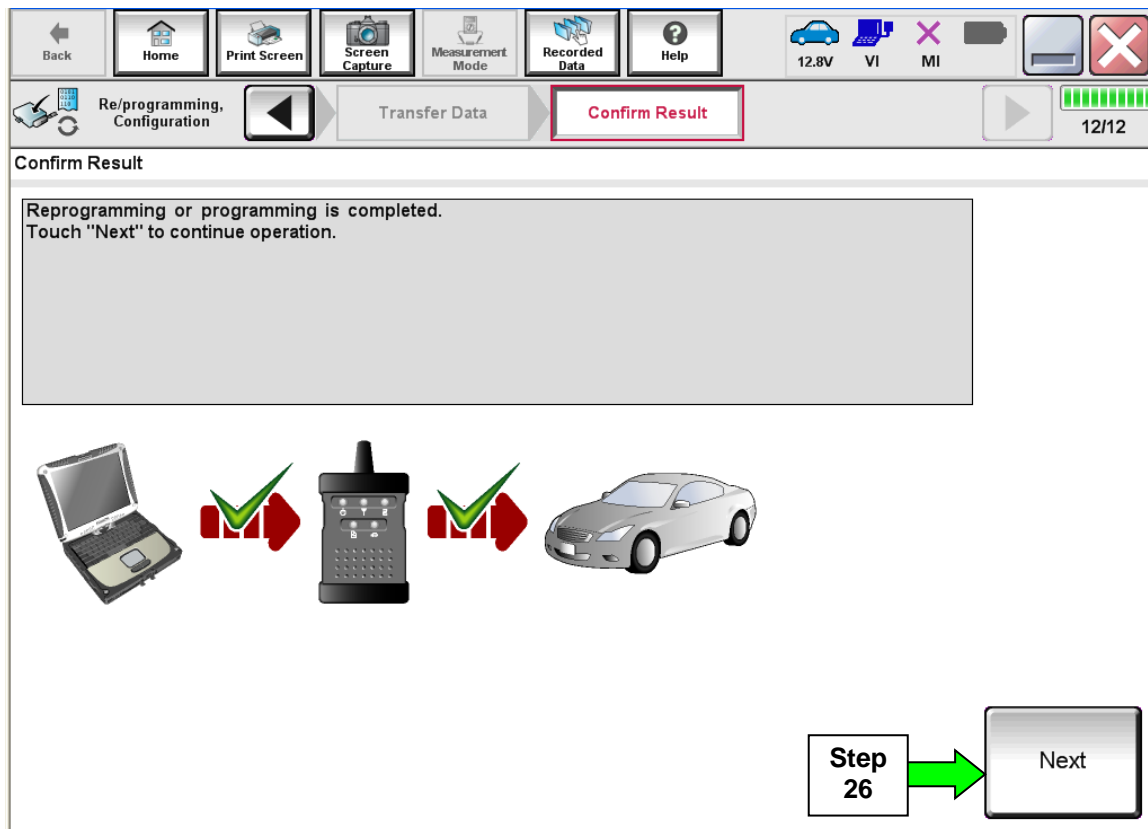
24. When the screen in Figure 13 displays, reprogramming is complete.

**NOTE:** If the screen in Figure 13 does not display (indicating that reprogramming did not complete), refer to TCM Recovery on the next page.

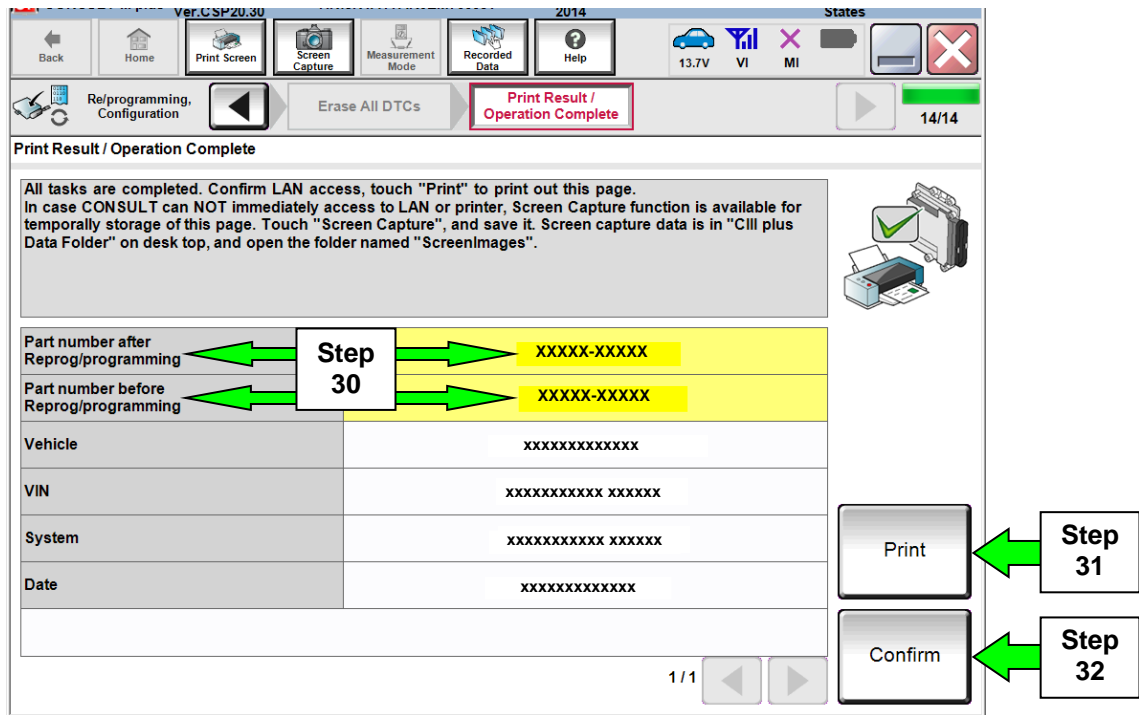
27. Follow the on-screen instructions to **Confirm Shift Lever Position Display**.
28. Follow the on-screen instructions to **Erase DTCs**.
29. When the entire reprogramming process is complete, the screen in Figure 16 will display.
30. Verify the before and after part numbers are different.
31. Print a copy of this screen (Figure 16) and attach it to the repair order for warranty documentation.
32. Select **Confirm**.
