SERVICE CAMPAIGN BULLETIN

SUBJECT:			No: SC-17-001
OUTLANDER ASC ECU REPROGRAMMING – SERVICE CAMPAIGN			DATE: December 2017
			MODEL: 2017 Outlander
CIRCULATE TO:	<input checked="" type="checkbox"/> GENERAL MANAGER	<input checked="" type="checkbox"/> PARTS MANAGER	<input checked="" type="checkbox"/> TECHNICIAN
<input checked="" type="checkbox"/> SERVICE ADVISOR	<input checked="" type="checkbox"/> SERVICE MANAGER	<input checked="" type="checkbox"/> WARRANTY PROCESSOR	<input checked="" type="checkbox"/> SALES MANAGER

This Service Campaign Bulletin provides instructions for reprogramming the ASC–ECU with a countermeasure software.

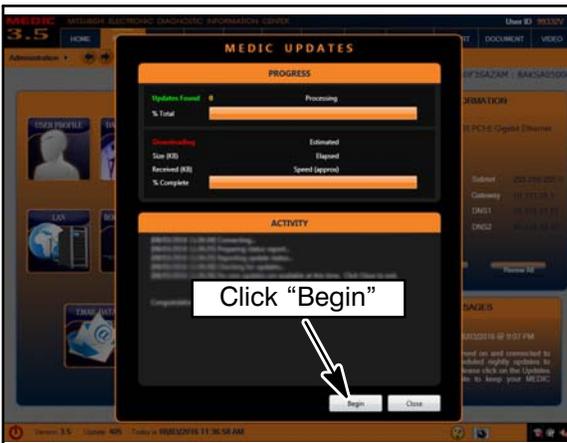
3. Select the MEDIC 3.5/4 Admin tab and click on "MEDIC UPDATES."

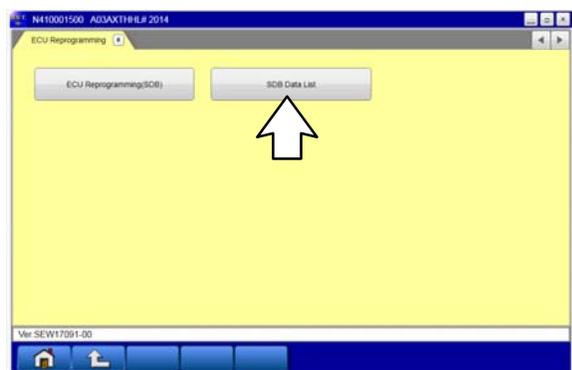
d. Click “SDB Data List.”

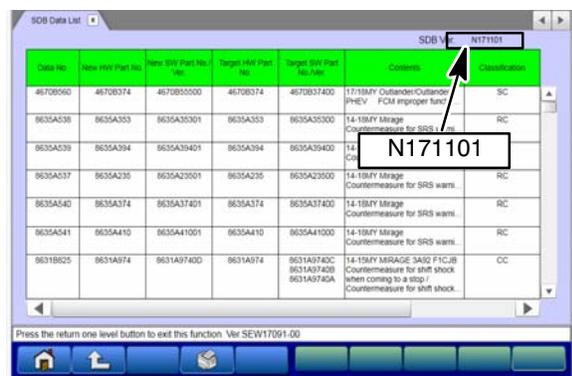
e. Confirm that the database number displayed in the upper right above the chart is **N171101 or higher**

- If the database number displayed on your MUT3-SE is N171101 or greater, continue to the **Reprogramming Procedure**.
- If the reprogramming database number displayed on your MUT3-SE is **lower** than **N171101**, then the MUT3-SE database needs to be updated.

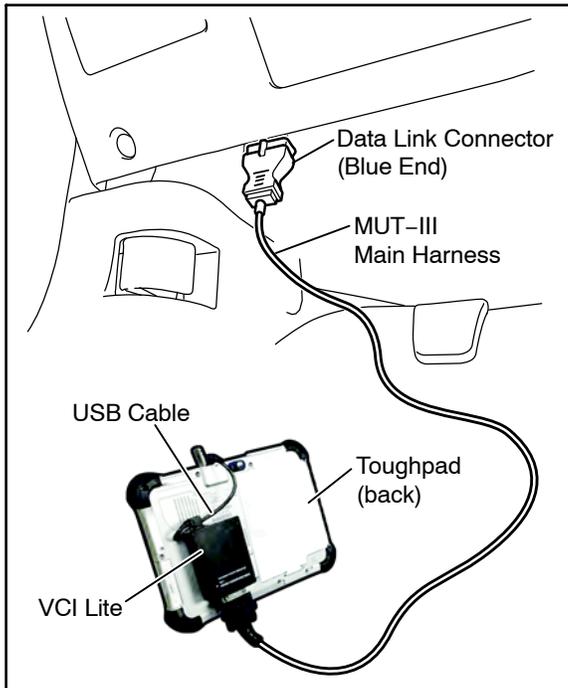
1. Connect the equipment as follows:

NOTE: VCI Lite and MEDIC 4.0 Toughpad shown for illustration purposes only.

- Turn the MEDIC PC/tablet on. If the battery indicator in the lower right hand corner of the screen does not show a full charge, it is recommended that either the battery be charged prior to beginning, or be used with the A/C power adaptor connected.
- Connect the USB cable to the VCI/VCI Lite.
- When the laptop/tablet displays the MEDIC main screen, connect the USB cable to the device.
- Connect the MUT-III main harness with the blue DLC connection to the VCI/VCI Lite.
- Connect the blue connection of the MUT-III main harness to the vehicle's data link connector.
- Turn the VCI power switch ON. Verify that the indicator lamp in the upper right corner of the screen is green.

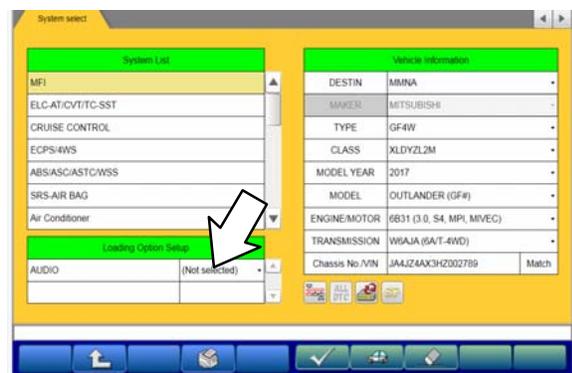
4. The System Select screen opens and populates with some basic information from the vehicle.

Look at the label on the passenger side B pillar to identify the appropriate class.

Then select the correct class from the drop–down list.

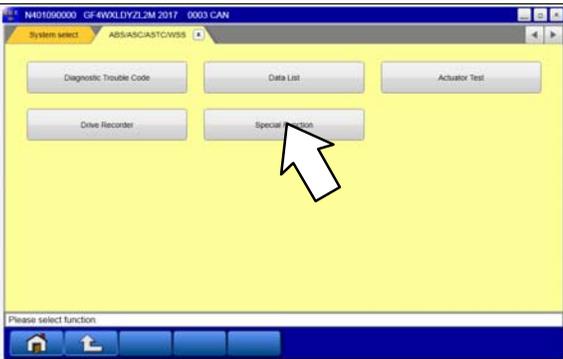
a. Select “ABS/ASC/ASTC/WSS” from the System List, then click on the check mark at the bottom of the screen.

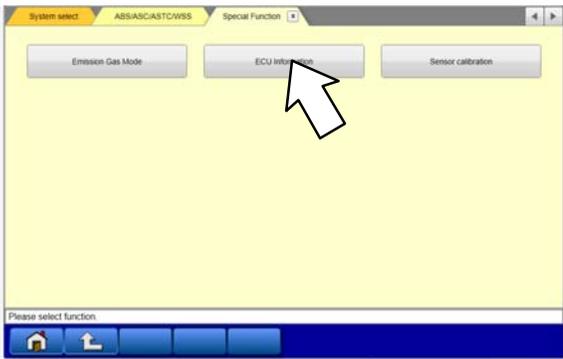
b. Select “Special Function.”

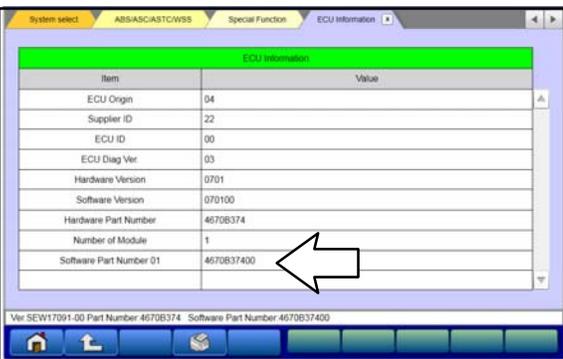
c. Select “ECU Information.”

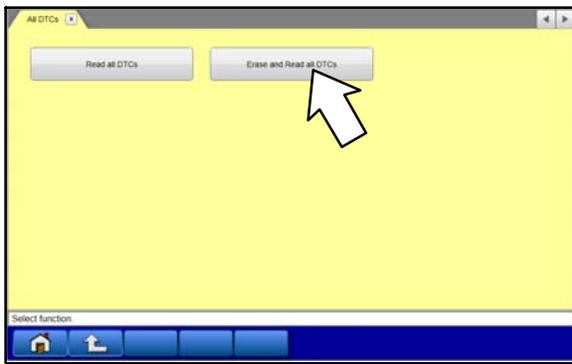
a. Click the home button to go back to the System Select screen.

Click the “ALL DTC” button.

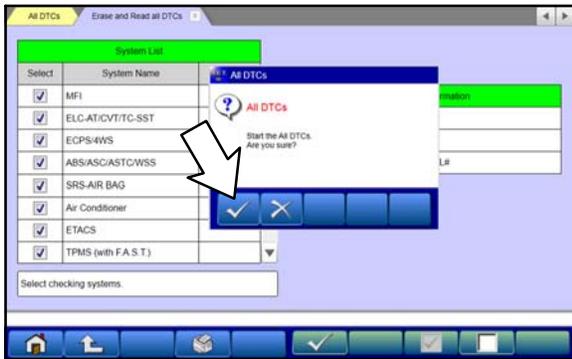
b. Select “Erase and Read All DTCs.”

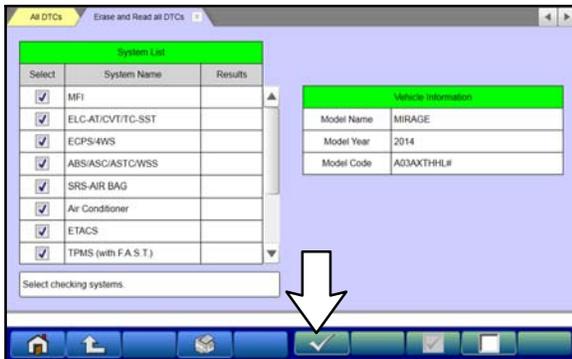
c. A window will pop up asking you to confirm DTC erasing. Click the check mark in the dialog box for DTC erasing and reading to begin.

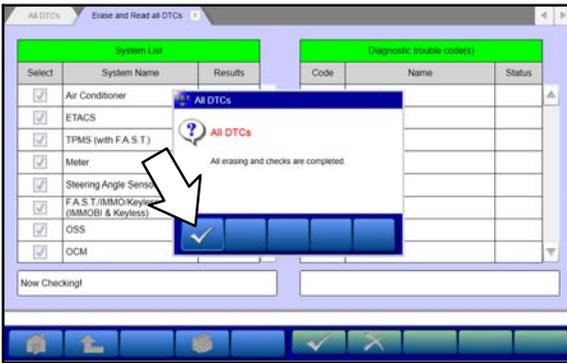
d. The “System List” on the left side of the screen will have all selections checked. Do not change these selections.

e. Click the check mark to continue.

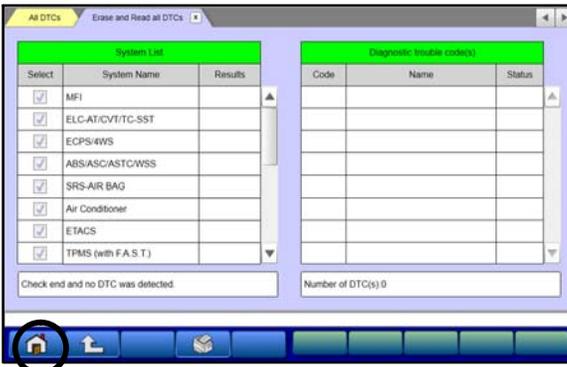
8. When DTC erasing is completed, click the check mark in the pop-up message that reads “All erasing and checks are completed.”

a. If DTCs return after erasing is completed, click the check mark to clear the window. Diagnose and repair per the Service Manual.

b. If DTCs do not return, click the check mark to clear the window, then click the Home icon in the lower left to return to the System Select menu.

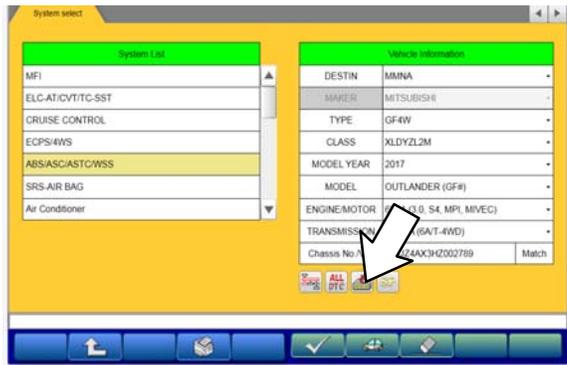
a. Click on the Reprogram button.

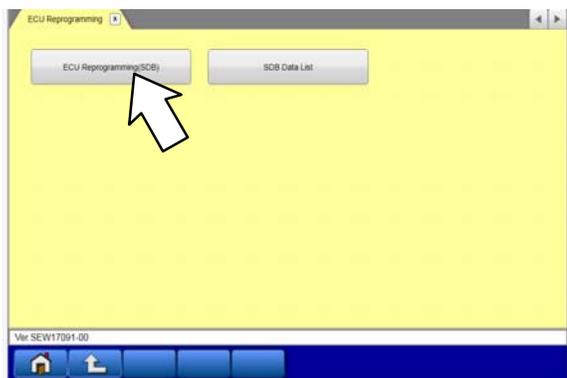
b. Select “ECU Reprogramming (SDB).”

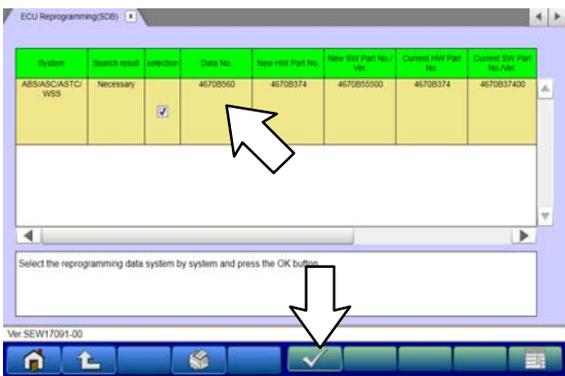
- c. Verify the “ABS/ASC/ASTC/WSS” is selected in the System List, then click the check mark.

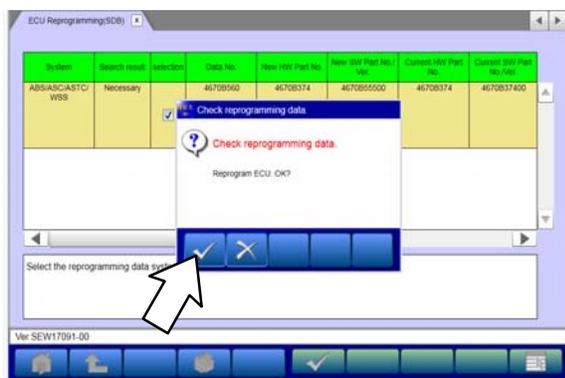
- d. Select the correct Data No. listed in the **ASC ECU Reprogramming Chart**.

- e. Click the check mark at the bottom of the page to initiate reprogramming.

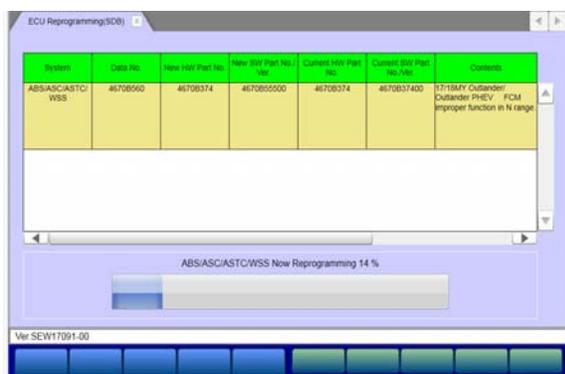
- f. Click the check mark in the “Check reprogramming data” dialog box.

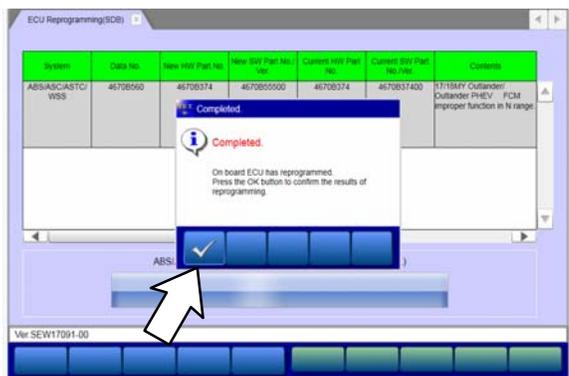
- g. Once the reprogramming is initiated, the screen shown will indicate the reprogramming progress.

NOTE: Do NOT disturb the cables or turn off the ignition during reprogramming.

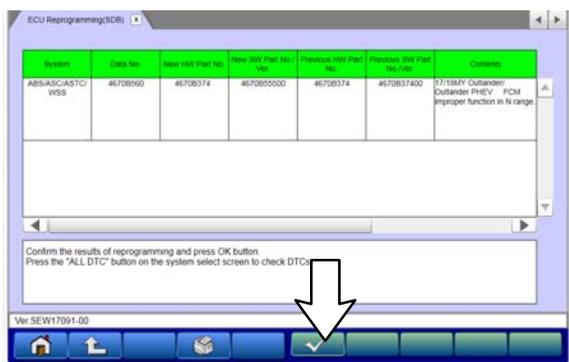
h. Click the check mark in the “Completed” dialog box.
