Technical product information

Topic	2012 MY onwards Continental family and Flying Spur - Infotainment unit (RNS) – Replacement Process
Market area	Bentley: worldwide (2WBE)
Brand	Bentley
Transaction No.	2030765/4
Level	EH
Status	Approval
Release date

2012MY onwards Continental family and Flying Spur

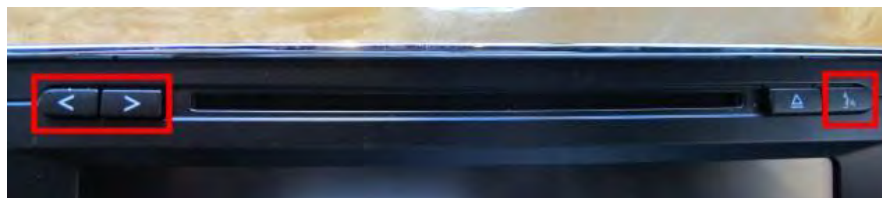
Figure 1

1. Option 1a Carry out a button press reset of the RNS unit
 - a. Insert the key into the ignition switch and turn on the ignition
 - b. Almost simultaneously, but ensuring the two buttons on the left are pressed slightly before, press and hold the three buttons at the top of the infotainment unit screen (see Figure 1)
 - c. Once the three buttons are released the infotainment screen will go blank, and then display the Bentley wings
 - d. Within five minutes the system should have fully re-started indicated by either the radio or media screen operating

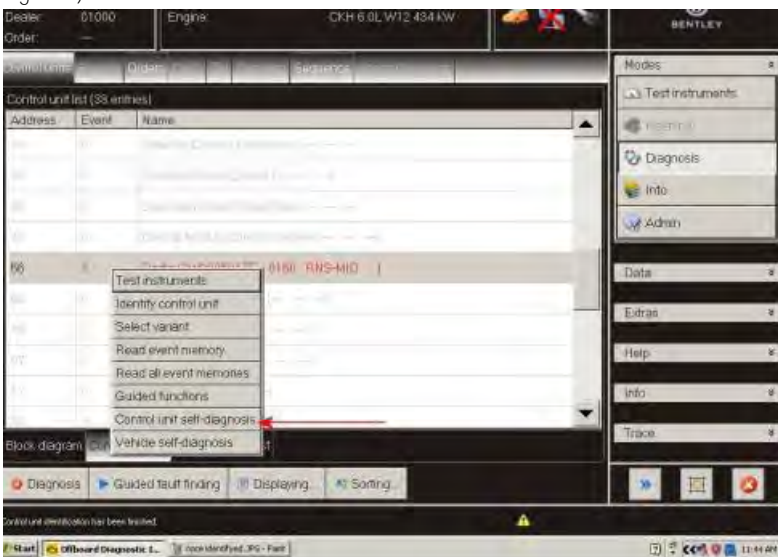
Figure 3

- Once the control module has been identify by the diagnostic program touch, hold then release the selected box again to reveal drop down menu this time select *Control unit self-diagnosis* (see Figure 3)
