June 08, 2017
Subject: Recall R89716
TO: All U.S. and Canadian Volvo Retailers

<h1>Quality Bulletin</h1>				
TITLE: Recall R89716: Replace 3rd Row Passengers Side Seatbelt Retractor Model Year 2017, Model XC90 with 7 Seats				
GROUP:	CAT/NO: R89716	ISSUING DEPARTMENT: Warranty		CAR MARKET: United States and Canada
REFERENCE BULLETINS: TJ 32813			ISSUE DATE: 2017-06-08	STATUS DATE: 2017-06-08
Service Personnel: Read and initial	SERVICE MANAGER	SERVICE WRITER	WARRANTY ADMINISTRATOR	
			Page 1 of 3

Title	Seat belt retractor, rear	Page	1 (9)
Action	Replacement	Operation number:	97195-2

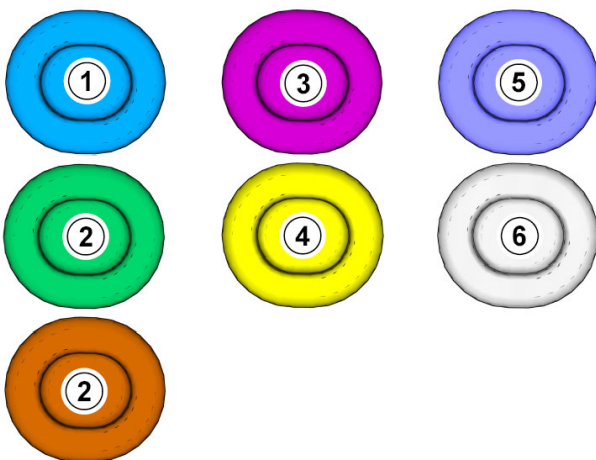
Color symbols

Note! This colour chart displays (in colour print and electronic version) the importance of the different colours used in the images of the method steps.

- 1 . Used for focused component, the component with which you will do something.
- 2 . Used as extra colors when you need to show or differentiate additional parts.
- 3 . Used for attachments that are to be removed/installed. May be screws, clips, connectors, etc.
- 4 . Used when the component is not fully removed from the vehicle but only hung to the side.
- 5 . Used for standard tools and special tools.
- 6 . Used as background color for vehicle components.

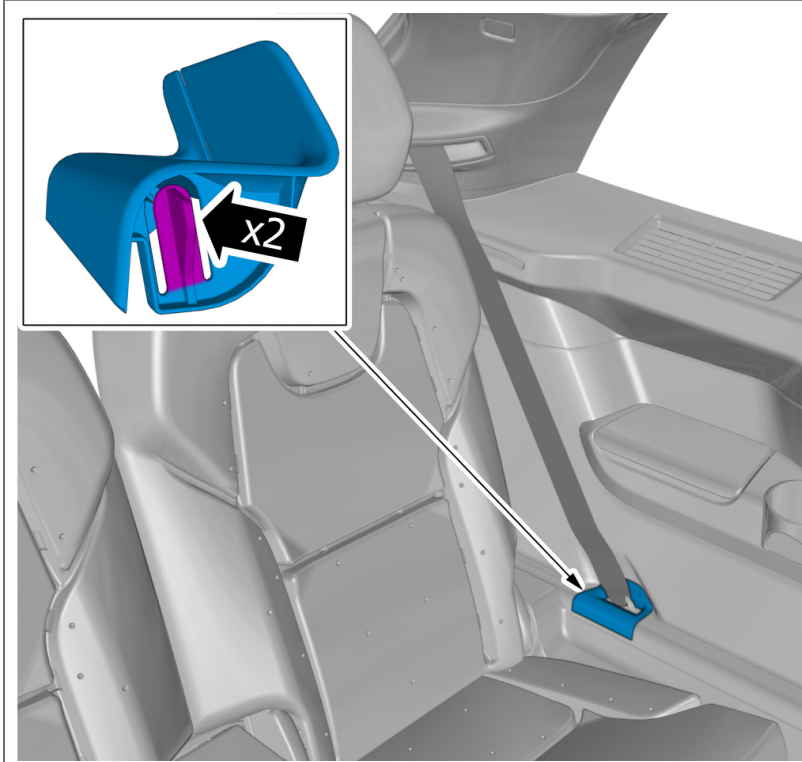
Right-hand side

Note: Although some of the below images for interior panel removal show the left side of the vehicle, this action applies to the right side of the vehicle only.

Remove the marked part.

Special Tool: T9814071, Interior trim remover

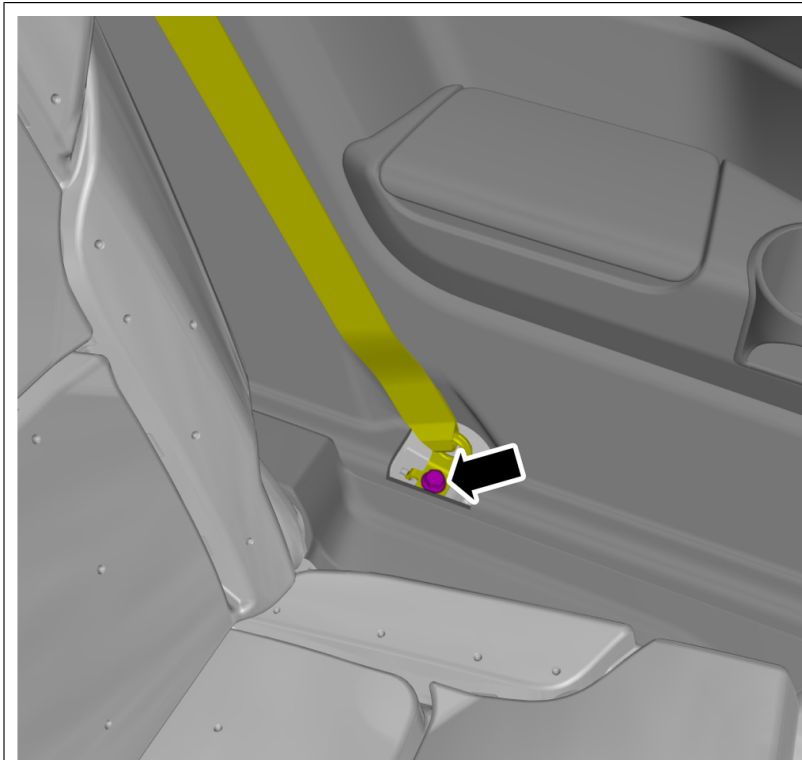
Right-hand side

Remove the screw.

Torque:

Safety belt lower anchor to body (rear) ,
40 Nm

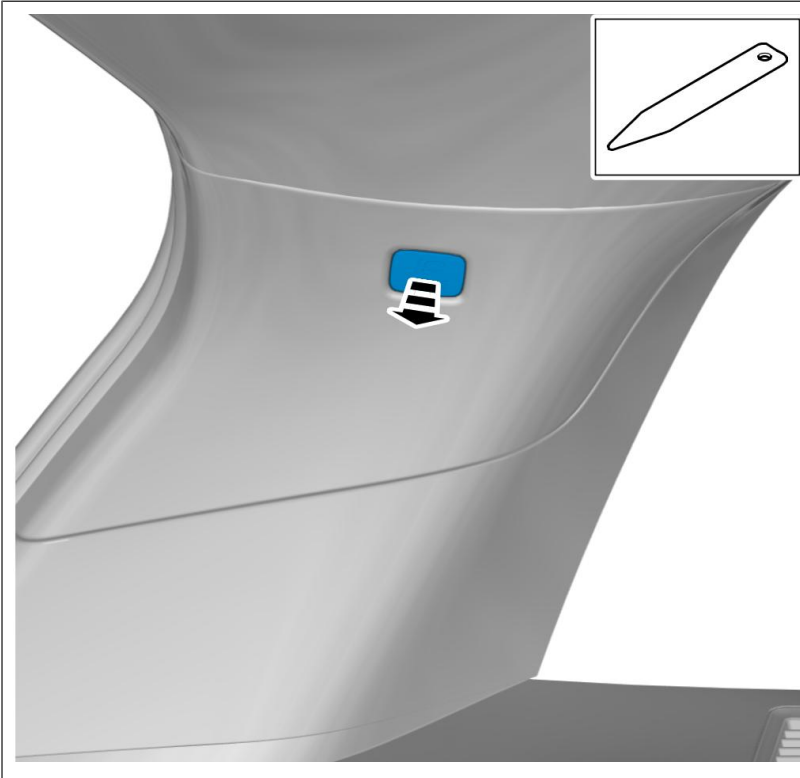
Right-hand side
Remove the marked part.

Special Tool: T9814071, Interior trim remover

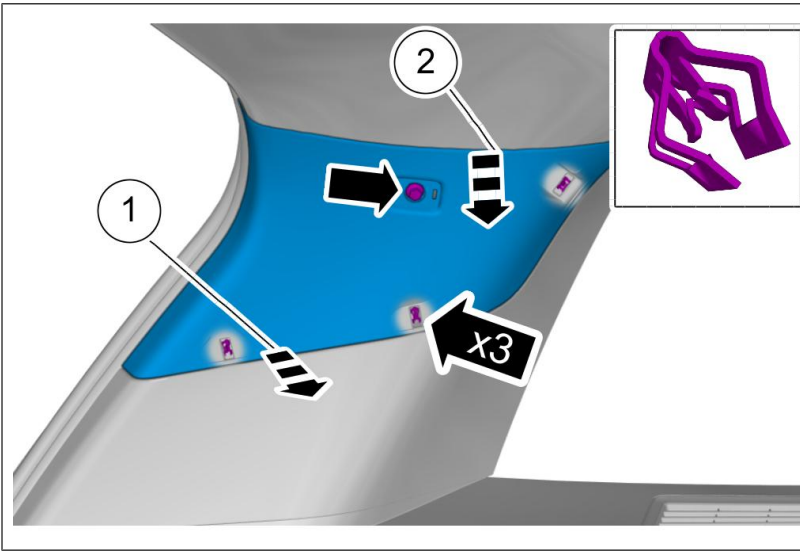
Right-hand side

1 . **Torque:**
Panel, to D-Pillar , 4.5 Nm

2 . Remove the screw.
3 . Remove the panel.

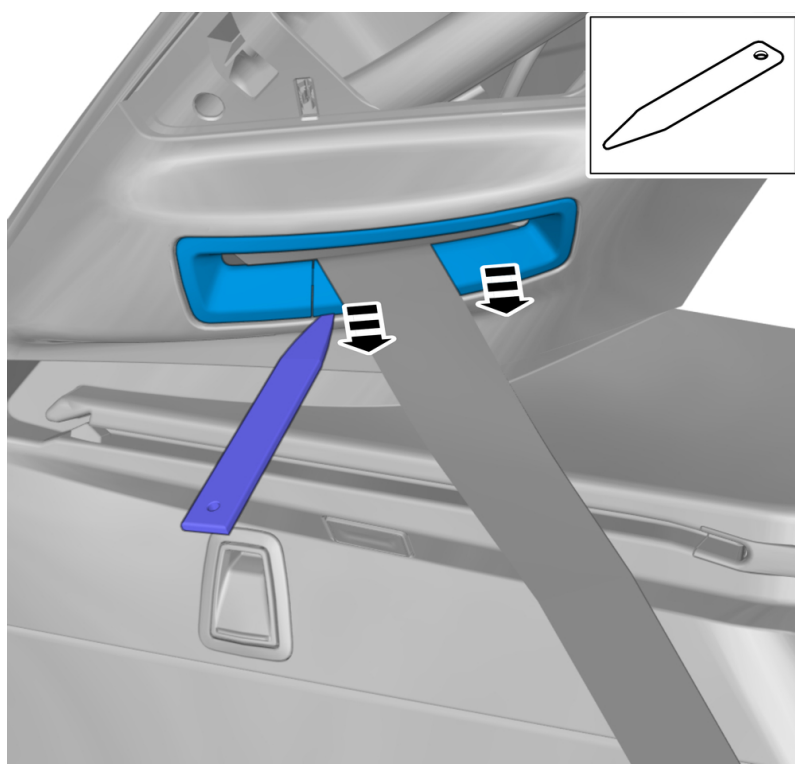
Right-hand side
Remove the marked part.
Special Tool: T9814071, Interior trim remover

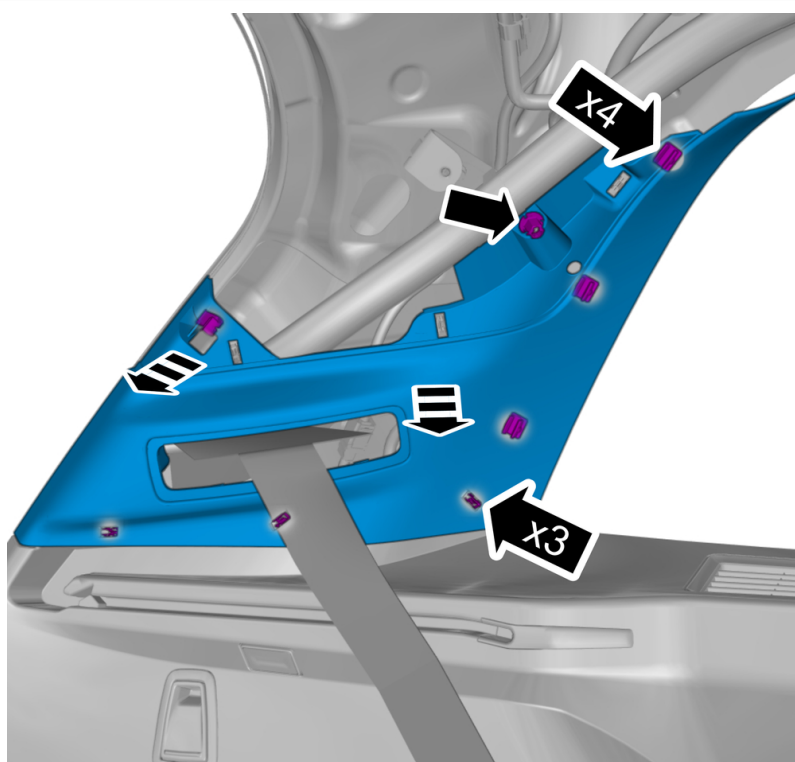
Right-hand side
Remove the nut.
Remove the marked part.

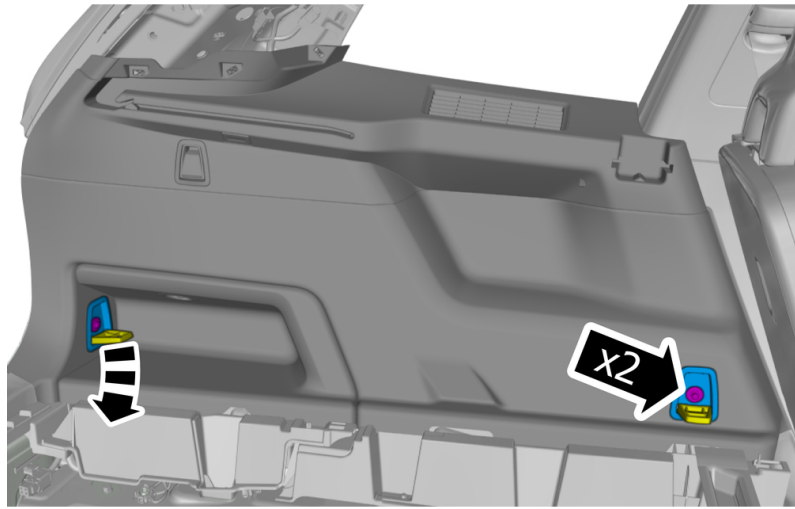
Right-hand side
Remove the screws.

Torque:

Cargo anchor, to body , 13 Nm

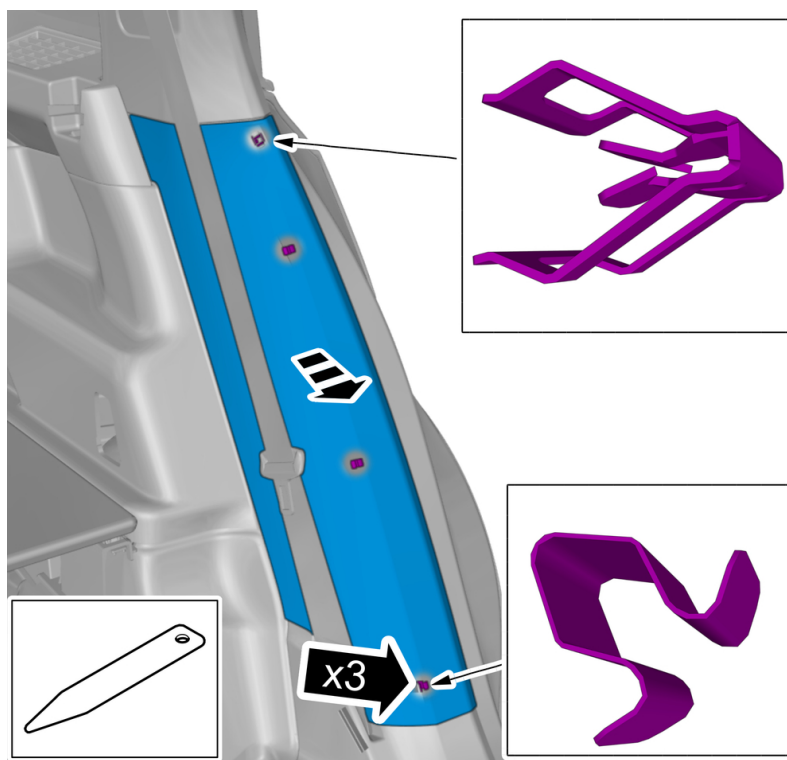
Right-hand side
Remove the panel.

Special Tool: T9814071, Interior trim remover

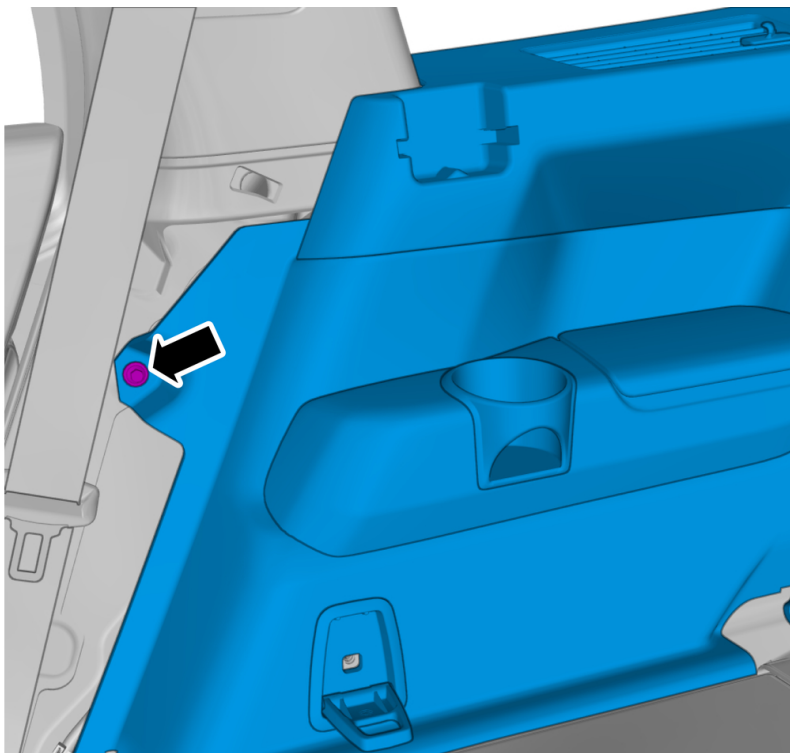
Right-hand side
Remove the screw.

Torque:
M5 , 5 Nm

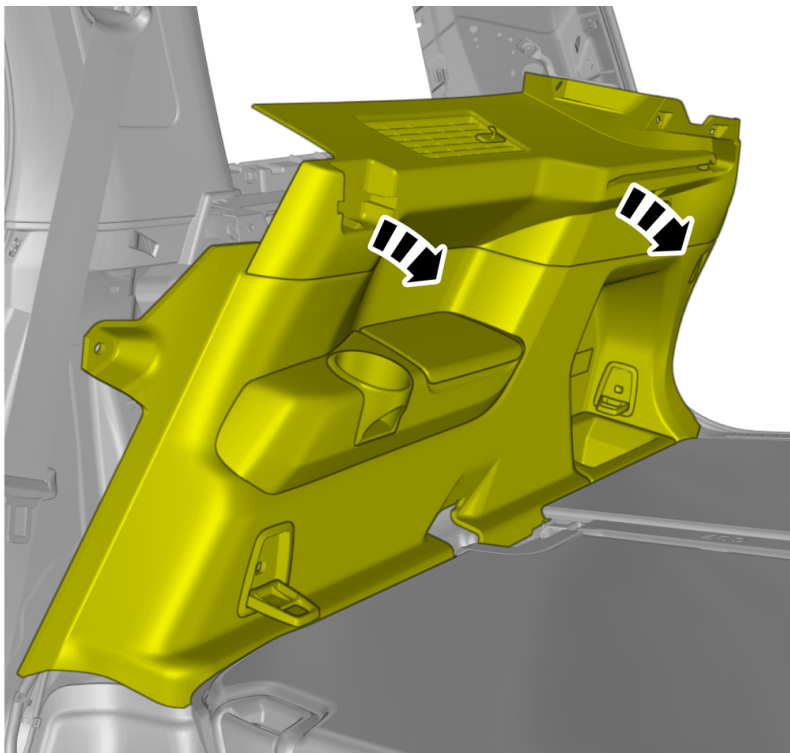
Right-hand side
Fold marked part to one side.

Disconnect connector ignition cable , refer to:
3 - Electrical system
37 - Cables and fuses
371 - cables

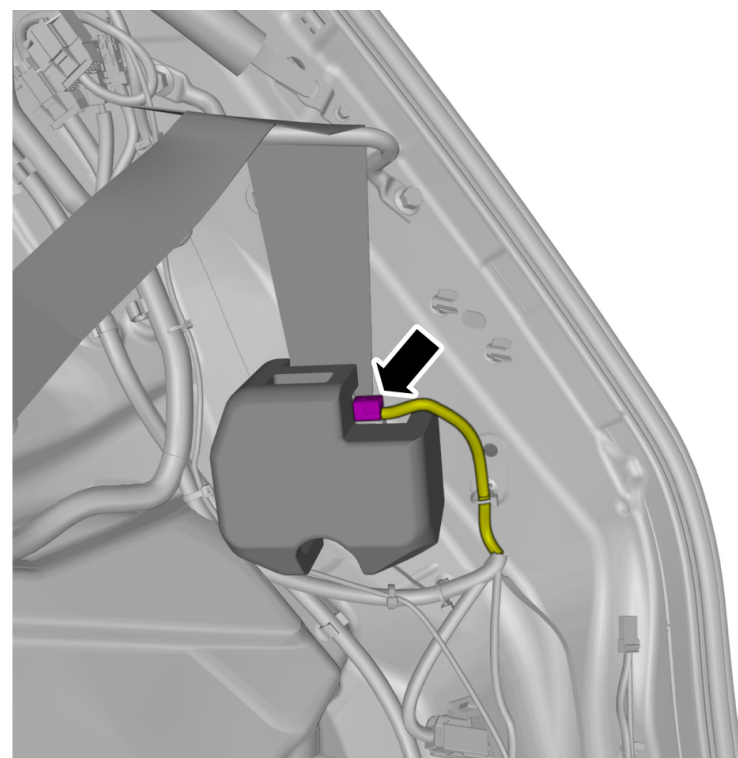
Right-hand side
Disconnect the connector.

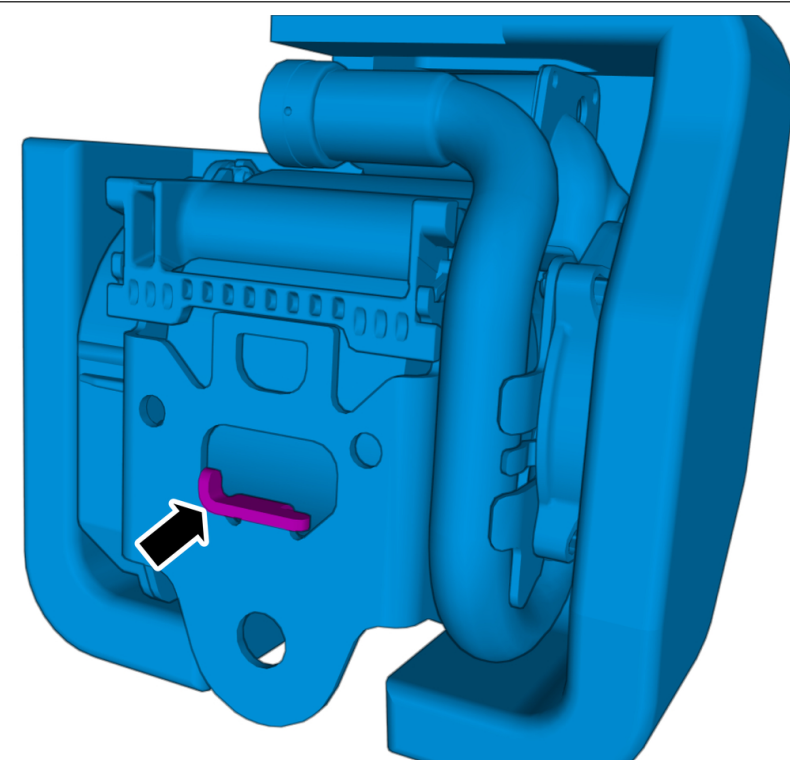
Note! The graphic shows the back of the component before removal.

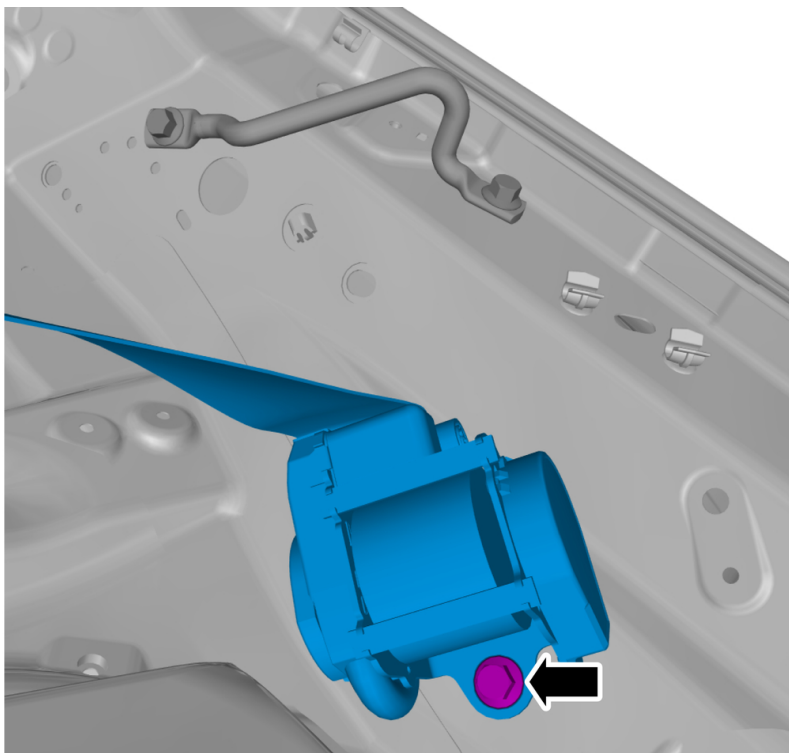
Right-hand side
Remove the screw.
Remove the marked part.

Torque:
