AT17-002c

2016-2017 QX80; SHIFT SHOCK, LACK OF POWER, AND/OR RPM FLUCTUATES

APPLIED VEHICLES: 2016-2017 QX80 (Z62)

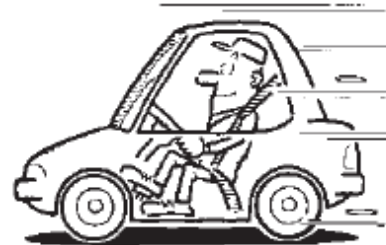
Figure A

- Take the vehicle for a 10 minute drive in order to meet the following Idle Air Volume Learn (IAVL) conditions:
 - Engine coolant temperature: 70 -100°C (158 - 212°F)
 - Battery voltage: More than 12.9V (At idle)
 - Transmission: Warmed up
