Classification:
EM17-006a

2016-2017 QX80; FAN COUPLING TICK / KNOCK NOISE IN TEMPERATURES 32°F (0°C) OR BELOW

APPLIED VEHICLE: 2016-2017 QX80 (Z62)

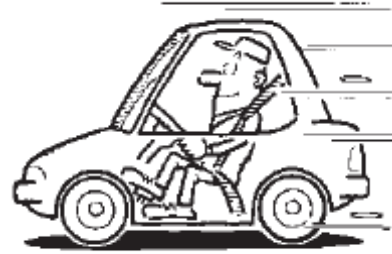
Figure A

- Most instructions for reprogramming with C-III plus are displayed on the CONSULT PC screen.
- If you are not familiar with the reprogramming procedure, *click here*. This will link you to the "CONSULT- III plus (C-III plus) ECM Reprogramming" general procedure.
- Take the vehicle for a 10 minute drive in order to meet the following Idle Air Volume Learn (IAVL) conditions:
 - Engine coolant temperature: 70 -100°C (158 - 212°F)
 - Battery voltage: More than 12.9V (At idle)
 - Transmission: Warmed up

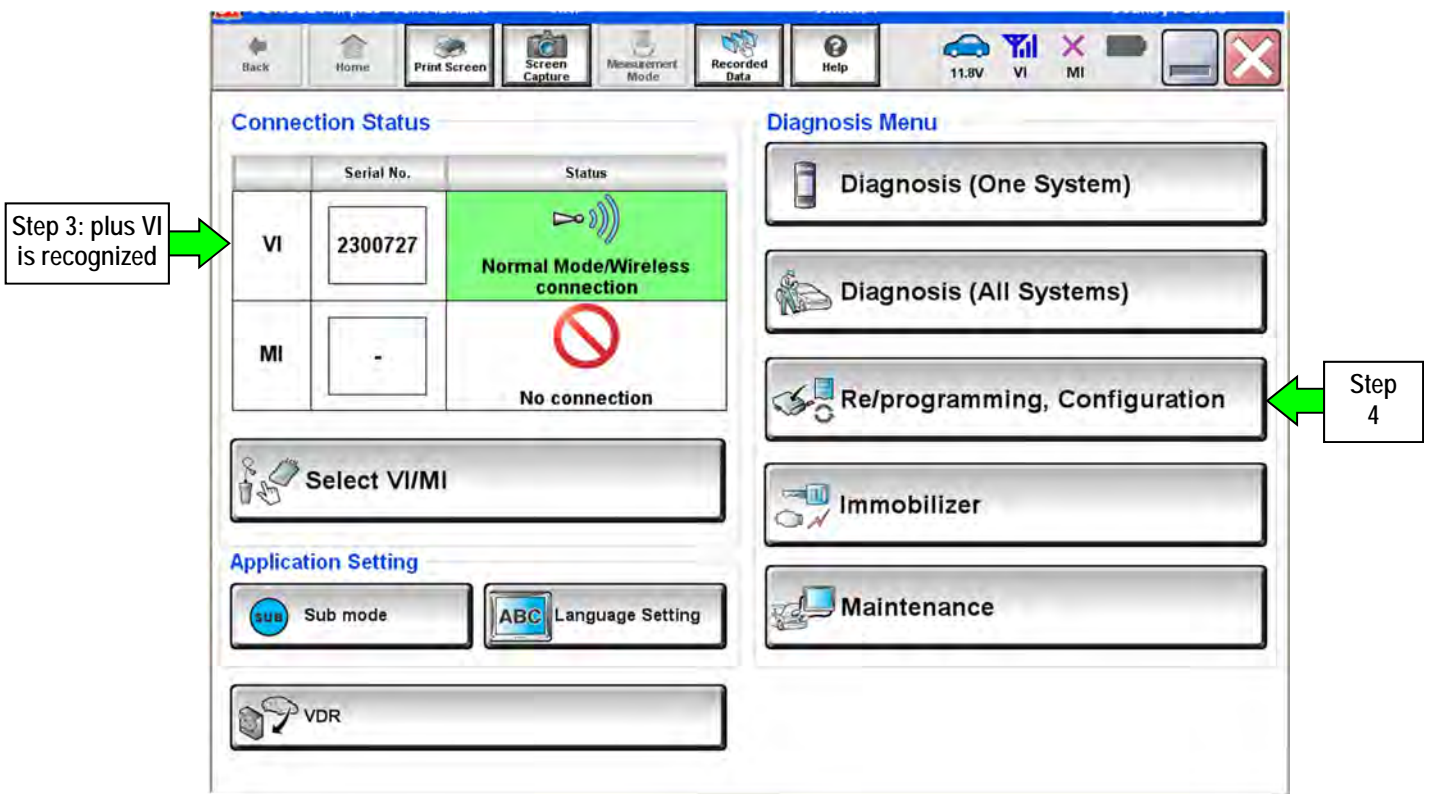
Figure 1

1. Connect the CONSULT PC to the vehicle to begin the reprogramming procedure.
2. Open ASIST on the CONSULT PC and start C-III plus.
3. Wait for the plus VI to be recognized / connected.
 - The serial number will display when the plus VI is recognized / connected.
4. Select Re/programming, Configuration.

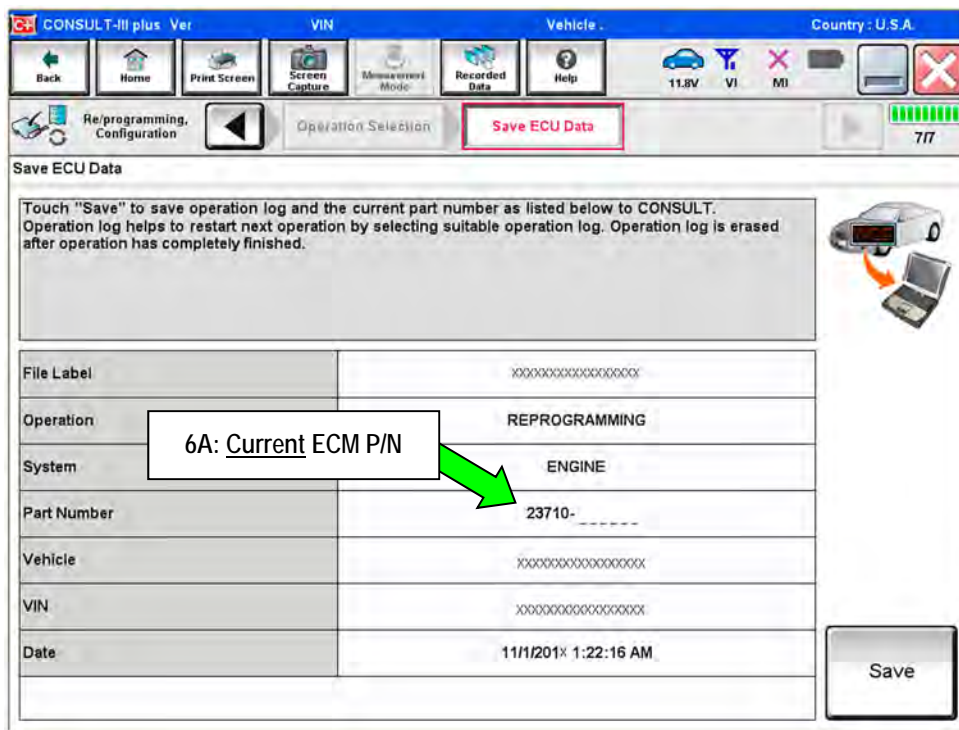
6. When you get to the screen shown in Figure 2, confirm this bulletin applies as follows.

A. Find the ECM Part Number and write it on the repair order.

NOTE: This is the current ECM Part Number (P/N).

5. Follow the on-screen instructions and navigate the C-III plus to the screen shown in Figure 2 on the next page.

B. Compare the P/N you wrote down to the numbers in the Current ECM Part Number column in Table A below.

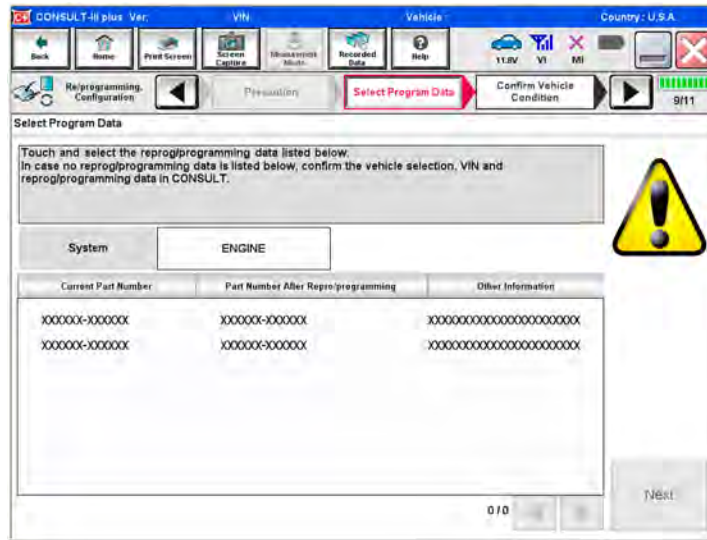
- In some cases, more than one new P/N for reprogramming is available.
 - If more than one new P/N is available, the screen in Figure 3 displays.
 - Select and use the reprogramming option that does **not** have the message "Caution! Use ONLY with ITBXX-XXX".
- If you get this screen and it is **blank** (no reprogramming listed), it means there is no reprogramming available for this vehicle. Close C-III plus and refer back to ASIST for further diagnosis.

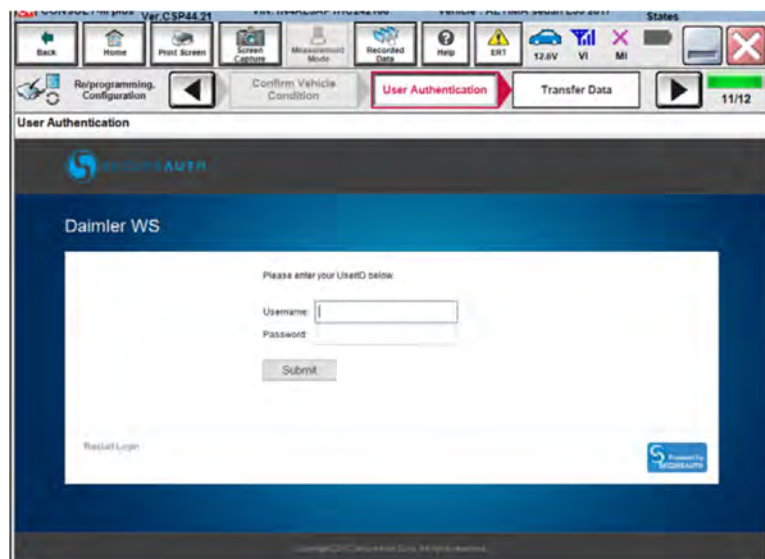
Figure 4

- Before reprogramming will start, you will be required to enter your User Name and Password.
 - The CONSULT PC must be connected to the Internet (Wi-Fi or cable).
 - If you do not know your User Name and Password, contact your Service Manager.

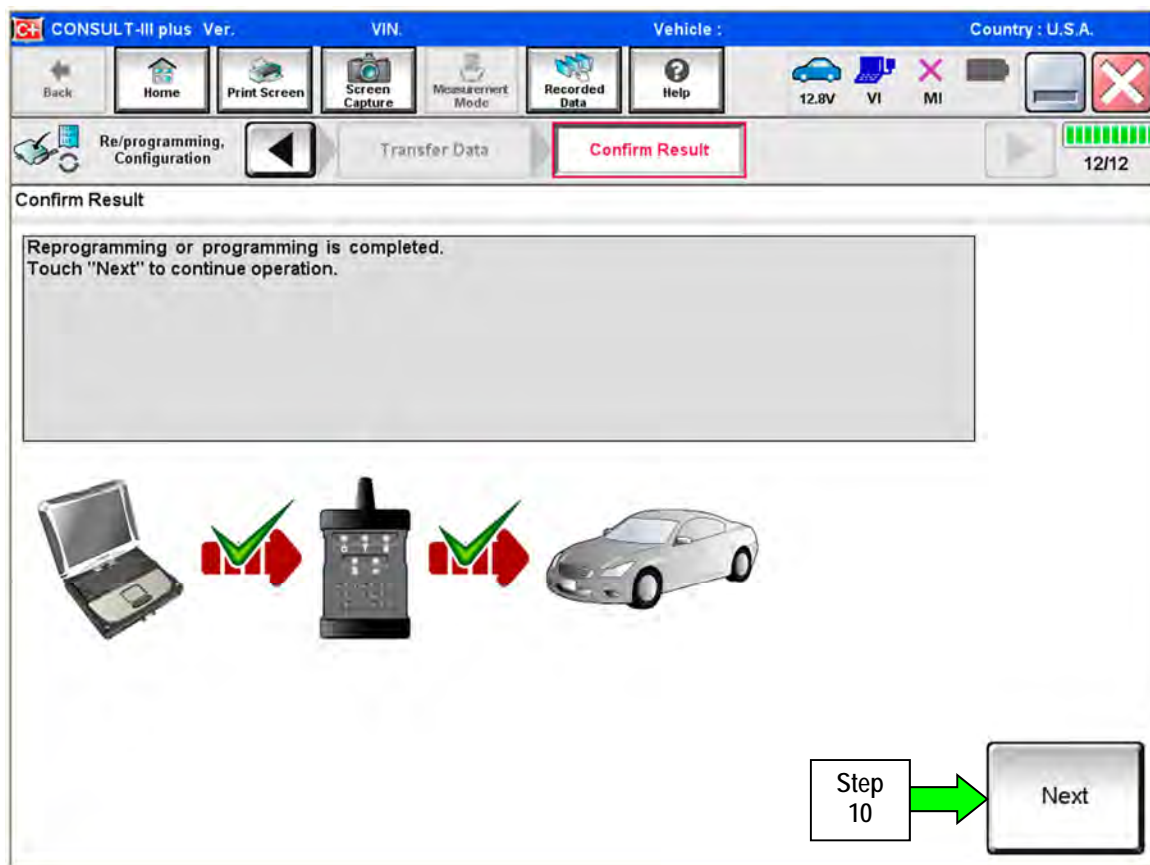
8. When the screen in Figure 5 displays, reprogramming is complete.

NOTE: If the screen in Figure 5 does not display (reprogramming does not complete), refer to the information on the next page.

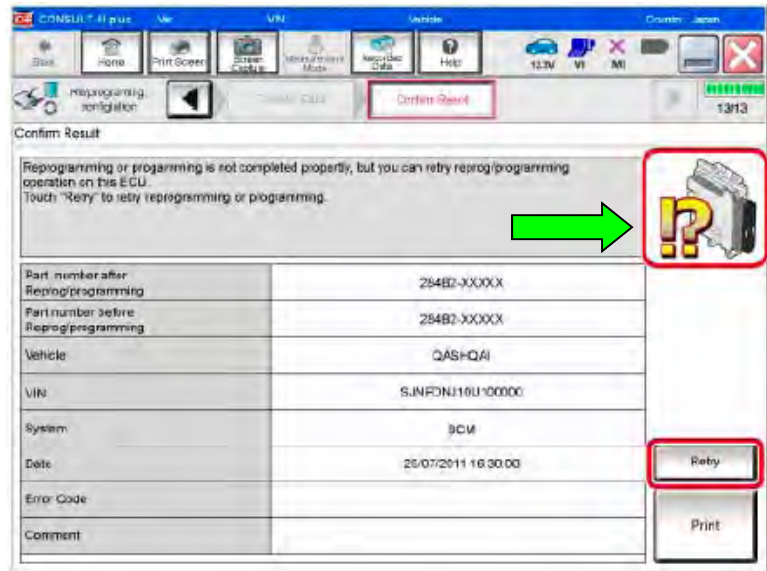
Figure 6

If reprogramming does not complete and the “!” icon displays as shown in Figure 6:

- Check battery voltage (12.0–15.5 V).
- Ignition is ON, engine OFF.
- External Bluetooth® devices are OFF.
- All electrical loads are OFF.
- Select retry and follow the on screen instructions.
- “Retry” may not go through on first attempt and can be selected more than once.

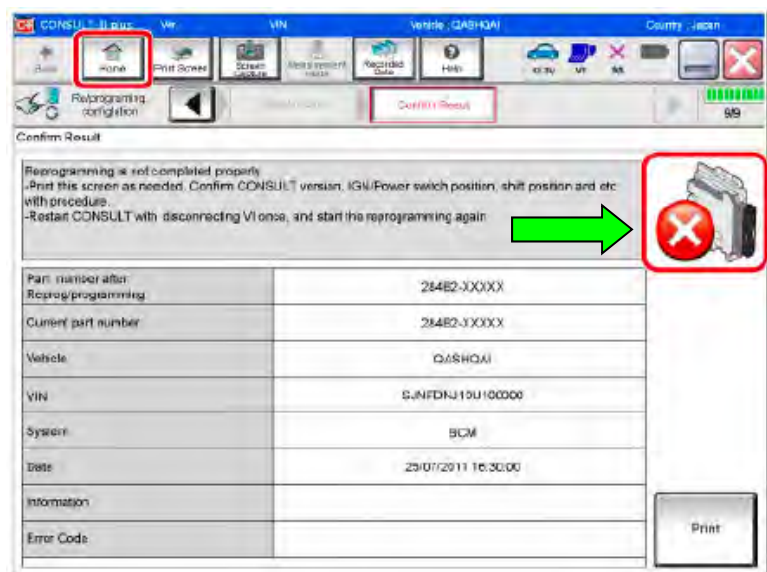
Figure 7

If reprogramming does not complete and the “X” icon displays as shown in Figure 7:

- Check battery voltage (12.0 – 15.5 V).
- CONSULT A/C adapter is plugged in.
- Ignition is ON, engine OFF.
- Transmission is in Park.
- All C-III plus / VI cables are securely connected.
- All C-III plus updates are installed.
- Select Home, and restart the reprogram procedure from the beginning.

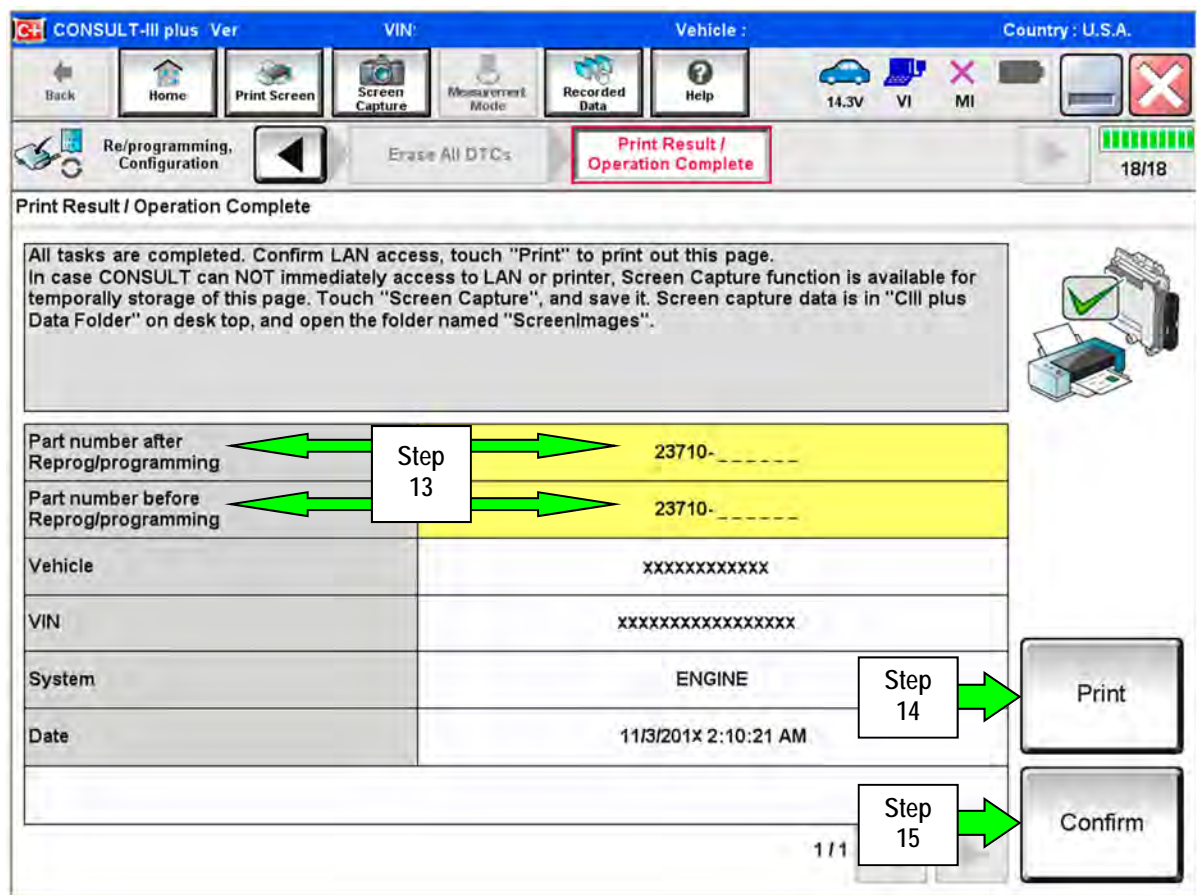
12. When the entire reprogramming process is complete, the screen in Figure 8 will display.
13. Verify the before and after part numbers are different.
14. Print a copy of this screen (Figure 8) and attach it to the repair order for warranty documentation.
15. Select **Confirm**.
