SERVICE BULLETIN

EC17-033

2017 ROGUE SPORT; WHEN COLD LONG CRANK TIME, ENGINE TURNS OFF, HESITATION, ROUGE IDLE, OR MISFIRE

APPLIED VEHICLES: 2017 Rogue Sport (J11)

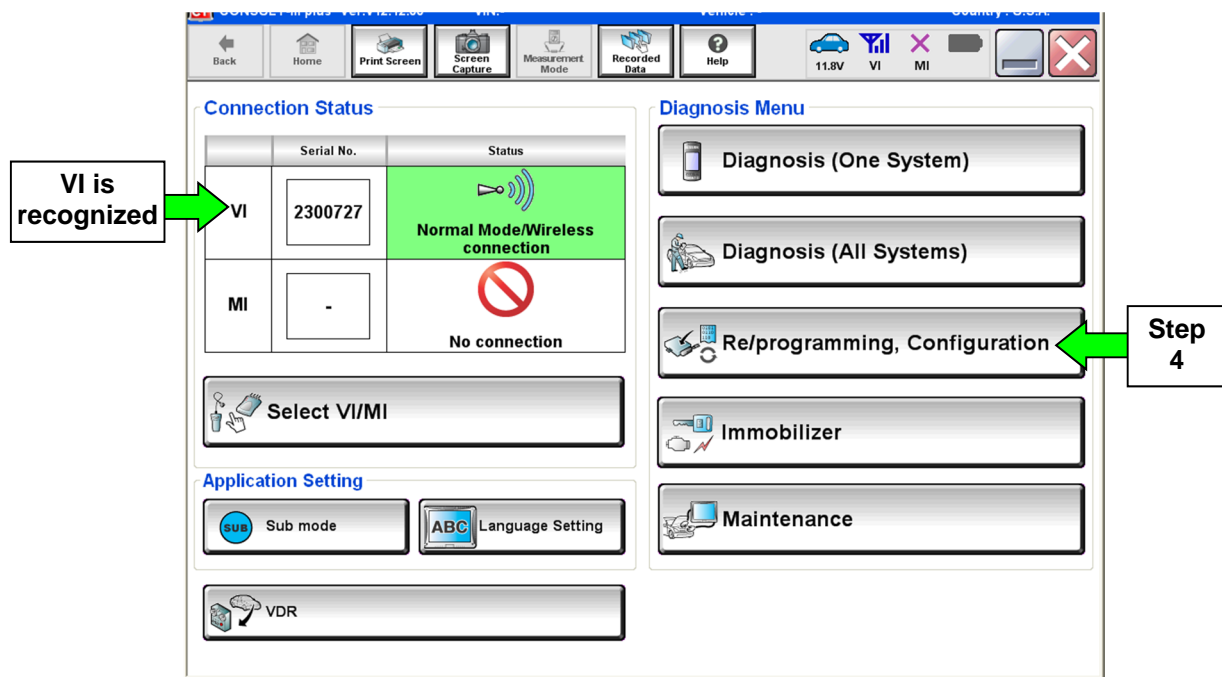
Figure 1

1. Connect the CONSULT PC to the vehicle to begin the reprogramming procedure.
2. Start C-III plus.
3. Wait for the plus VI to be recognized.
 - The serial number will display when the plus VI is recognized.
4. Select **Re/programming, Configuration**.

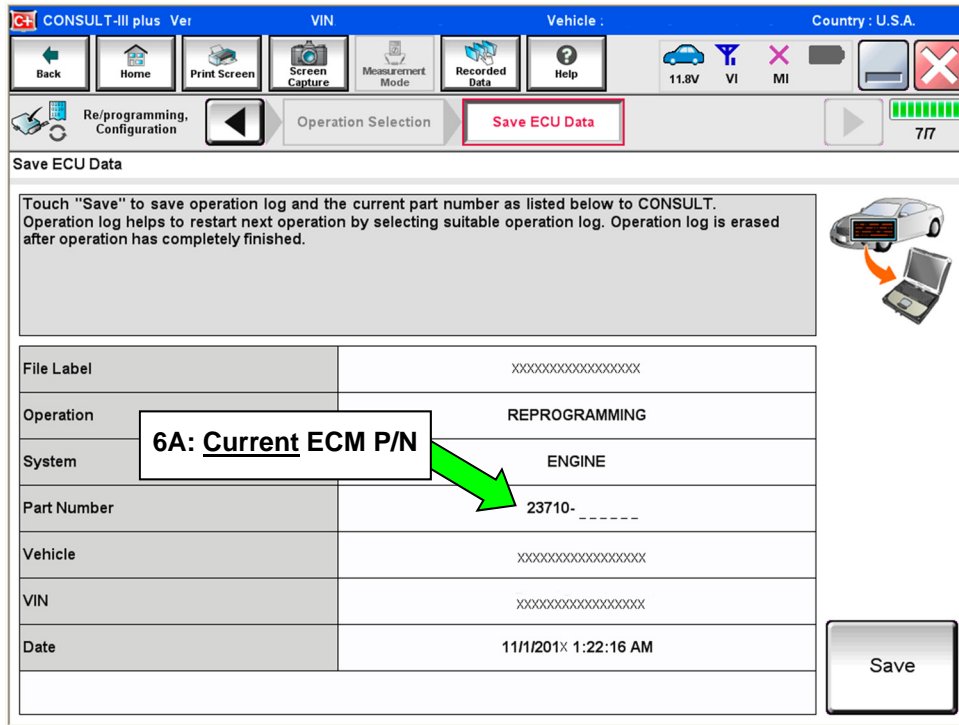
6. When you get to the screen shown in Figure 2, confirm this bulletin applies as follows.

A. Find the ECM **Part Number** and write it on the repair order.

NOTE: This is the current ECM Part Number (P/N).

5. Follow the on-screen instructions and navigate the C-III plus to the screen shown in Figure 2 on the next page.

B. Compare the P/N you wrote down to the numbers in the **Current ECM Part Number** column in **Table A** below.

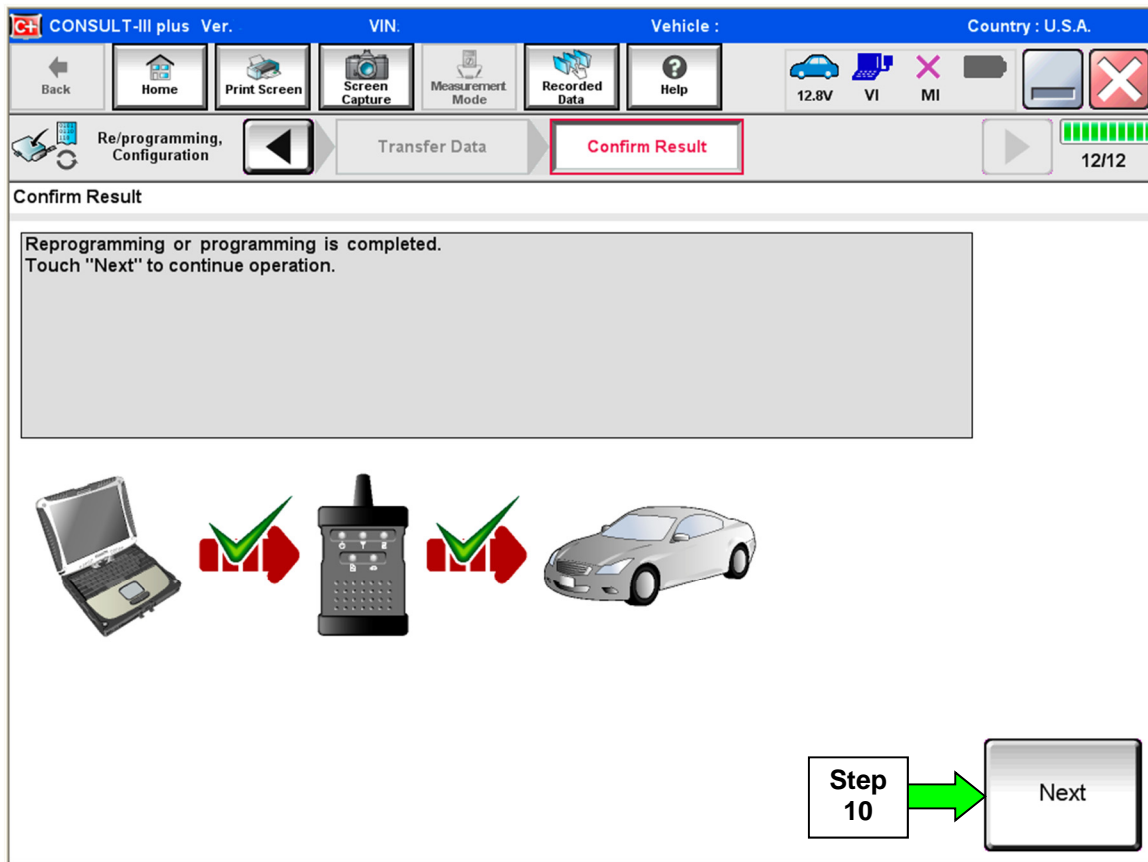
8. When the screen in Figure 4 displays, reprogramming is complete.

NOTE: If the screen in Figure 4 does not display (indicating that reprogramming did not complete), refer to the information on page 7.

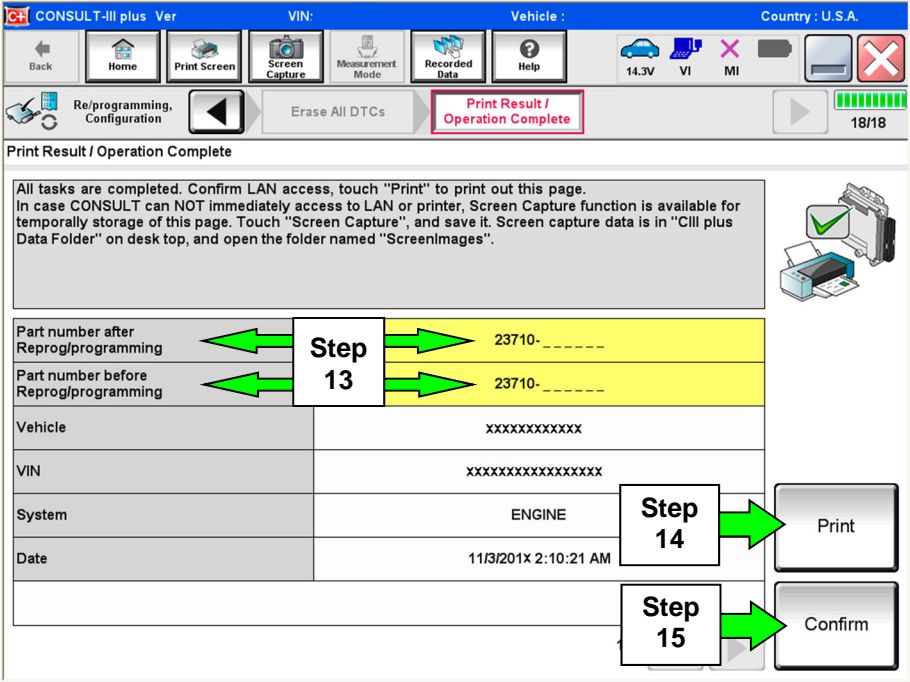
- 12. When the entire reprogramming process is complete, the screen in Figure 7 will display.
- 13. Verify the before and after part numbers are different.
- 14. Print a copy of this screen (Figure 7) and attach it to the repair order for warranty documentation.
- 15. Select **Confirm**.
