SERVICE BULLETIN

2017 ARMADA; FAN COUPLING TICK / KNOCK NOISE IN TEMPERATURES 32°F (0°C) OR BELOW

APPLIED VEHICLES: 2017 Armada (Z62)

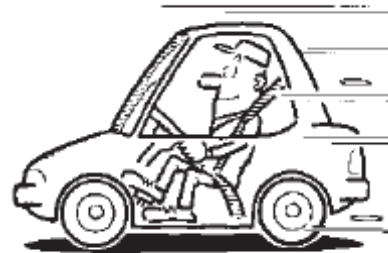
Figure A

- Most instructions for reprogramming with C-III plus are displayed on the CONSULT PC screen.
- If you are not familiar with the reprogramming procedure, *click here*. This will link you to the "CONSULT- III plus (C-III plus) ECM Reprogramming" general procedure.
- Take the vehicle for a 10 minute drive in order to meet the following Idle Air Volume Learn (IAVL) conditions:
 - Engine coolant temperature: 70 -100°C (158 - 212°F)
 - Battery voltage: More than 12.9V (At idle)
 - Transmission: Warmed up

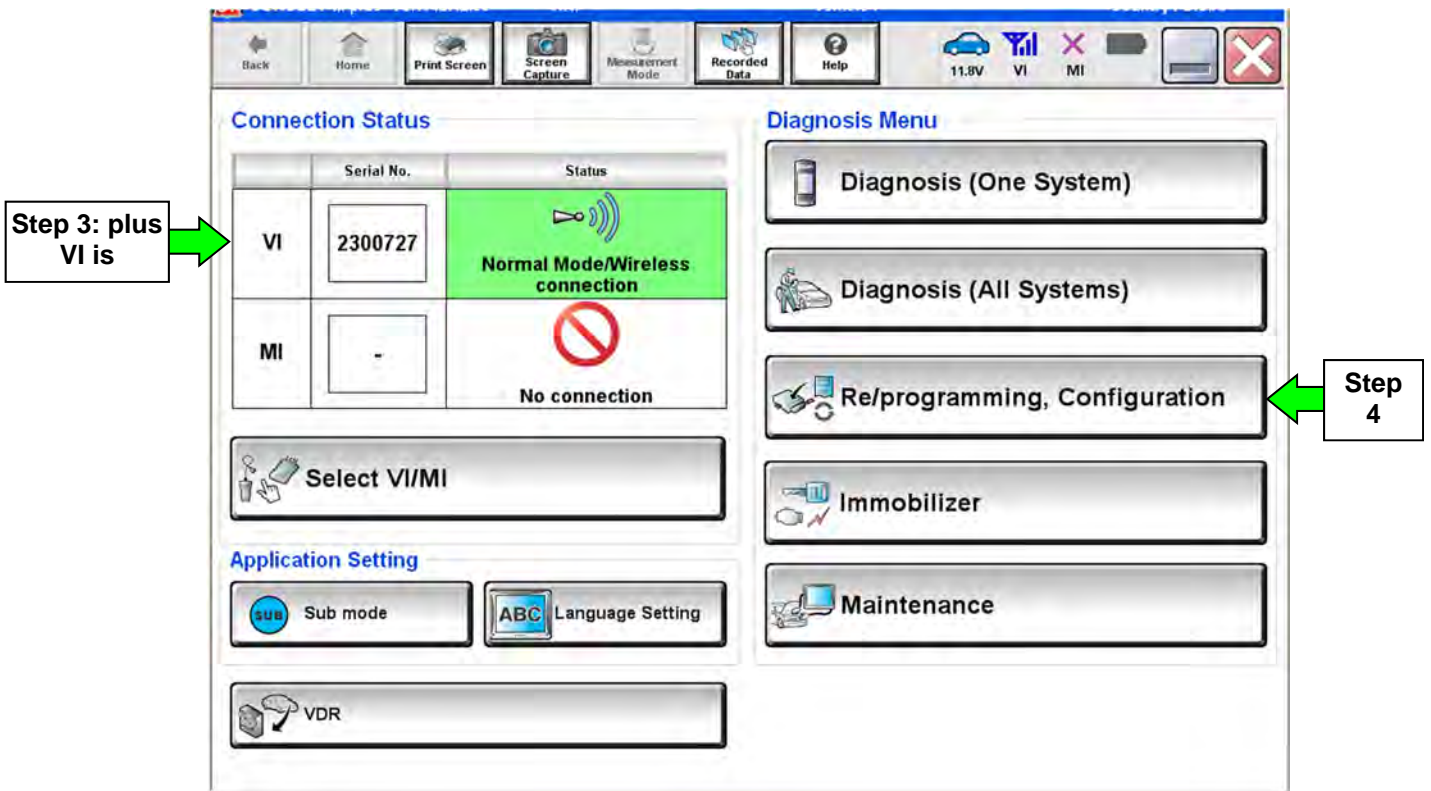
Figure 1

1. Connect the CONSULT PC to the vehicle to begin the reprogramming procedure.
2. Open ASIST on the CONSULT PC and start C-III plus.
3. Wait for the plus VI to be recognized / connected.
 - The serial number will display when the plus VI is recognized / connected.
4. Select **Re/programming, Configuration**.

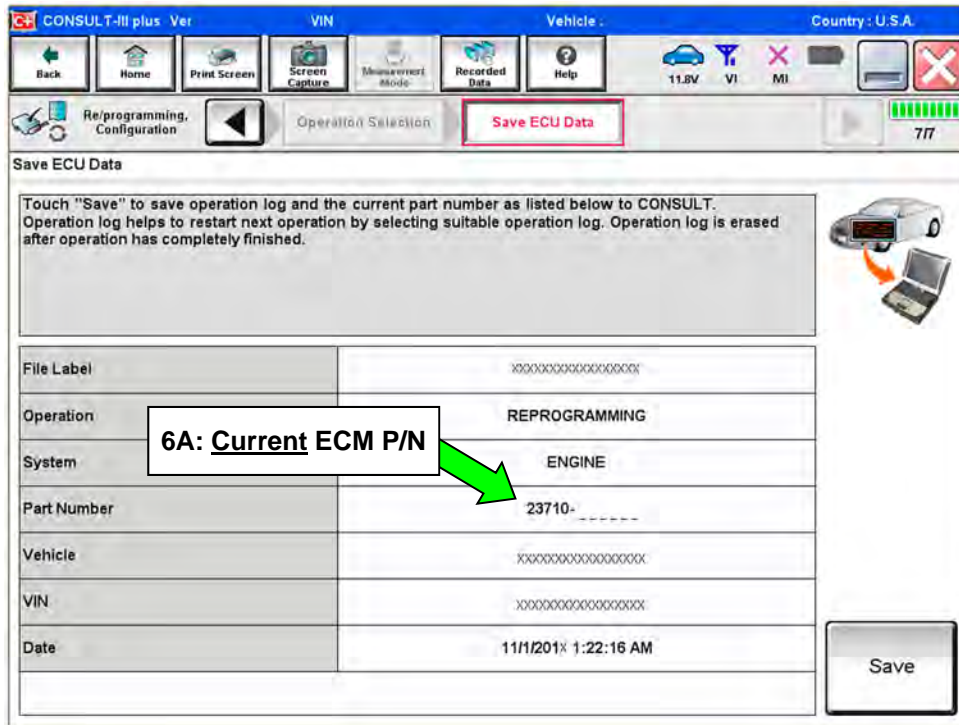
6. When you get to the screen shown in Figure 2, confirm this bulletin applies as follows.

A. Find the ECM Part Number and write it on the repair order.

NOTE: This is the current ECM Part Number (P/N).

5. Follow the on-screen instructions and navigate the C-III plus to the screen shown in Figure 2 on the next page.

B. Compare the P/N you wrote down to the numbers in the Current ECM Part Number column in Table A below.

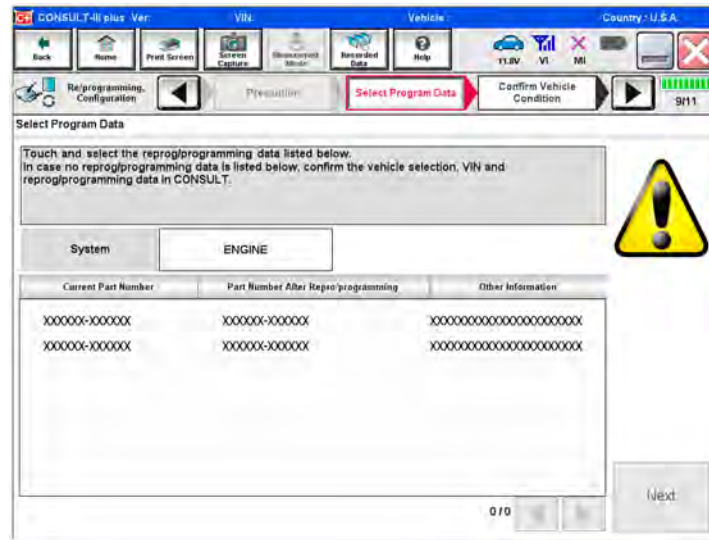
- In some cases, more than one new P/N for reprogramming is available.
 - If more than one new P/N is available, the screen in Figure 3 displays.
 - Select and use the reprogramming option that does **not** have the message “Caution! Use ONLY with NTBXX-XXX”.
- If you get this screen and it is blank (no reprogramming listed), it means there is no reprogramming available for this vehicle. Close C-III plus and refer back to ASIST for further diagnosis.

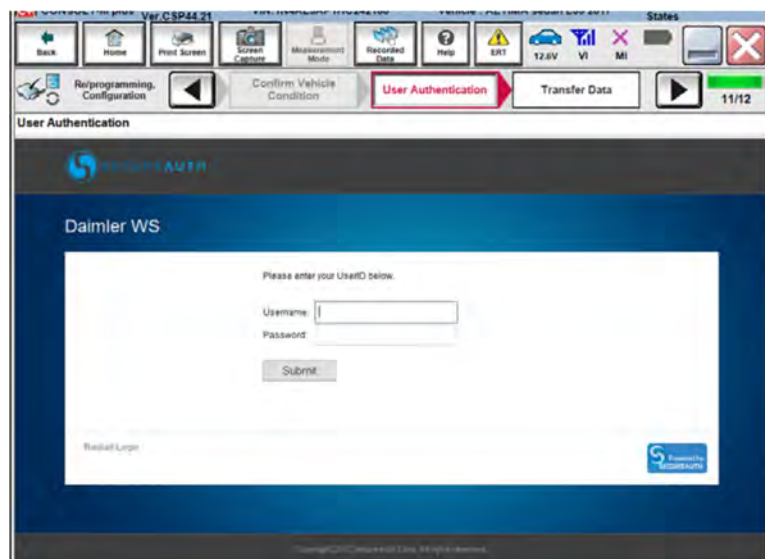
Figure 4

- Before reprogramming will start, you will be required to enter your User Name and Password.
 - The CONSULT PC must be connected to the Internet (Wi-Fi or cable).
 - If you do not know your User Name and Password, contact your Service Manager.

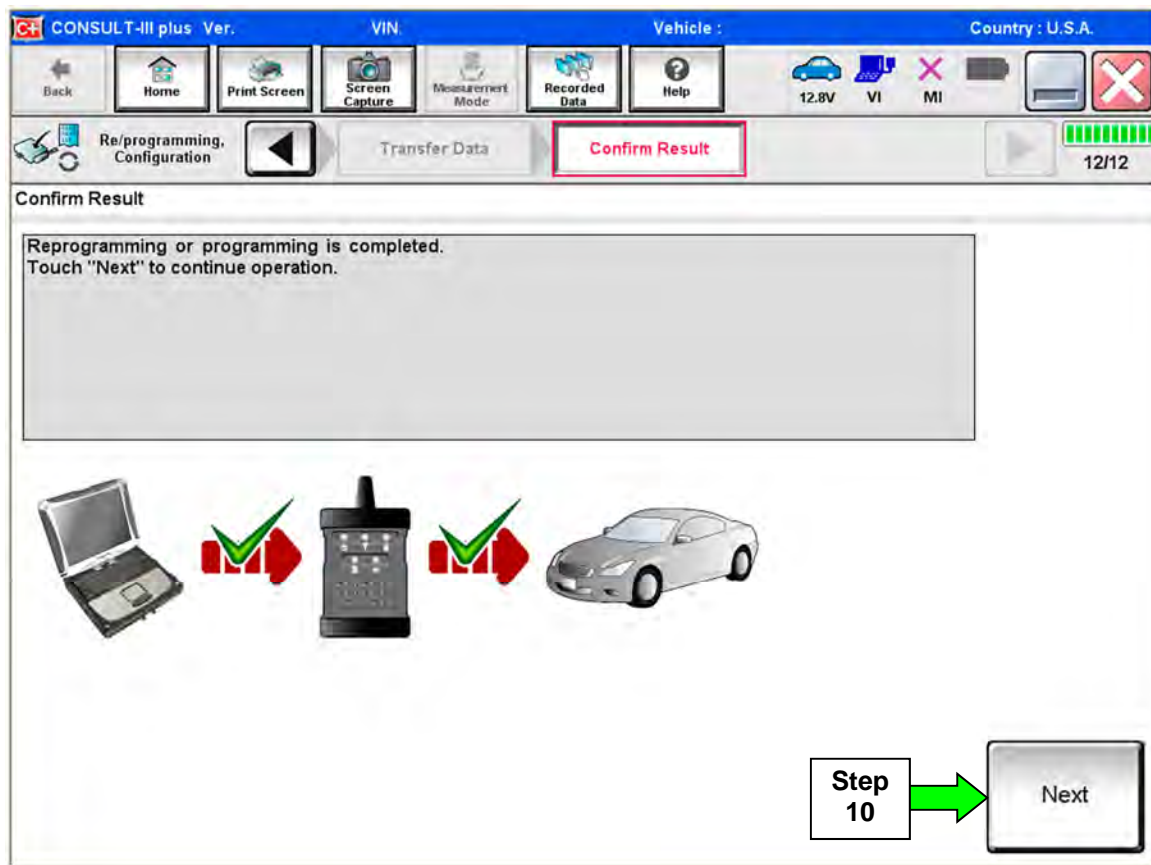
8. When the screen in Figure 5 displays, reprogramming is complete.

NOTE: If the screen in Figure 5 does not display (reprogramming does not complete), refer to the information on the next page.

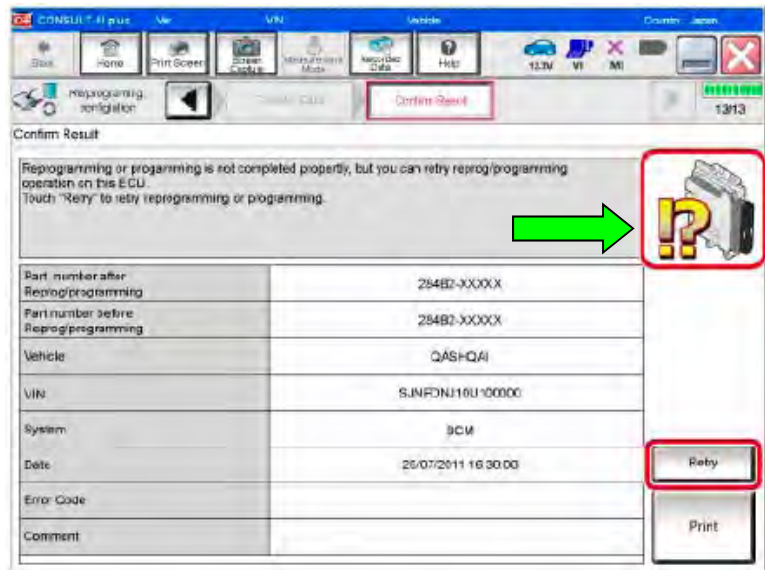
Figure 6

If reprogramming does not complete and the “!” icon displays as shown in Figure 6:

- Check battery voltage (12.0–15.5 V).
- Ignition is ON, engine OFF.
- External Bluetooth® devices are OFF.
- All electrical loads are OFF.
- Select retry and follow the on screen instructions.
- “Retry” may not go through on first attempt and can be selected more than once.

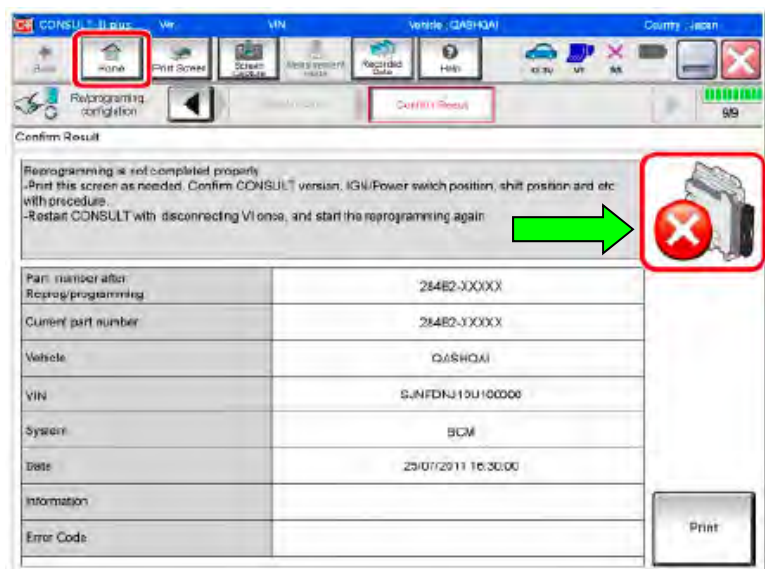
Figure 7

If reprogramming does not complete and the “X” icon displays as shown in Figure 7:

- Check battery voltage (12.0 – 15.5 V).
- CONSULT A/C adapter is plugged in.
- Ignition is ON, engine OFF.
- Transmission is in Park.
- All C-III plus / VI cables are securely connected.
- All C-III plus updates are installed.
- Select Home, and restart the reprogram procedure from the beginning.

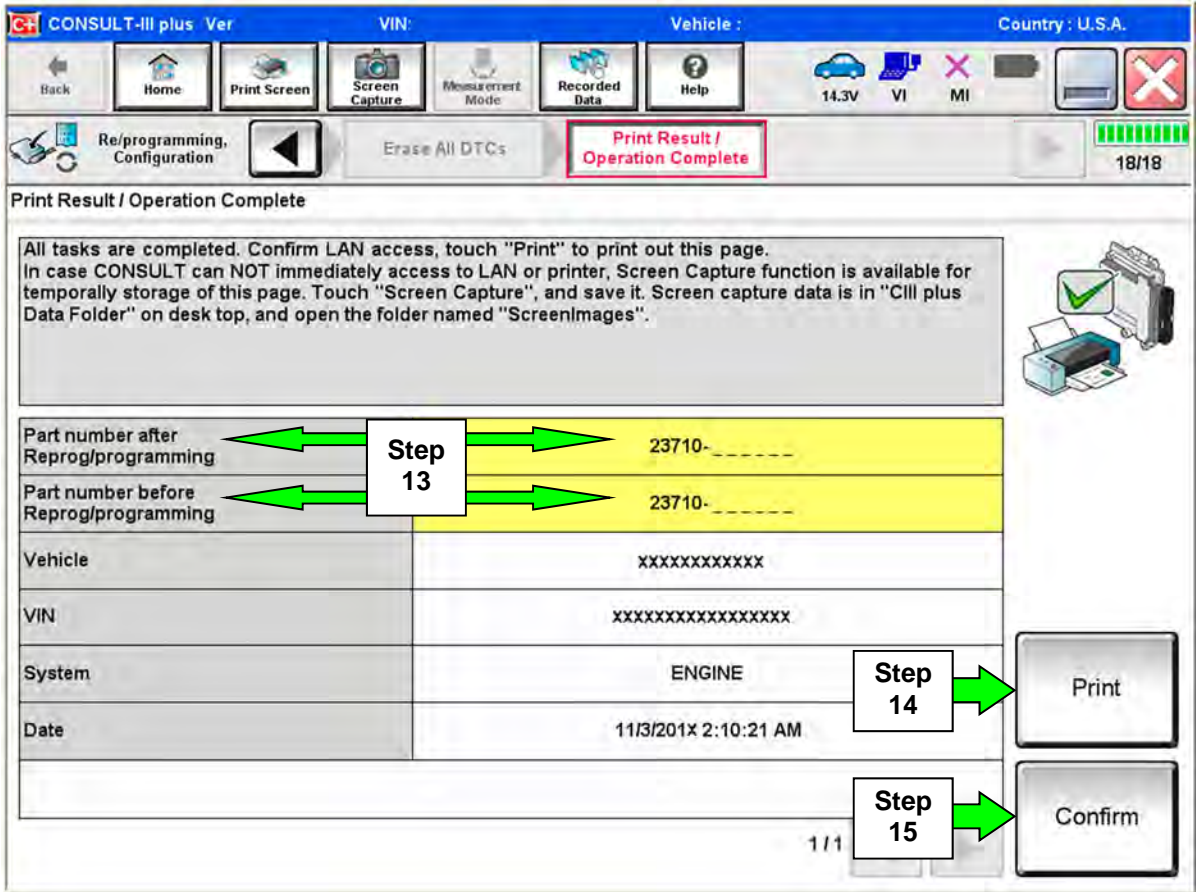
- 12. When the entire reprogramming process is complete, the screen in Figure 8 will display.
- 13. Verify the before and after part numbers are different.
- 14. Print a copy of this screen (Figure 8) and attach it to the repair order for warranty documentation.
- 15. Select **Confirm**.
