WH05 - Performing PCM Software Update (Workshop Campaign)

Model Year: 2017

Model Line: Cayenne (92A)
Macan (95B)
718 Boxster/Cayman (982)
911 (991)

Subject: Porsche Communication Management (PCM) 4.0

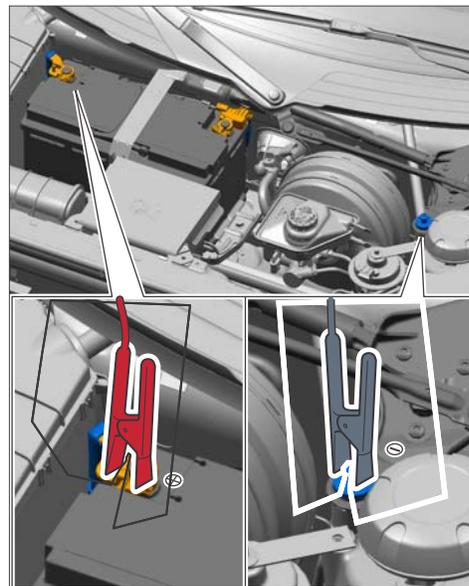
External power connection

- Work Procedure: 1 Connect battery charger.
First connect the positive cable of the charger to the positive terminal of the battery and then connect the negative cable of the charger to the ground point for jump-lead starting ⇒ *External power connection*.
Then switch on the charger and start trickle charging.
- 2 Switch on the ignition using the **original driver's key**. For vehicles with "Porsche Entry & Drive", replace the control panel in the ignition lock with the original driver's key, if necessary.

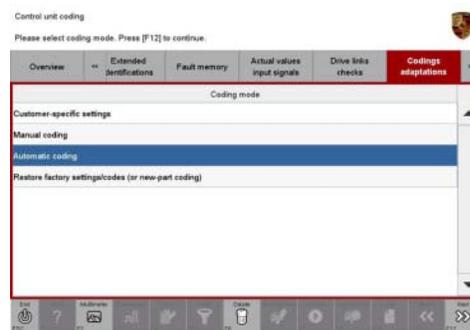
Automatic coding

- 2 Select the '**Automatic coding**' function and press •F12“ (“Next”) to start coding ⇒ *Automatic coding*.

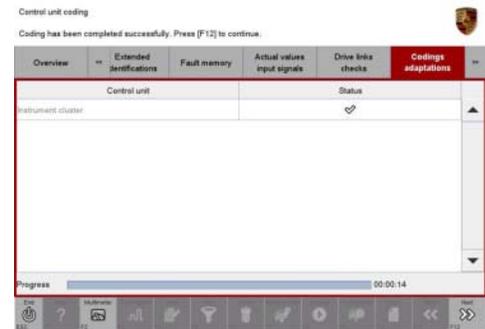
Coding successful

- When coding is complete, the message "Coding has been completed successfully" is displayed and a tick appears in the 'Status' box ⇒ *Coding successful*.

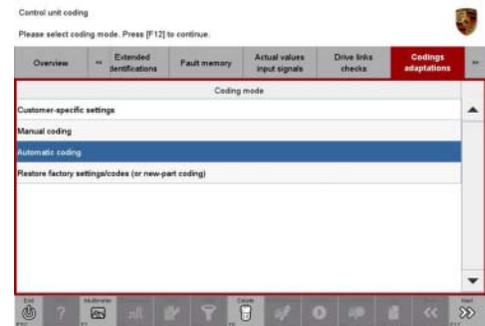
Automatic coding

- Work Procedure:
- Select the **External amplifier** control unit in the control unit selection screen ('Overview' menu) and press •F12" ("Next") to confirm your selection.
 - Call up the '**Coding/programming**' menu.
 - Select the '**Automatic coding**' function and press •F12" ("Next") to start coding ⇒ *Automatic coding*.

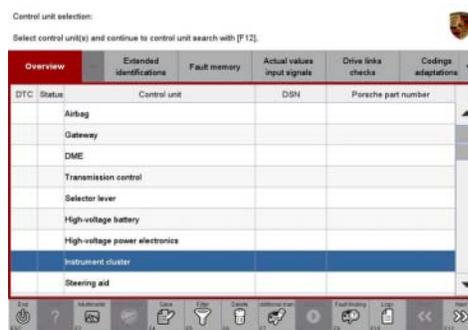
Control unit selection – Instrument cluster

- Work Procedure: 1 Using the PIWIS Tester, select **'Instrument cluster'** in the control unit selection screen (**'Overview'** menu) and press •F12" ("Next") to confirm your selection ⇒ *Control unit selection – Instrument cluster.*
- 2 Once the instrument cluster has been found and is displayed in the overview, select the **'Coding/programming'** menu.

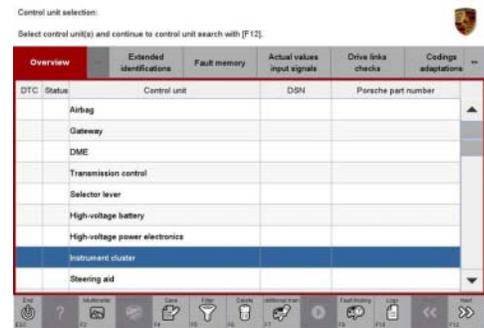
Control unit selection – Instrument cluster

- Work Procedure: 1 Using the PIWIS Tester, select '**Instrument cluster**' in the control unit selection screen ('**Overview**' menu) and press •F12" ("Next") to confirm your selection ⇒ *Control unit selection – Instrument cluster*.
- 2 Once the instrument cluster has been found and is displayed in the overview, select the '**Coding/programming**' menu.

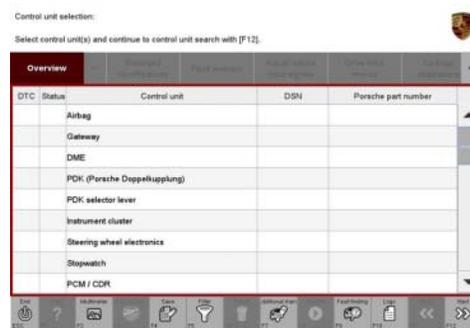
Control unit selection

- 1.1 In the control unit selection screen ('Overview' menu), press •F7" to call up the 'Additional menu' (⇒ Control unit selection).
- 1.2 Select the function "Read all fault memories and erase if required" and press •F12" ("Next") to confirm your selection ⇒ Erasing fault memories.

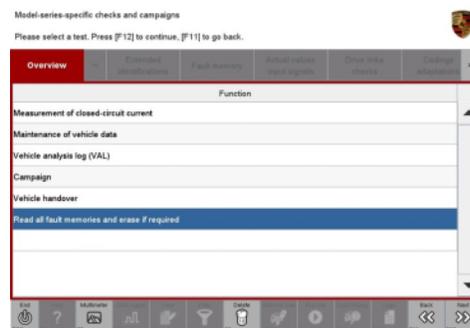
Erasing fault memories

- 1.4 Press •F8" to delete fault memory entries.
- 1.5 Press •F12" ("Yes") in response to the question as to whether you really want to delete all fault memory entries.
