Emissions Recall

Code: 23Q3

Subject	2.0L TDI Engine (GEN 3) Emissions Control Software – <u>USA ONLY</u>											
Release Date	July 14, 2017											
Revision Summary	Updated work instructions.											
Affected Vehicles	U.S.A.: 2015 MY Volkswagen 2.0L TDI (Gen 3)

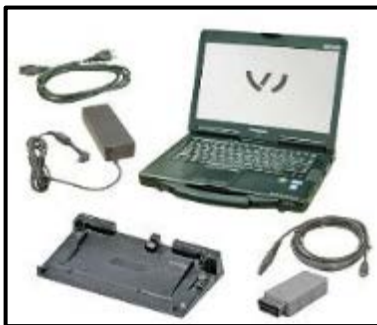
- VAS6150X – Diagnostic Tester (or equivalent)
- VAS5054X – Remote Diagnosis Head (or equivalent)

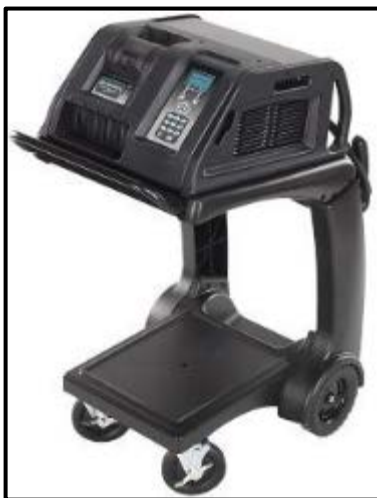
- GRX3000VAS – Battery Tester/Charger

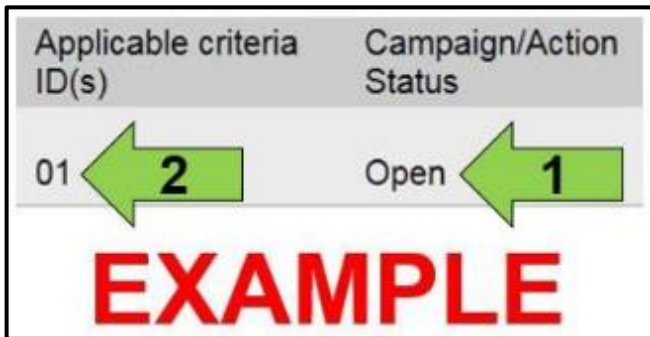
- Enter the VIN in Elsa and proceed to the “Campaign/Action” screen.

- Confirm the Campaign/Action is open <arrow 1>. If the status is closed, no further work is required.
- Note the Applicable Criteria ID <arrow 2> for use in determining the correct work to be done and corresponding parts associated.
- Check for other Open campaign actions <arrow>.
- Other Open campaign actions must be completed prior to releasing the vehicle to the customer.

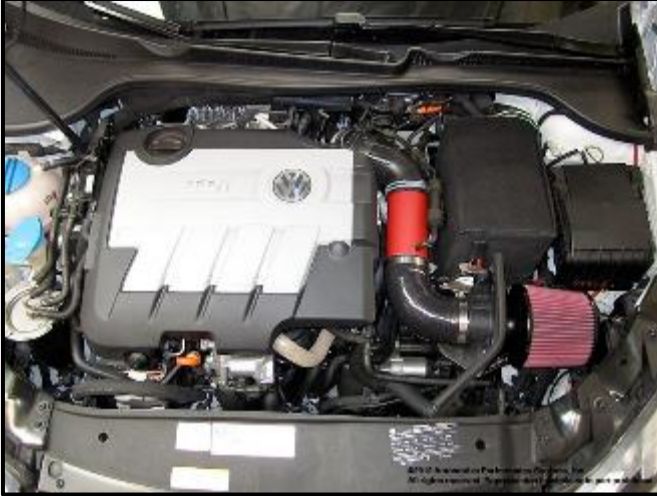
- Perform a visual inspection of the intake, exhaust, and emissions systems.
 - If the visual inspection of the intake, exhaust, or emissions equipment reveals damage or concerns, **STOP**, create a VTA ticket and contact the Volkswagen Technicians Helpline.
 - If the visual inspection of the intake, exhaust, or emissions equipment reveals no damage or concerns, continue the work procedure.

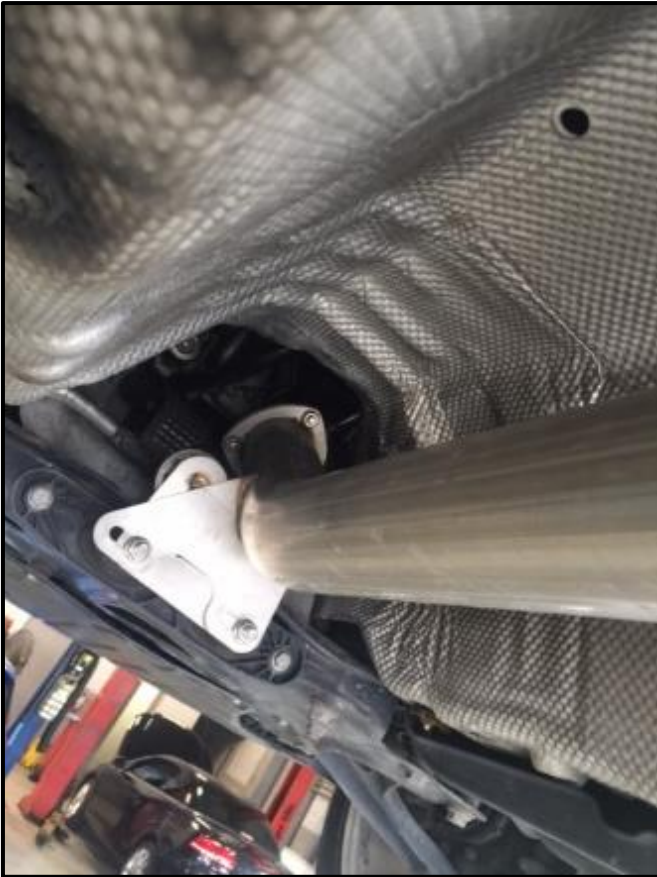
- Check for vehicle modifications from original equipment.
 - If vehicle modifications from original equipment related to emissions components are found, **STOP**, create a VTA ticket and contact the Volkswagen Technicians Helpline.
 - If vehicle modifications from original equipment related to emissions components are not found, continue the work procedure.

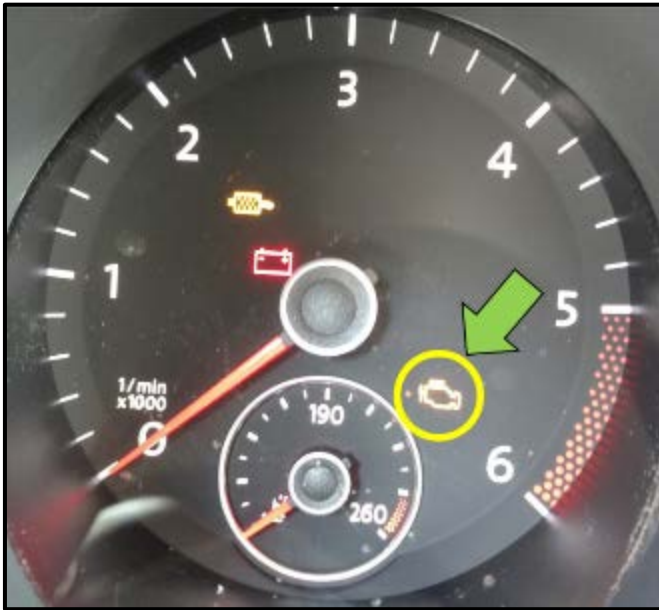
- Check for illumination of the MIL <arrow>.
 - If MIL is illuminated, **STOP**, create a VTA ticket and contact the Volkswagen Technicians Helpline.
 - If MIL is not illuminated, continue the work procedure.

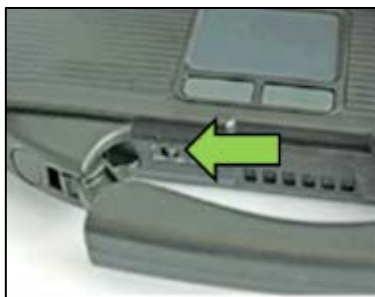
VAS 6150 & VAS 6150A
(Front panel behind handle)

- Performing a software update using a Bluetooth connection increases the risk of losing connection during the update, which could result in damage to the control module. It also greatly increases the time required to perform the update. Requests for additional time or parts will be denied if the GFF log shows the update was performed using Bluetooth.
- ✓ **The Bluetooth function of the scan tool is physically switched off <see pictures below>.**

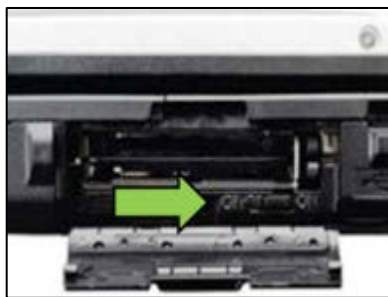
VAS 6150B
(Right side behind WIRELESS door)

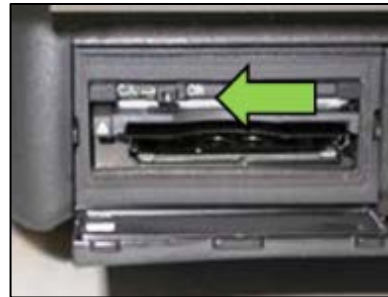
VAS 6150C
(Left side behind SC/EX door)

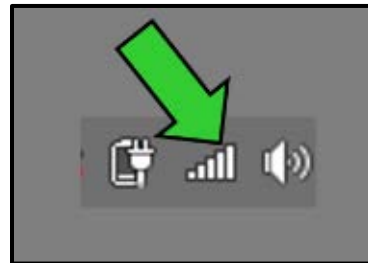
- ✓ Check the icon <arrow> within the ODIS software that you have a connection.

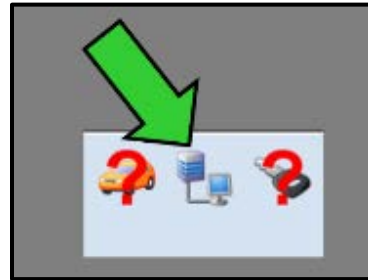
- ✓ Within the Connection Tab, verify that the Connection type(s) display "Internet" <as shown>.

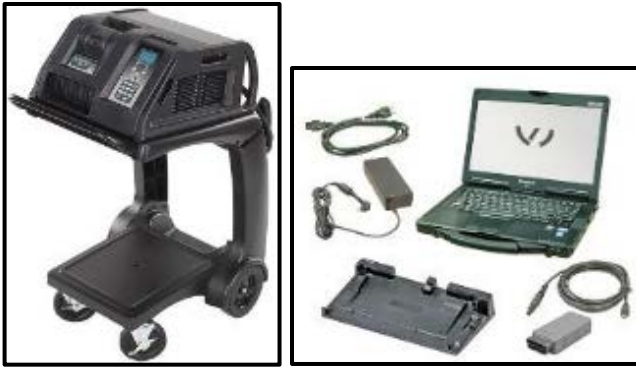
- Open the hood.
- Open the battery cover.
- Attach the GRX3000VAS Tester/Charger (or equivalent) to the vehicle battery.
- Switch the ignition on.
- Apply the parking brake.
- Switch the headlights off.
- Connect the VAS6150X Diagnostic Tester (or equivalent) to the vehicle.
- Start the ODIS program.

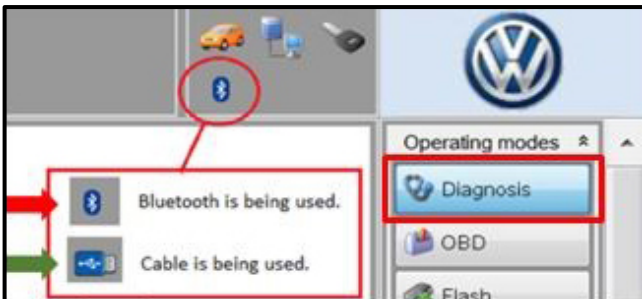
- Confirm that scan tool is communicating with the diagnostic head by USB <Green Arrow>.
 - If the Bluetooth symbol is shown <Red Arrow> then disconnect the diagnostic head from the vehicle and reconnect the USB cable to the diagnostic head and then reattach to the vehicle.
- Upon ODIS startup, verify the “Diagnosis” operating mode is selected <as shown>.

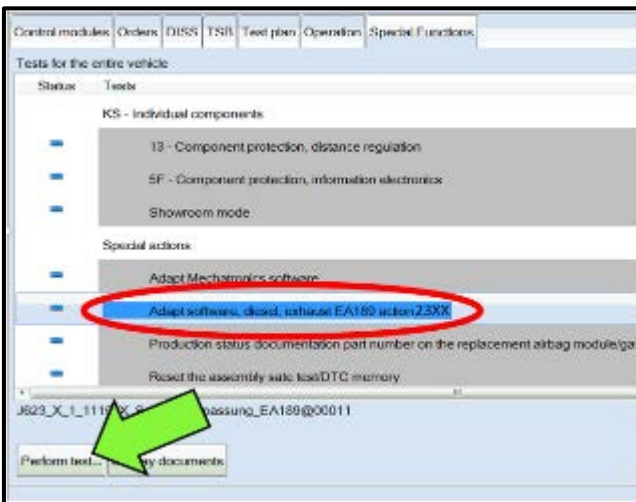
- Once the GFF scan is complete, select “Special functions”.
- Select the test plan “**Adapt software, diesel, exhaust EA189 action 23XX**” <as shown>.
- Select “Perform test” <arrow>.

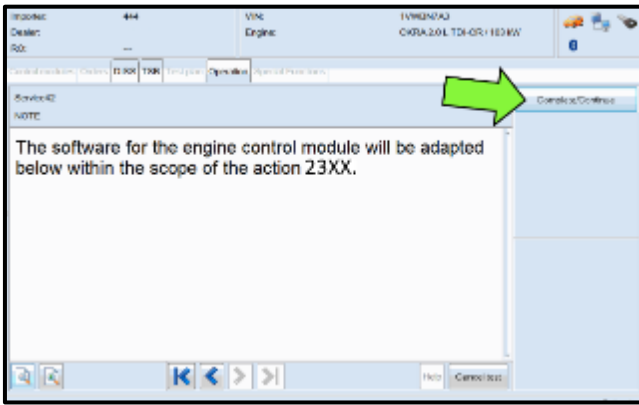
- Select “Complete/Continue” <arrow> after the control module adaptation, action 23XX note appears.

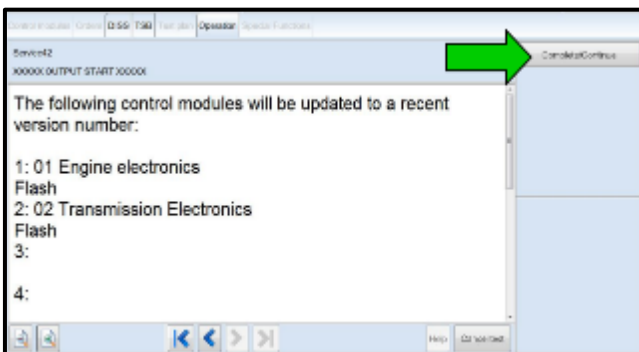
- Select “Complete/Continue” <arrow> to begin the software update process.

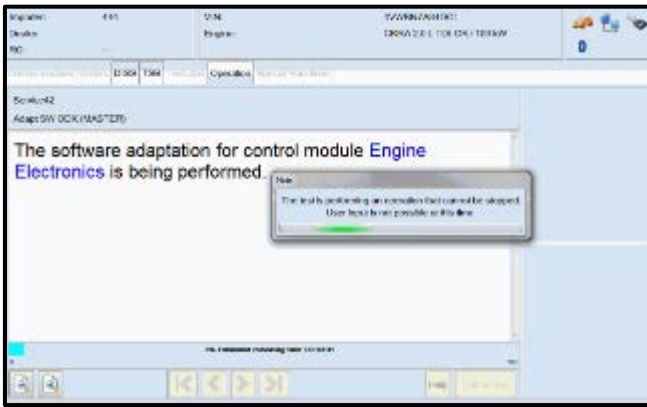
- Observe flash process and follow any on-screen prompts to complete the test plan.

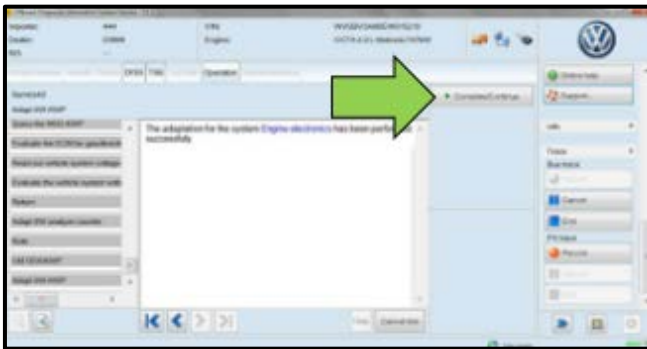
- When the SVM update is complete a confirmation message is displayed <as shown>.
- Select "Complete/Continue" <arrow>.

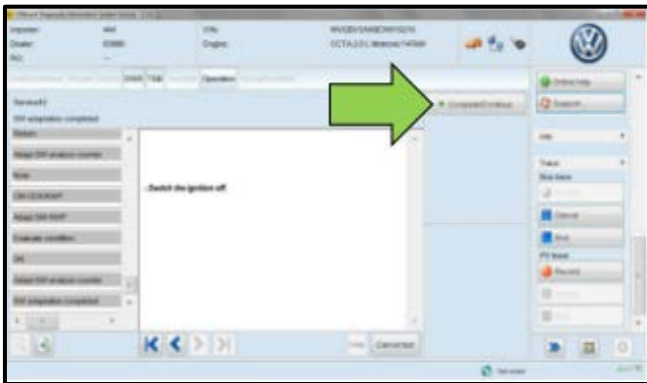
- Switch the ignition off, then select "Complete/Continue" <arrow>.

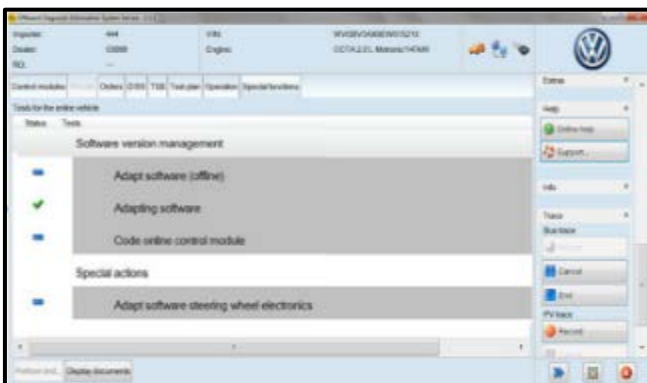
- The green check mark indicates the test plan was successfully carried out.

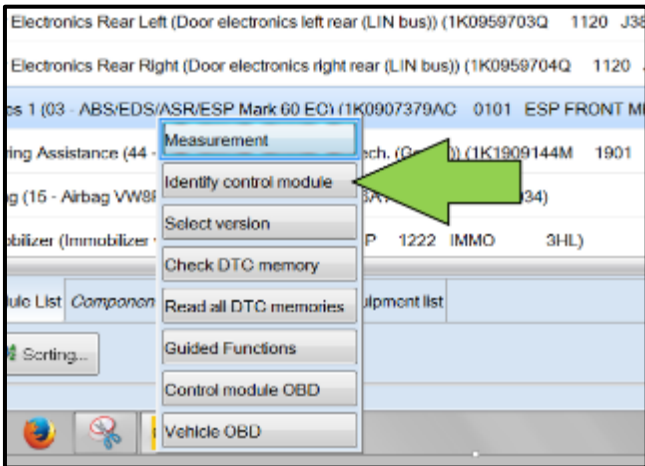
- After the software update is completed and before sending the GFF Log Online:
 - Select the "Control Module" tab.
 - Scroll down and right click on Address Word 0001/ Engine Control Module.
 - Select "Identify Control Module" <arrow>.

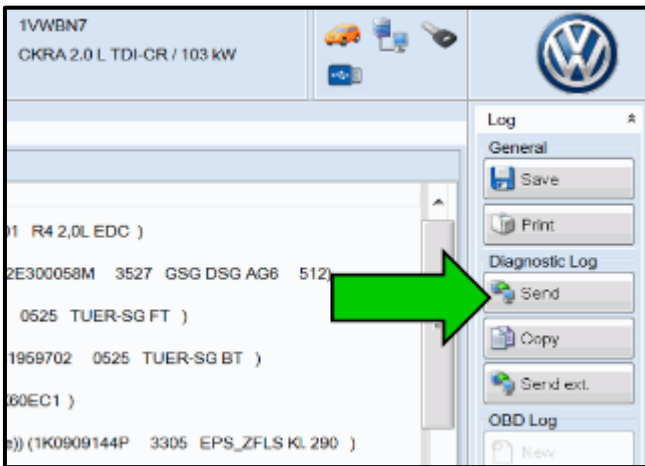
- At the end of the diagnostic session, Select "Send" <arrow> and follow the prompt for sending the log on-line.

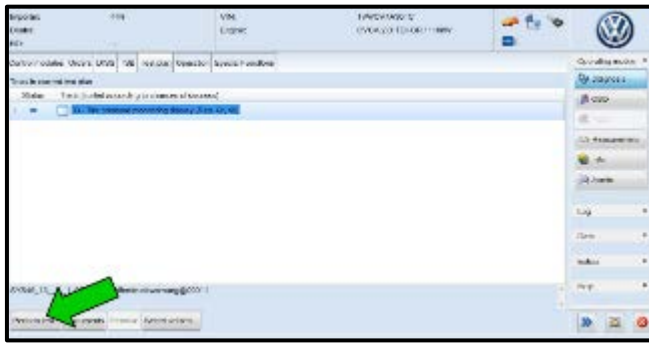
It is possible after the flash that the TPMS light may be illuminated. Follow test plan "03 – Tire pressure monitoring display" <as shown>.

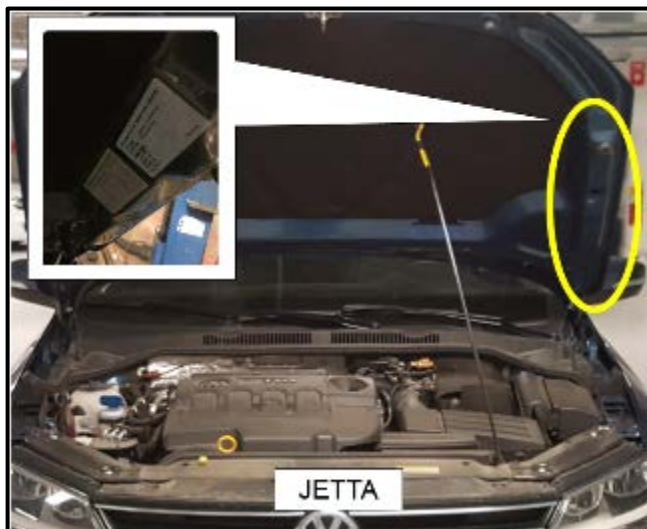
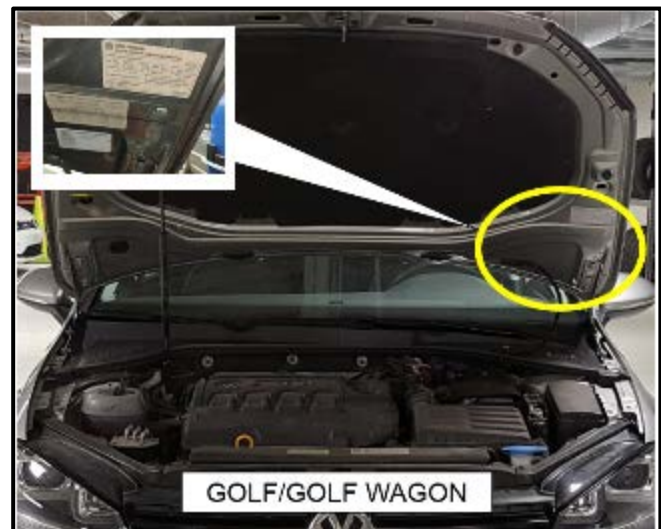
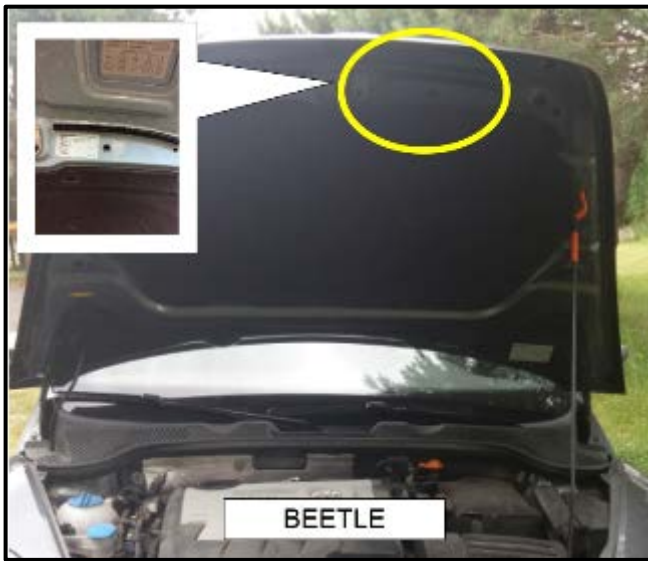
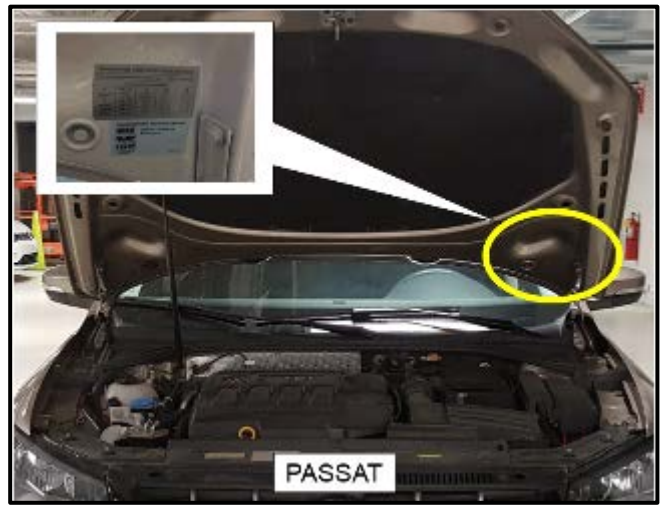
- See Examples of properly installed labels on the next page:

New Vehicle Emissions Control Information (VECI) label MUST NOT be placed over original VECI label.

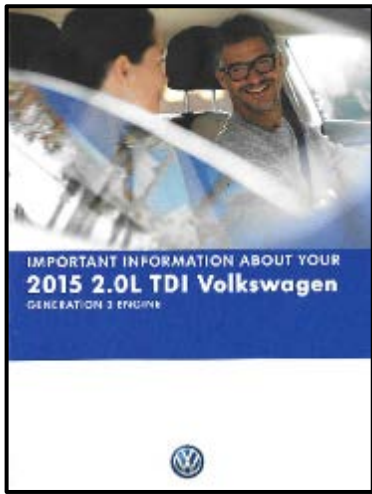
- Open glove box and insert the 2015 2.0L TDI (Generation 3) Information Packet <pictured left>.

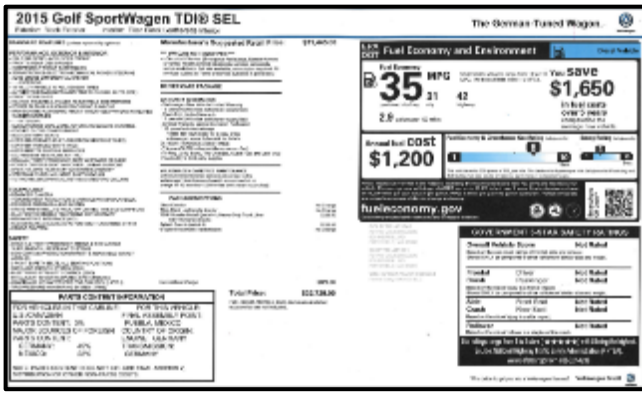
- Remove original Monroney Label and discard.
- Install new Monroney Label <example pictured left> on the rear passenger side window <example pictured below>.

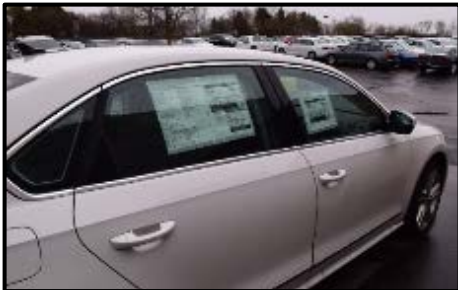
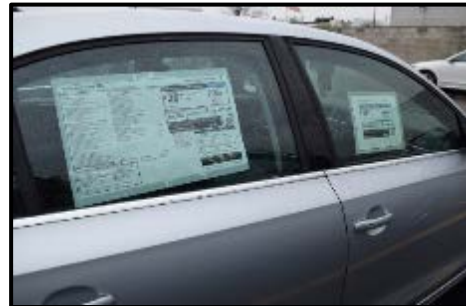
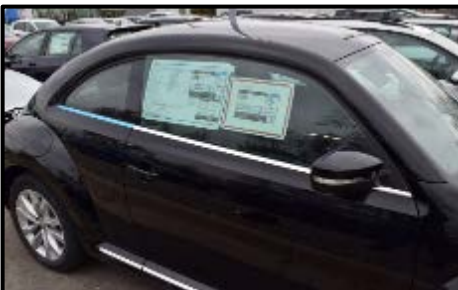
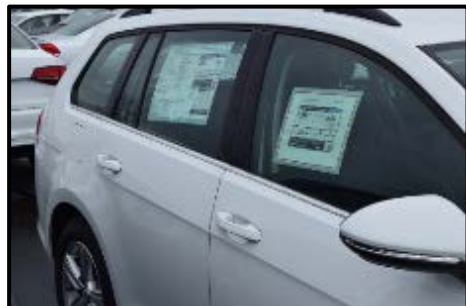
Examples of properly Installed Monroney and Fuel Economy Labels <pictured below> on various vehicle models.

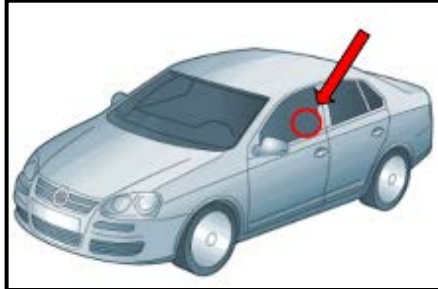
- Place the “more information” permanent window sticker <pictured left> on the front driver-side window in the lower right corner of the window <arrow>. Install the sticker from the inside of the window.
 - Affix the “more information” sticker to the front driver-side window as necessary either above, beside, or under any other required State and/or Local Labels (example, California Prop 65).
