Emissions Recall

Code: 23U4

Subject	2.0L TDI Engine (GEN 2 – Automatic Transmission) Emissions Modification – Customer Only (Retail Sold) <u>USA ONLY</u>
Release Date	July 12, 2017
Revision Summary	One day loaner available for repairs over three hours. Claim entry instructions updated.
Repair Applicability	The ONLY Vehicles eligible for repair under this action are: <ul style="list-style-type: none">• Customer owned automatic transmission vehicles only
Affected Vehicles	U.S.A. ONLY: 2012-2014 MY Volkswagen Passat 2.0L TDI (Automatic Transmission only) <i>Check Campaigns/Actions screen in Elsa on the day of repair to verify that a VIN qualifies for repair under this action. Elsa is the <u>only</u> valid campaign inquiry & verification source.</i> <ul style="list-style-type: none">✓ Campaign status must show “open.”✓ If Elsa shows other open action(s), inform your customer so that the work can also be completed at the same time the vehicle is in the workshop for this campaign.

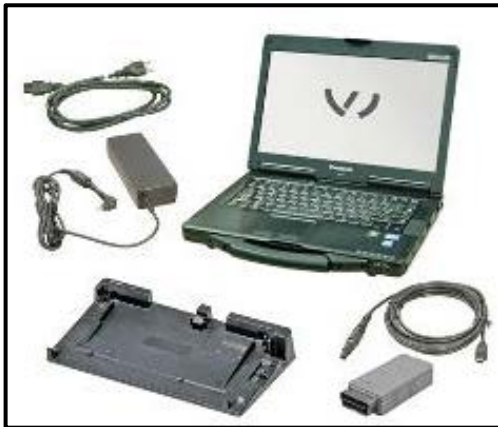
- VAS6150X – Diagnostic Tester (or equivalent)
- VAS5054X – Remote Diagnosis Head (or equivalent)

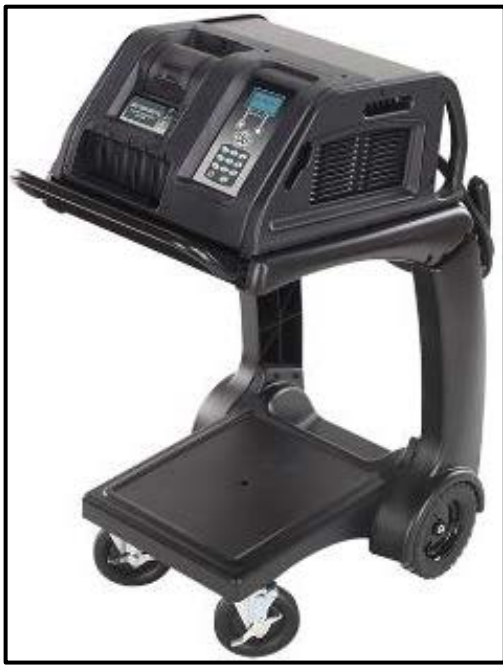
- GRX3000VAS – Battery Tester/Charger (or equivalent)

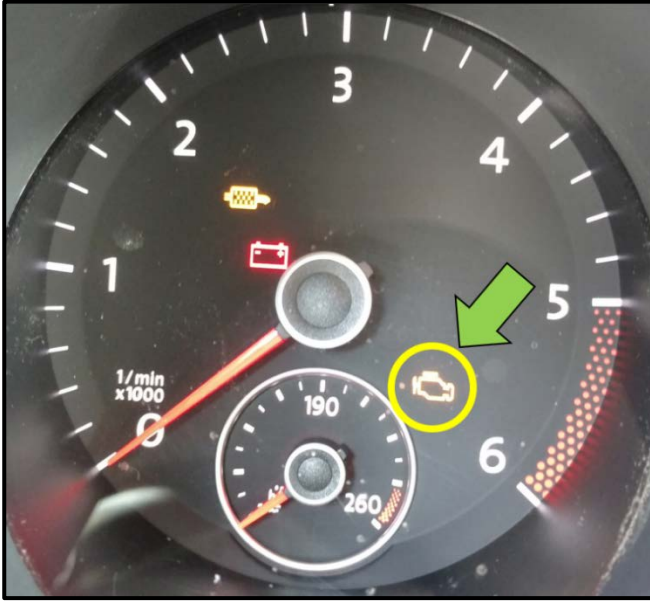
- Check for illumination of the MIL <arrow>.
 - If MIL is illuminated, STOP, obtain GFF diagnostic log, create a VTA ticket and contact the Volkswagen Technicians Helpline.
 - If MIL is not illuminated, continue work procedure.

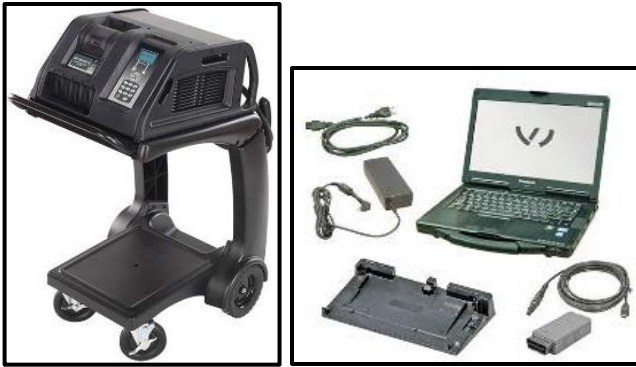
- Open the hood.
- Open the battery cover.
- Attach the GRX3000VAS Tester/Charger (or equivalent) to the vehicle battery.
- Switch the ignition on.
- Apply the parking brake.
- Switch the headlights off.
- Connect the VAS6150X Diagnostic Tester (or equivalent) to the vehicle.
- Start the ODIS program.

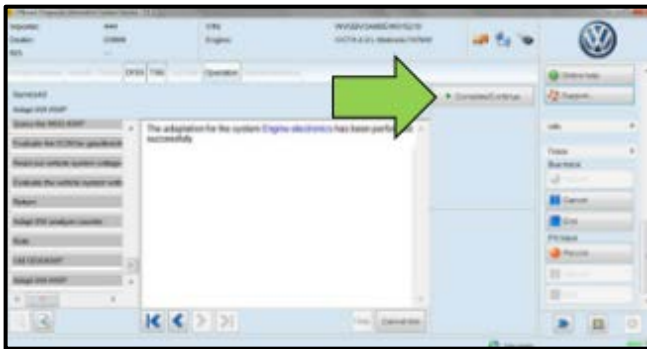
- When the SVM update is complete a confirmation message is displayed <as shown>.
- Select "Complete/Continue" <arrow>.

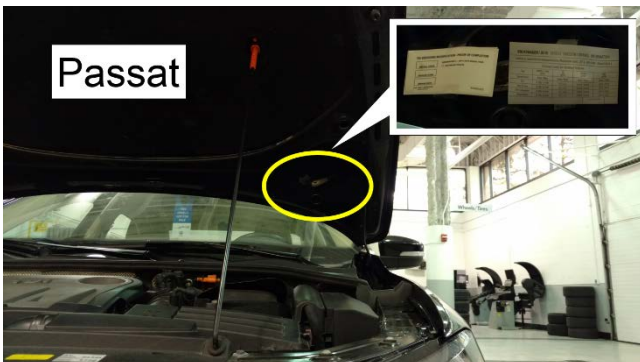
- Open the hood.
- Clean the surface where the label is to be installed <circle>.
- Install the supplemental Vehicle Emissions Control Information label, 03L 010 005 H, in the location shown <circle>.

- The surface where the label is to be installed must be clean, dry, and free from oil residue prior to installing the label.
- Label must NOT cover any existing label(s).
- Label must be installed in location shown.
- Photo documentation of label installed is required.
