# Emissions Recall

## Code: 23U4

| <b>Subject</b> | <b>2.0L TDI Engine (GEN 2 – Automatic Transmission)</b><br><b>Emissions Modification – <u>USA ONLY</u></b> |

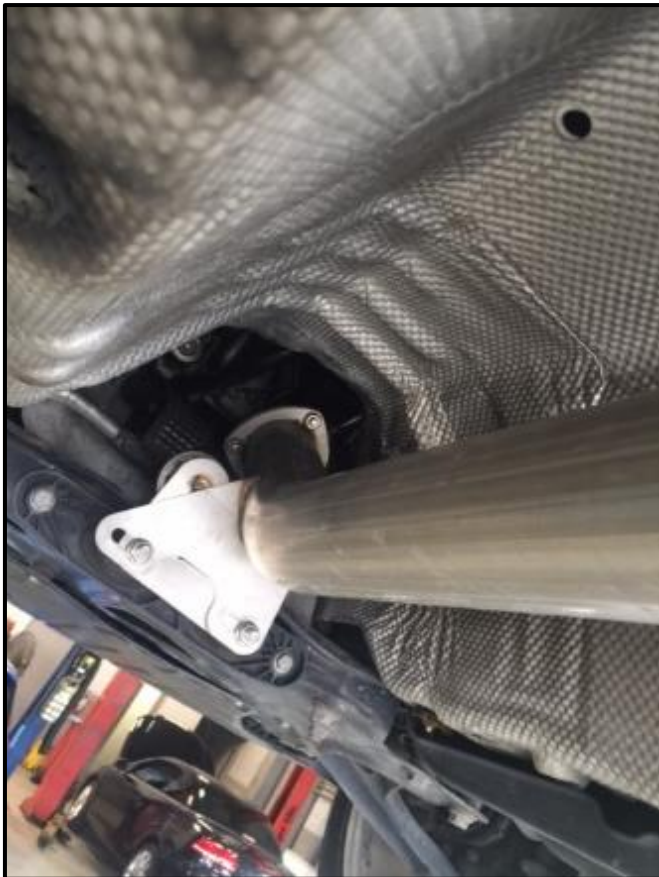
- Check for vehicle modifications from original equipment.
  - o If vehicle modifications from original equipment related to emissions components are found, **STOP**, create a VTA ticket and contact the Volkswagen Technicians Helpline.
  - o If vehicle modifications from original equipment related to emissions components are not found, continue the work procedure.

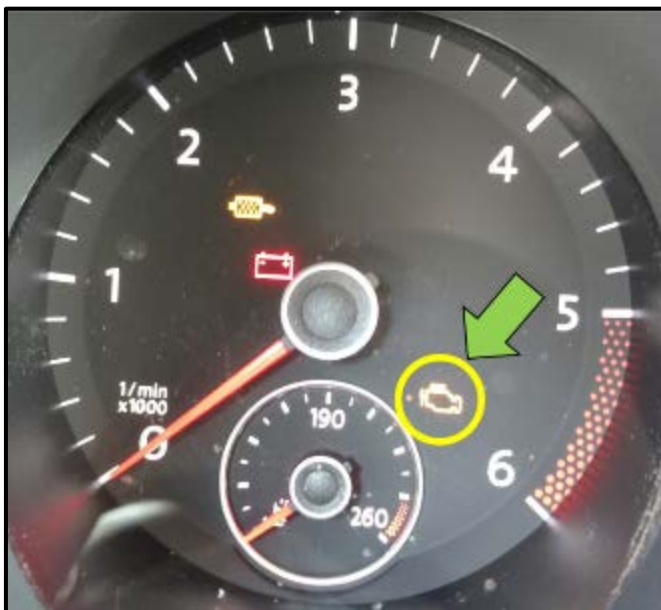
- Check for illumination of the MIL <arrow>.
  - o If MIL is illuminated, **STOP**, create a VTA ticket and contact the Volkswagen Technicians Helpline.
  - o If MIL is not illuminated, continue the work procedure.

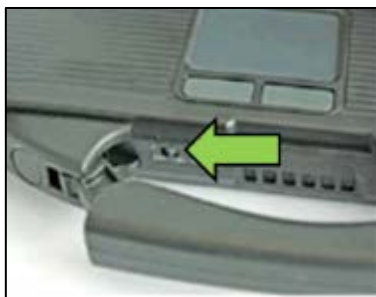
**VAS 6150 & VAS 6150A**  
(Front panel behind handle)

- Performing a software update using a Bluetooth connection increases the risk of losing connection during the update, which could result in damage to the control module. It also greatly increases the time required to perform the update. Requests for additional time or parts will be denied if the GFF log shows the update was performed using Bluetooth.
- ✓ **The Bluetooth function of the scan tool is physically switched off <see pictures below>.**

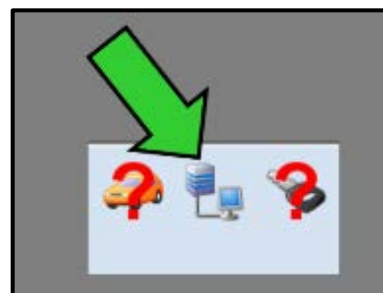
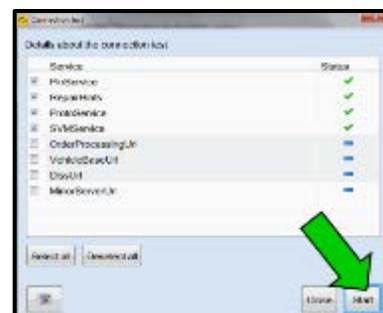
- ✓ Verify your network connection <arrow> either thru LAN or WIFI by checking the connection icon (lower right of the home screen).
- ✓ Check the icon <arrow> within the ODIS software that you have a connection.
- ✓ Within the Connection Tab, verify that the Connection type(s) display “Internet” <as shown>.
- ✓ Start a connections test <arrow> and verify that all connections pass.

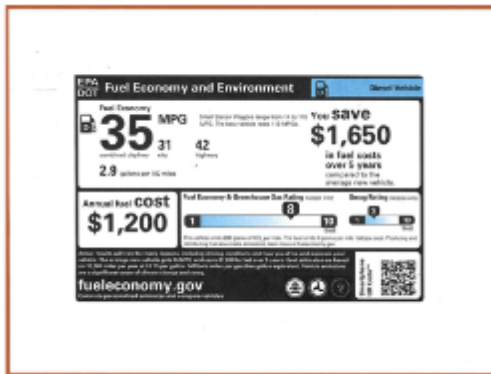
- Install new Fuel Economy Label <example pictured left> to the right of the new Monroney Label. If necessary, use the passenger front window <examples pictured below>.

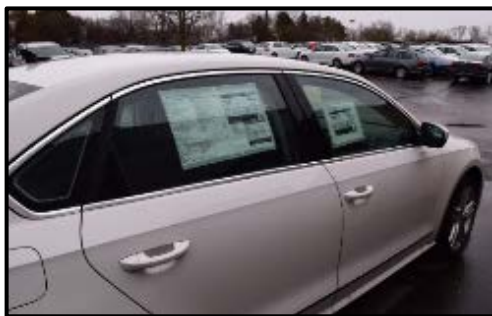
- Example of properly installed labels.
