# Emissions Recall

## Code: 23U4

| Subject | 2.0L TDI Engine (GEN 2 – Automatic Transmission)<br>Emissions Modification – <u>USA ONLY</u> |
| Corrective Action | Install updated emissions control system software, install a supplemental Vehicle Emissions Control Information label and TDI Emissions Modification Completion Label.<br><br>If the vehicle has been modified by the customer prior to receiving the emissions modification in a manner that may yield a non-compliant emissions system (for example, removal of a catalyst, installation of parts that impact emissions or emissions-related parts, or modifications to the ECU or computer software of the vehicle), Volkswagen may not be able to perform the emissions modification until the customer corrects such modification. |

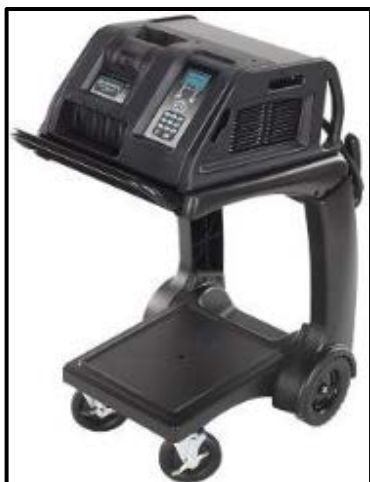
- GRX3000VAS – Battery Tester/Charger (or equivalent)

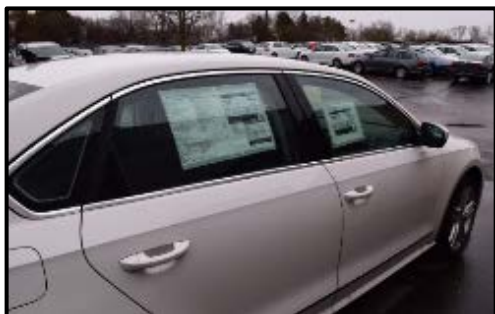
- Example of properly installed labels.
