Emissions Recall Code: 23U7

Subject	2.0L TDI Engine (GEN 1) Emissions Modification – Customer Only (Retail Sold) <u>USA</u> <u>ONLY</u>
Release Date	August 11, 2017
Important Repair Information!	CAMPAIGN 23W1MUST BE COMPLETED BEFORE BEGINNING THE 23U7 CAMPAIGN! Over the next few weeks there will be updates made to ODIS and the campaign circular. Do not retain any hard copies of campaign circulars – only refer to the electronic copies posted to Elsa and ServiceNet.
Affected Vehicles	U.S.A.: 2010-2013 MY Audi A3 2.0L TDI (Generation 1)
	Check Campaigns/Actions screen in Elsa on the day of repair to verify that a VIN qualifies for repair under this action. Elsa is the <u>only</u> valid campaign inquiry & verification source.
	✓ Campaign status must show "open."
	 If Elsa shows other open action(s), inform your customer so that the work can also be completed at the same time the vehicle is in the workshop for this campaign.
Problem Description	The Environmental Protection Agency and California Air Resources Board have determined that Audi A3 vehicles equipped with a 2.0L 4-cylinder TDI engine do not comply with applicable emissions regulations. The emissions control systems on the veh

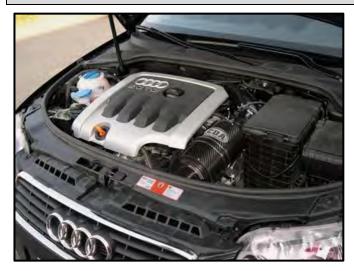
- Perform a visual inspection of the intake, exhaust, and emissions systems.
 - If the visual inspection of the intake, exhaust, or emissions equipment reveals damage or concerns, STOP, create an ATA ticket and contact the Audi Technicians Helpline.
 - If the visual inspection of the intake, exhaust, or emissions equipment reveals no damage or concerns, continue the work procedure.

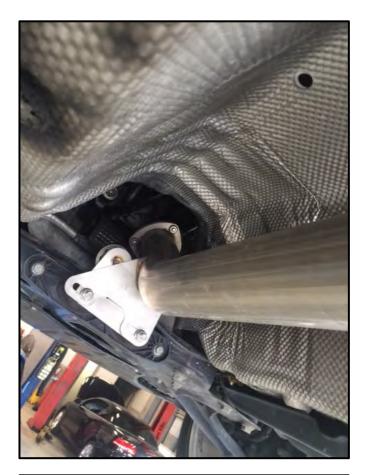
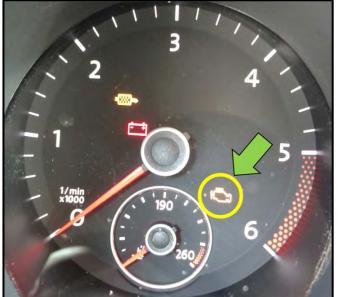
- Check for vehicle modifications from original equipment.
 - If vehicle modifications from original equipment related to emissions components <u>are</u> found, **STOP**, create an ATA ticket and contact the Audi Technicians Helpline.
 - If vehicle modifications from original equipment related to emissions components are <u>not</u> found, continue the work procedure.

- Check for illumination of the MIL <arrow>.
 - If MIL is illuminated, STOP, create an ATA ticket and contact the Audi Technicians Helpline.
 - If MIL is not illuminated, continue the work procedure.

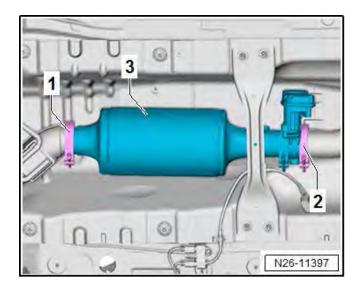
Loosen clamps <1 and 2> and remove NOx storage catalytic converter together with exhaust door control unit -J883-.

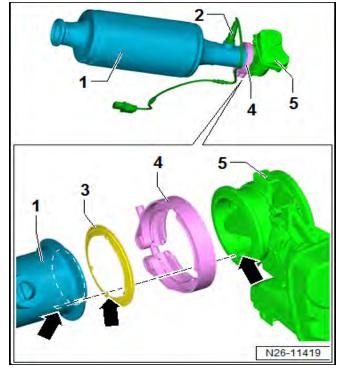
- Screw new oxygen sensor after catalytic converter -G130- <2> into new NOx storage catalytic converter <1> and tighten to 52 Nm using socket, 22 mm -T10491-.
- Set new exhaust door control unit -J883- <5> with new seal <3> on NOx storage catalytic converter <1>. Note notches <arrows>.

Renew all clamps and seals. The clamps before and after the exhaust door control unit are narrower than the clamp connecting the particulate filter to the NOx storage catalytic converter. Ensure that they are correctly allocated.

- Position clamp 1K0 253 725 B <4> and tighten to 7 Nm.
- Place NOx storage catalytic converter together with exhaust door control unit -J883- with new seals in installation position. Note notches at rear connection.

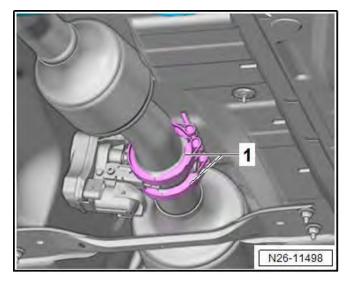
• Position all clamps <1> so that they will not collide with underbody.

- Set clamp 1K0 253 725 B <2> in place and engage and torque to 7 Nm.
- Set clamp 1K0 253 725 <1> in place and engage. Then tighten to 7 Nm.

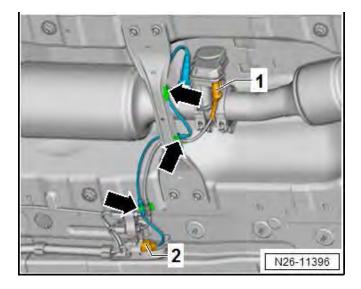
- Connect »brown« connector for oxygen sensor after catalytic converter -G130- <2> and attach to bracket.
- Push connector <1> onto exhaust door control unit. Secure lines in retainers <arrows>.

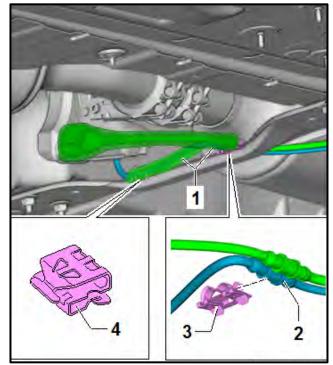
- Wrap new heat insulation mats <1> around wiring and close fasteners.
- Place wires <2> in clips <3 and 4>.

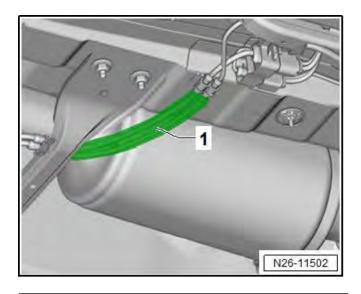
• Wrap new heat insulation mats <1> around wiring and close fasteners.

• Press underbody cladding upward and tighten nuts <arrows> to 2 Nm.

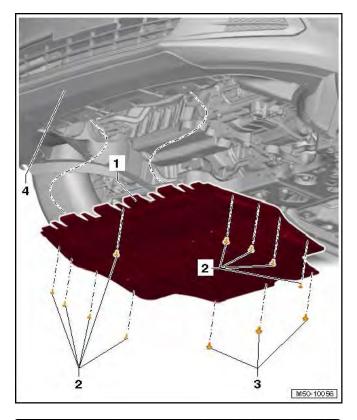
- Remove bolts <2 and 3>.
- Pull noise insulation <1> back, out of front bumper cover <4>.

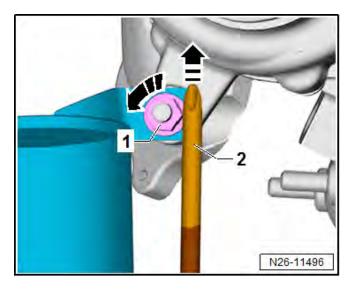
- Remove nut <2> from exhaust gas recirculation filter <1> from below using 13 mm ratchet box wrench (e. g. Snap-on OEXRM13).
- Wrap tape around the tip of a long screwdriver (e.g. Snap-on SDD162 No.2).

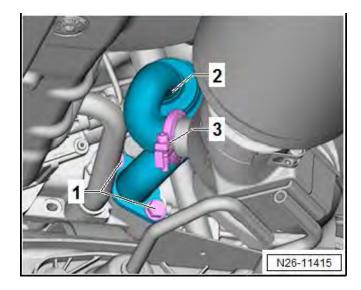
• Apply screwdriver <2> on side of nut <1> and unscrew nut while simultaneously pressing up on nut.

- Open clamp <3> and remove it.
- Remove bolts <1> and remove exhaust gas recirculation filter <2>.

- Set new exhaust gas recirculation filter <2> with new seals in place, screw in bolts <1> and tighten to 9 Nm.
- Position clamp <3> and tighten to 3.5 Nm.

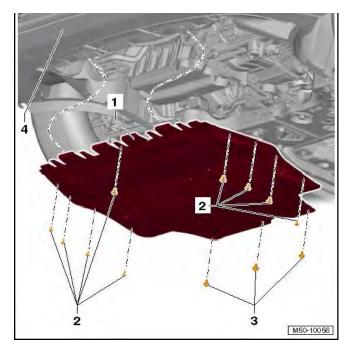
- Push noise insulation <1> forward into front bumper cover <4>.
- Screw in bolts <2> and new bolts <3> and tighten as follows:
 - o Bolt <2>: 2 Nm
 - Bolt <3>: 6 Nm (renew)
