# Emissions Recall

## Code: 23U7

<b>Subject</b>	<b>2.0L TDI Engine (GEN 1) Emissions Modification – Customer Only (Retail Sold) <u>USA ONLY</u></b>
<b>Release Date</b>	August 15, 2017
<b>Revision Summary</b>	<b>Criteria I.D. updated in Saga claiming instructions.</b>
<b>Important Repair Information!</b>	<b>CAMPAIGN 23W1MUST BE COMPLETED BEFORE BEGINNING THE 23U7 CAMPAIGN!</b> <b>Over the next few weeks there will be updates made to ODIS and the campaign circular. Do not retain any hard copies of campaign circulars – only refer to the electronic copies posted to Elsa and ServiceNet.</b>
<b>Affected Vehicles</b>	<b>U.S.A.: 2010-2013 MY Audi A3 2.0L TDI (Generation 1)</b>  <i>Check Campaigns/Actions screen in Elsa on the day of repair to verify that a VIN qualifies for repair under this action. Elsa is the <u>only</u> valid campaign inquiry &amp; verification source.</i> <ul style="list-style-type: none"><li>✓ Campaign status must show “open.”</li><li>✓ If Elsa shows other open action(s), inform your customer so that the work can also be completed at the same time the vehicle is in the workshop for this campaign.</li></ul>

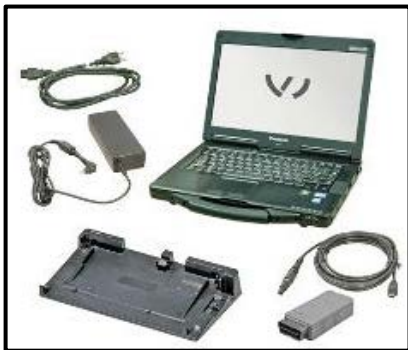
- VAS6150X – Diagnostic Tester (or equivalent)
- VAS5054X – Remote Diagnosis Head (or equivalent)

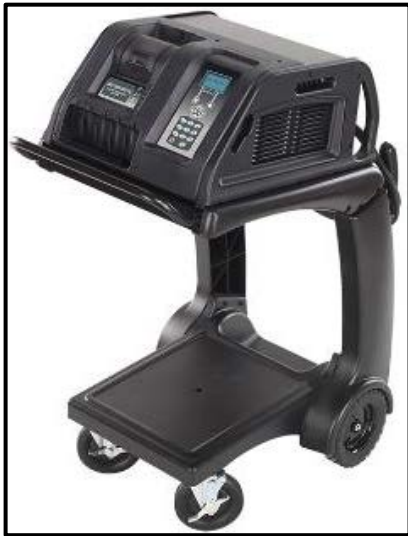
- GRX3000VAS – Battery Tester/Charger

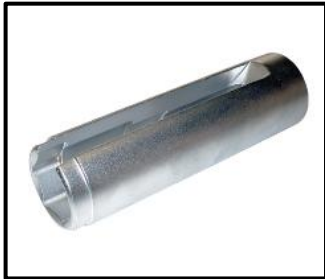
- Socket 22mm –T10491–

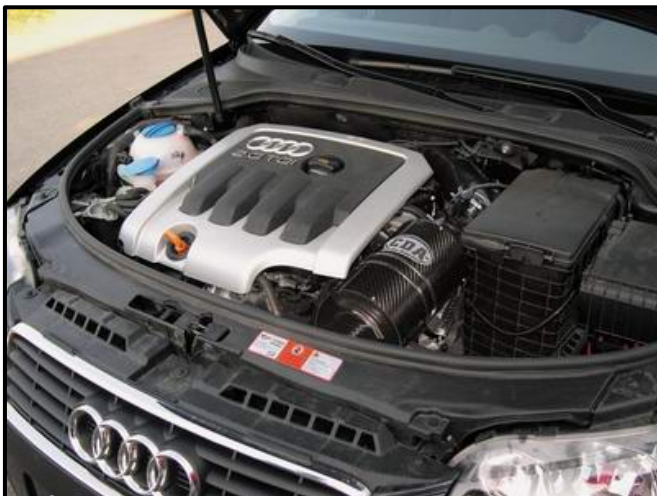
- Perform a visual inspection of the intake, exhaust, and emissions systems.
  - If the visual inspection of the intake, exhaust, or emissions equipment reveals damage or concerns, **STOP**, create an ATA ticket and contact the Audi Technicians Helpline.
  - If the visual inspection of the intake, exhaust, or emissions equipment reveals no damage or concerns, continue the work procedure.

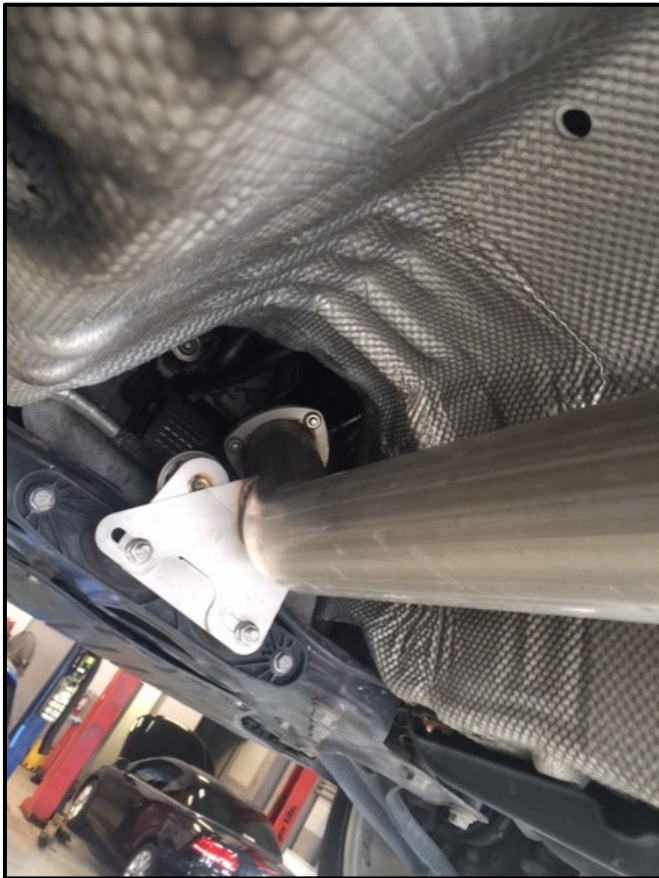
- Check for vehicle modifications from original equipment.
  - If vehicle modifications from original equipment related to emissions components are found, **STOP**, create an ATA ticket and contact the Audi Technicians Helpline.
  - If vehicle modifications from original equipment related to emissions components are not found, continue the work procedure.

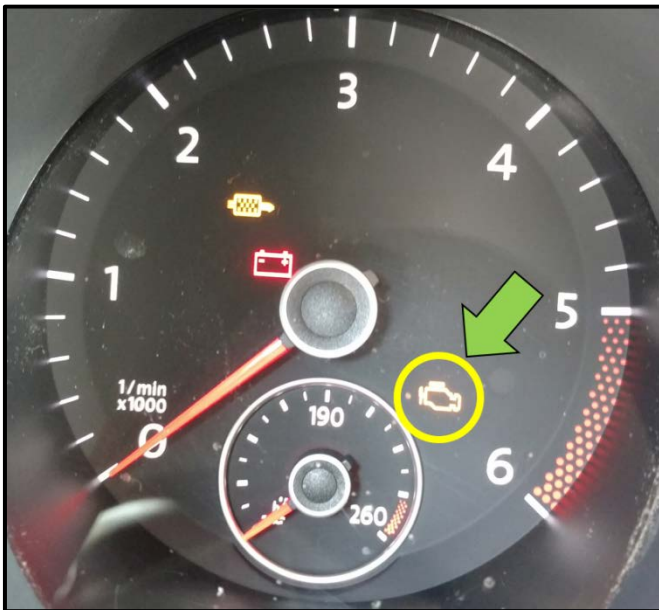
- Check for illumination of the MIL <arrow>.
  - If MIL is illuminated, **STOP**, create an ATA ticket and contact the Audi Technicians Helpline.
  - If MIL is not illuminated, continue the work procedure.

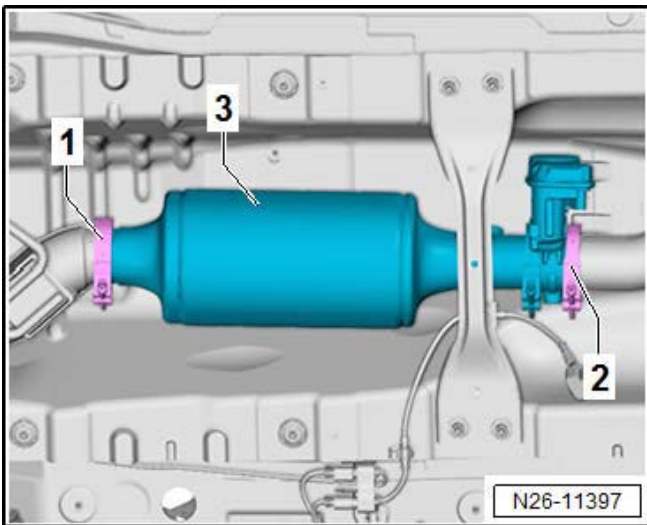
- Set clamp 1K0 253 725 B <2> in place and engage and torque to 7 Nm.
- Set clamp 1K0 253 725 <1> in place and engage. Then tighten to 7 Nm.

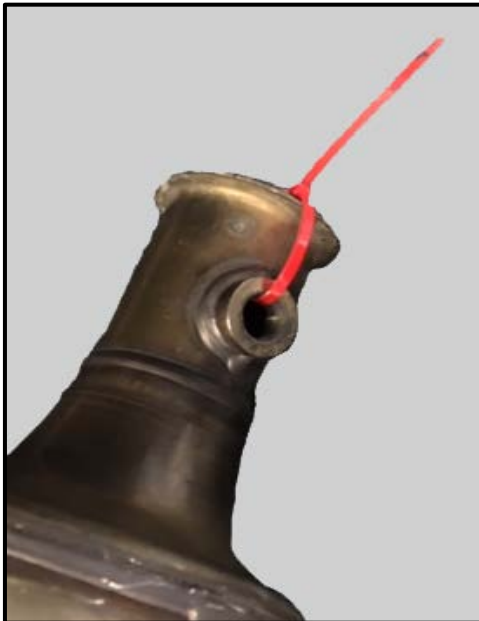
- Install the **RED** validation strap to the NOx catalytic converter <as shown> to confirm that the proper part is being returned for core.

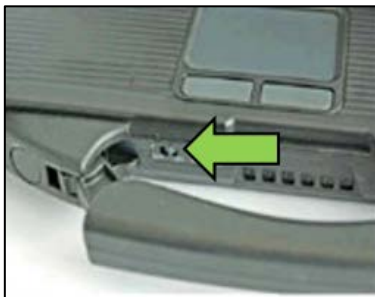
**VAS 6150 & VAS 6150A**  
(Front panel behind handle)

- Performing a software update using a Bluetooth connection increases the risk of losing connection during the update, which could result in damage to the control module. It also greatly increases the time required to perform the update. Requests for additional time or parts will be denied if the GFF log shows the update was performed using Bluetooth.
- ✓ **The Bluetooth function of the scan tool is physically switched off <see pictures below>.**

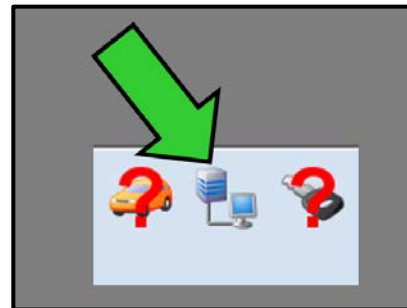
- ✓ Check the icon <arrow> within the ODIS software that you have a LAN connection.

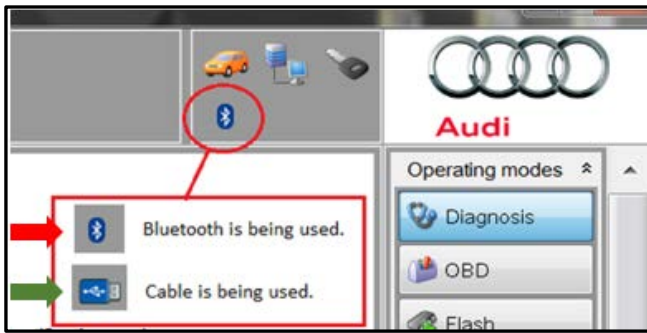
- Confirm that scan tool is communicating with the diagnostic head by USB <Green Arrow>.
  - If the Bluetooth symbol is shown <Red Arrow> then disconnect the diagnostic head from the vehicle and reconnect the USB cable to the diagnostic head and then reattach to the vehicle.

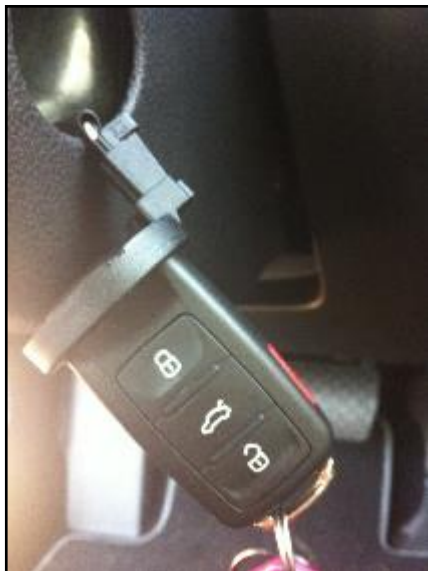
For the duration of the flash, the following is required to keep the BUS system active during the flash process:

- Driver side door open
- Doors unlocked
- Hazzard flashers in the "On" position

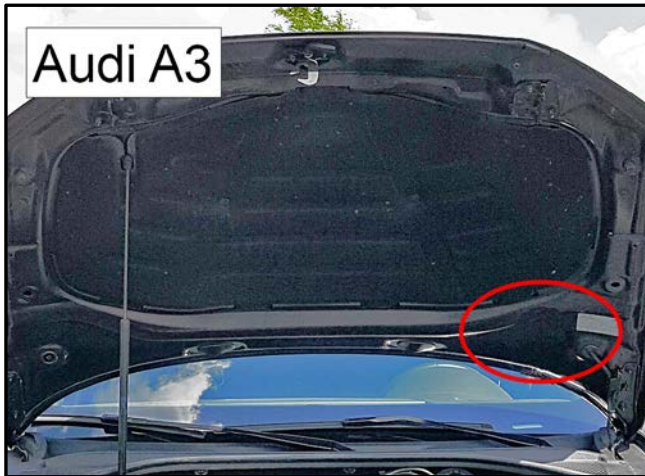
- The surface where the label is to be installed must be clean, dry, and free from oil residue prior to installing the label.
- Label must NOT cover any existing label(s).
- Label must be installed in location shown.
- Photo documentation of label installed is required.

- Open the hood.
- Clean the surface where the label is to be installed <circle>.
- Install the Supplemental Vehicle Emissions Control Information Label, **03L 010 005 G**, in the location shown.
